Customer Notification

VR4133TM

64-bit Microprocessor

Operating Precautions

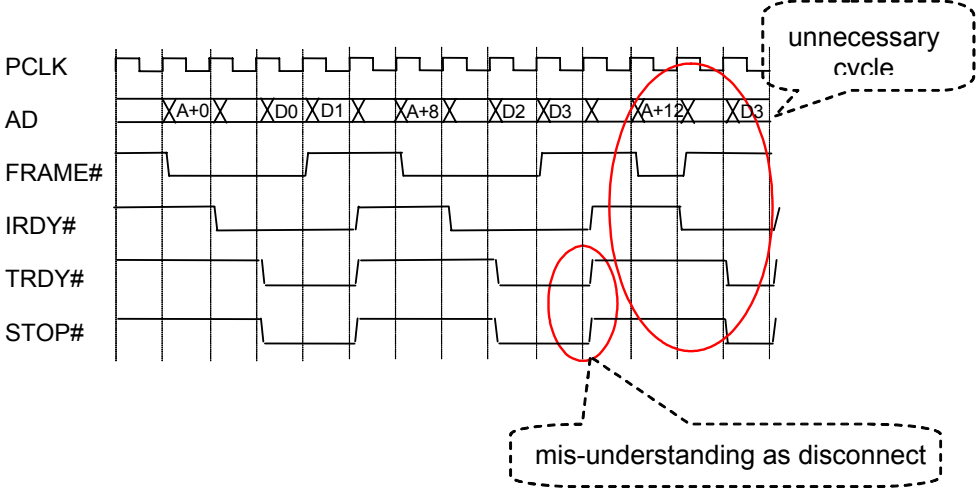
<p>No. 7</p>	<p>Disconnect at the end of PCI burst cycle (Specification change notice)</p>
	<p><u>Details</u> The last transfer of a PCI burst cycle is regarded as a disconnect cycle by VR4133, if STOP# and TRDY# are both asserted during the last-but-one data cycle, as shown in the following figure:</p>

<p>D0 ,D1,D2 are burst data; D3 is last burst data and D2 is last-but-one burst data. TRDY# and IRDY# are both asserted during D2 and D3. So data transfer of D2 and D3 is finished. But because of this restriction, VR4133 mis-interpreting data phase as if it is disconnected at D2. Therefore D3 cycle is performed again.</p> <p>Therefore one of the following workarounds must be implemented:</p> <ol style="list-style-type: none"> (1) Do not use PCI-DMA function. (2) Do not use LD and SD instructions and do not locate PCI memory and I/O areas in cached memory region of the CPU, so that burst cycles as shown above are not generated.
