**BOOM ARM MOWER**

# **INFORMATION & SERVICE BULLETINS**

Manual P/N 02980501  
(08/05)

**2005 Edition**

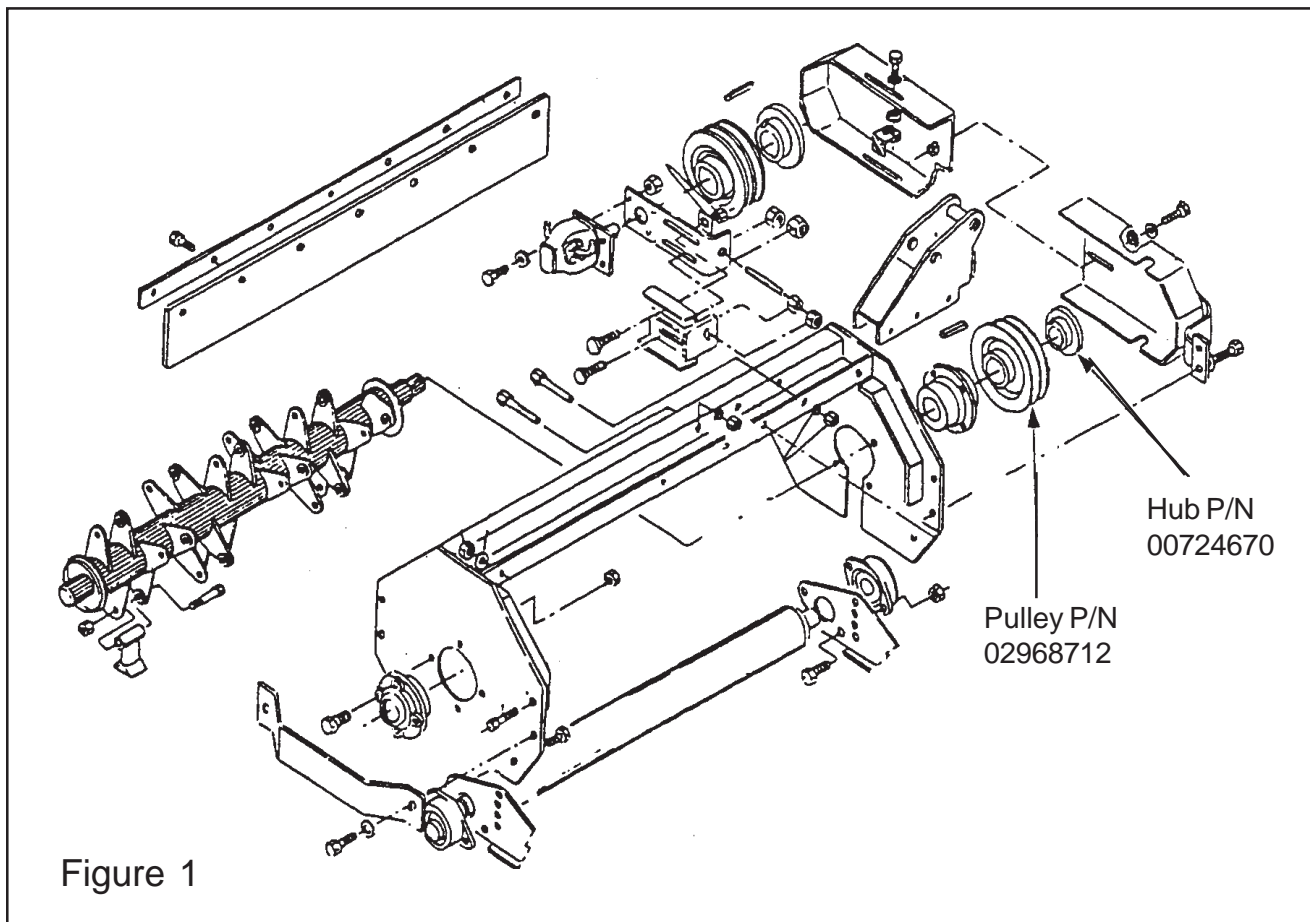
A new method has been devised to secure the pulley to the cuttershaft. A new pulley, P/N 02968712 and a QD Pulley Hub P/N 00724670 has replaced the old pulley with setscrew, washer, lockwasher and bolt. The new pulley and hub are a keyed, taper lock design which will provide a better fit and longer service life for the shaft.

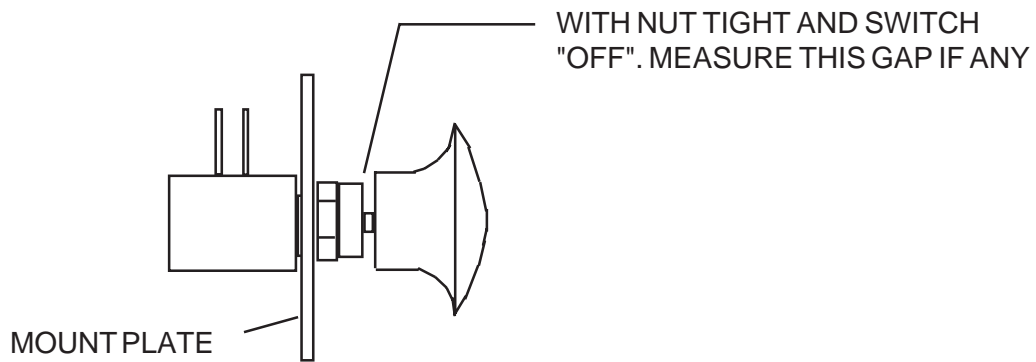
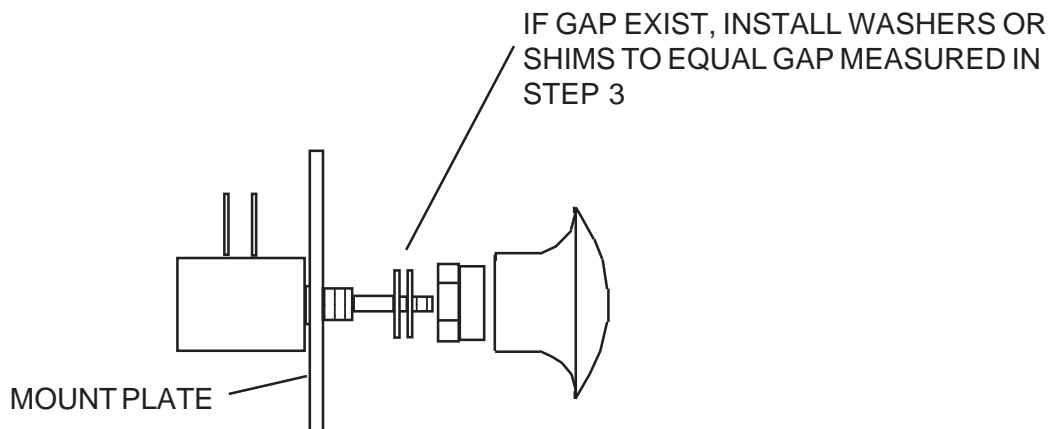
## Information Bulletin 092895 Continued from previous Page

Test performed on numerous switches indicates that the (b) failures are due to excessive force being applied to the knob when shutting off the mower. Specifically, the knobs are usually roughly slapped to turn the mower off. After internal parts of the switch are damaged, the rod can then be pulled out easily. The (a) failures are due to the knobs not being securely tightened.

To prevent these failures from occurring, or to replace a damaged switch, use the following procedure to adjust the travel of the switch. (See attached diagram).

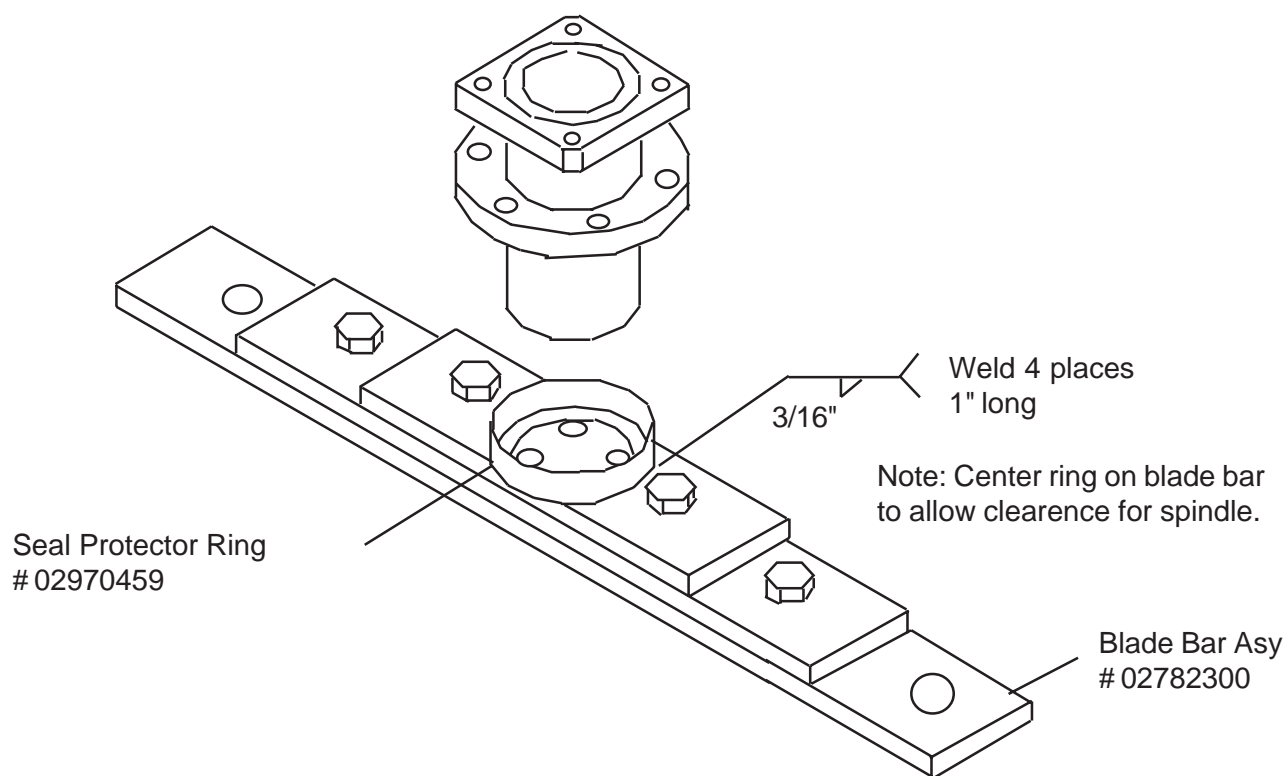
# Information Bulletin 032596 Continued from previous Page

The problem is usually found to be that the spindle end cap cover is binding on the spindle housing, creating sufficient drag on the shaft to result in the symptoms described above. This condition is a result of material (Vines, Wire, etc.) wrapping around the cover and forcing it to contact and drag against the spindle housing, causing no damage to internal components of the spindle.

The new seal protector will have to be welded to the upper blade bar as shown on the next page and the old seal protector which is on the spindle will be discarded. Make sure that the Blade bar retaining bolts are properly torqued when reattaching to spindle and that components are good condition.

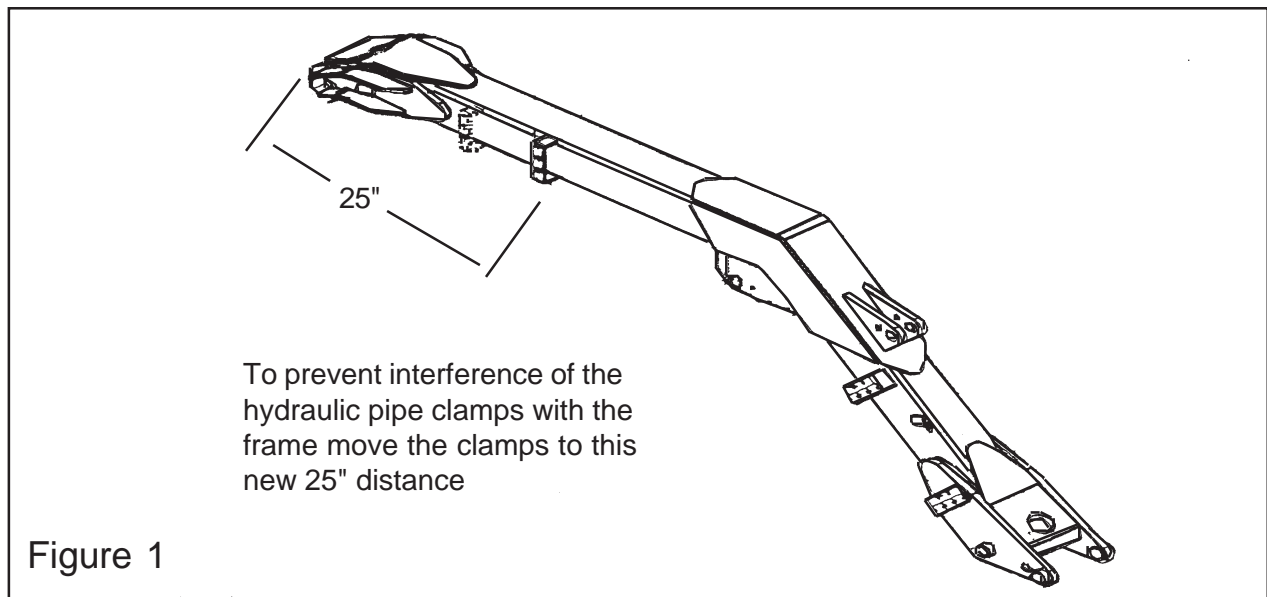
It is possible that the boom hydraulic tube clamps may contact the main frame when boom is raised to its highest position. This condition effects only machines with certain frames. If you have a machine that has this interference problem use the procedures described in this bulletin to correct the problem. (See Figure 1).

If the parts on your unit are damaged, loosen the six bolts that hold the three tubes. Cut the bracket away from the boom. Relocate the bracket on the boom so it clears the frame. Weld in place and paint. Tighten the six bolts. Total time to perform this modification will be approximately 1.5 hours time or less. If parts are required there is a kit that can be installed, the Kit # 02971938.

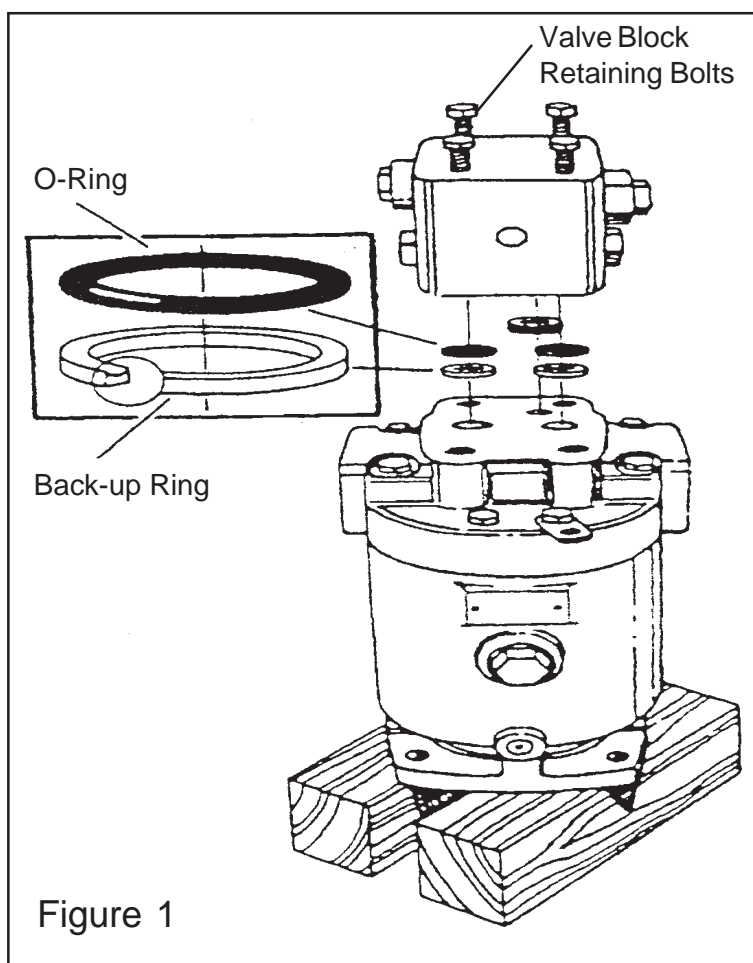
A kit (Kit # 02972094) to replace the O-Ring and Back-up Rings which are located between the valve block and the motor housing on the piston motors # 02977193 used on the Brahma rotary and Machete boom mounted cutters is available. The Valve block must be removed when the motor is replaced as it is attached to the support plate. This causes an occasional failure of the seals.

When installing the valve block the retaining bolts to the motor they must be torqued to 35 ft. lbs. in an alternating pattern.

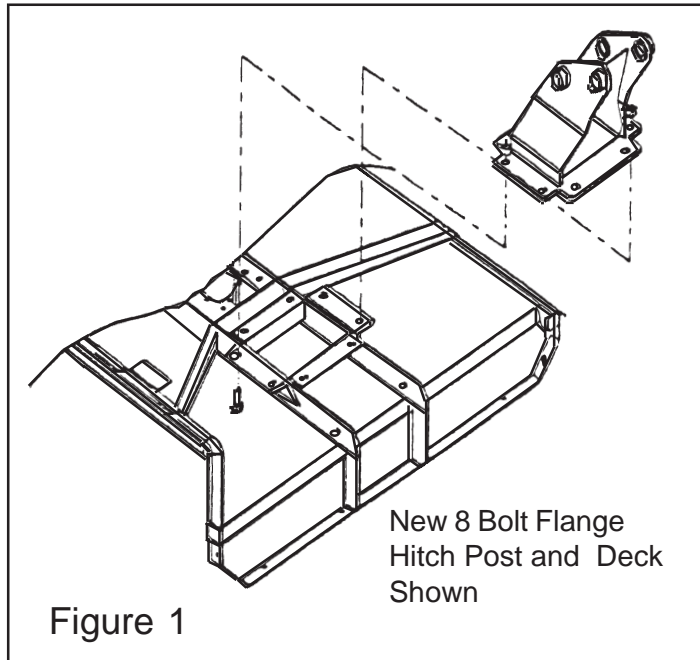
Hitch Post replacement kits are now available for Machete Boom models MB21 & MB24. The new design utilizes an 8 bolt flange design which requires angle braces to be welded to the cutter head. If you are experiencing problems with the original hitch post, it could be replaced with the new design. Install the new Hitch Post using the following procedure.

1. Remove Head from Boom by following cutting head removal & install instructions in the Operators Parts manual. If you do not have this manual it is recommended you obtain one before proceeding with this repair.
2. Remove the old Hitch Post from the head. Clean all debris and Oil off of deck. Clean the paint off around the area where the new flange will be welded.
3. Place angles (02971946 & 02972111) on rotary head as shown in Figure 2 and Figure 3. All measurements are to be taken from the edge of the 3/8" X 3" ribs running across the rotary head.

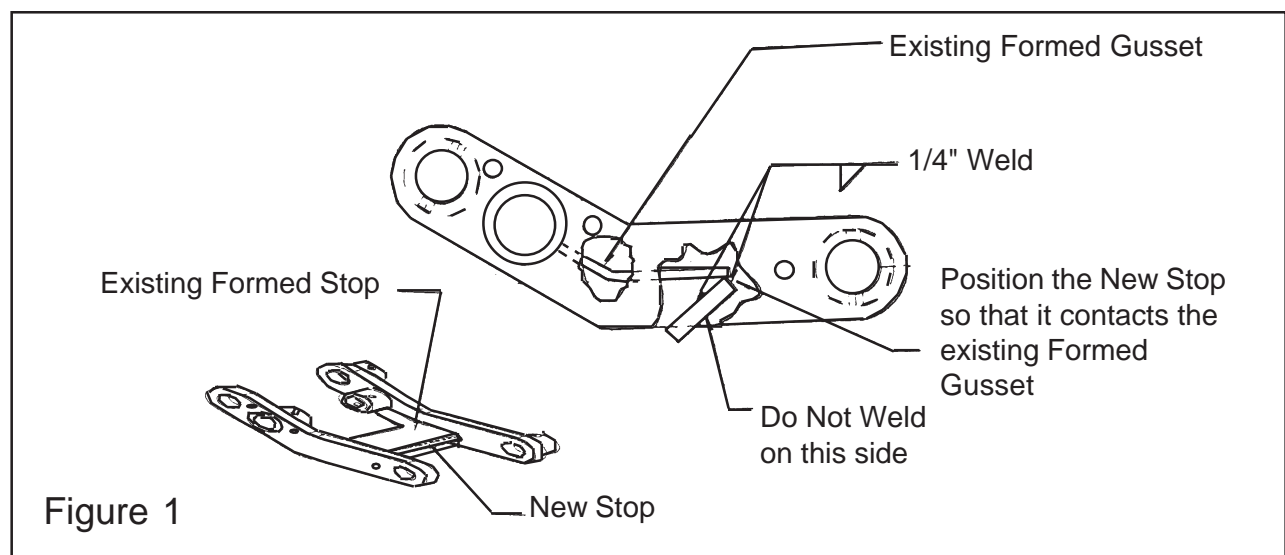
In order to avoid possible damage, a stop should be fabricated and installed which will limit the head tilt retraction before interference occurs.

To locate the proper angle position of the new stop, carefully retract the head until the cutter motor support plate and the head tilt cylinder has a clearance of 1". Use caution, do not damage cylinder when retracting the head. Place the new stop plate in the head tilt link weldment and lay it flat on the dipper arm. Mark this position, and weld the stop in place as shown in Figure 1. It is important that the stop is installed so that it flatly contacts the dipper when retracted in order to avoid point loading on the boom. Extend and retract the cylinder to ensure proper installation.
