Information on Software Update
BERNINA 8 Series, V29.39.00

Information on Software Update *BERNINA 830 / 820*

The Release Note V29.39.00 is in addition to the Release Note V29.21.40 (6/2009).

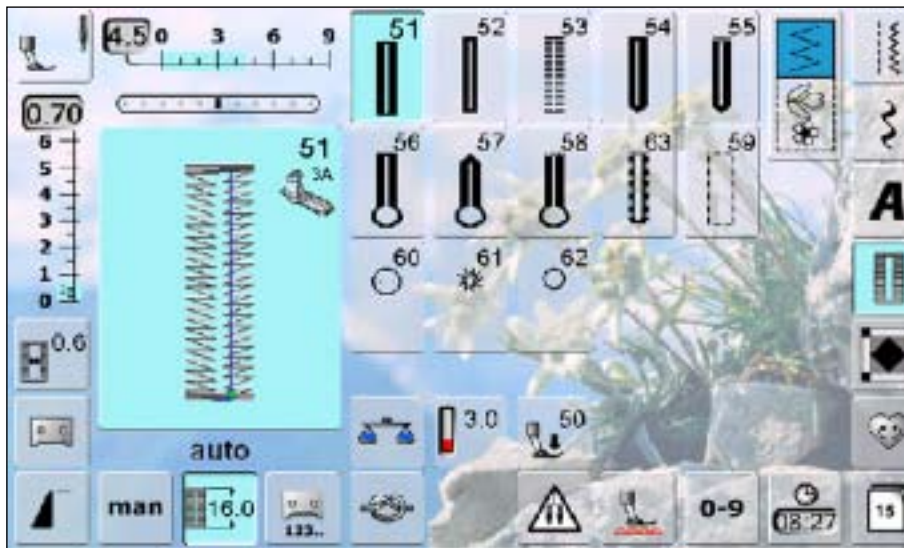
2.1 Thread tension for the underlay segments (buttonholes)

To eliminate possible thread loops, the thread tension for segments with short step stitches is increased from 2.0 to 3.0.

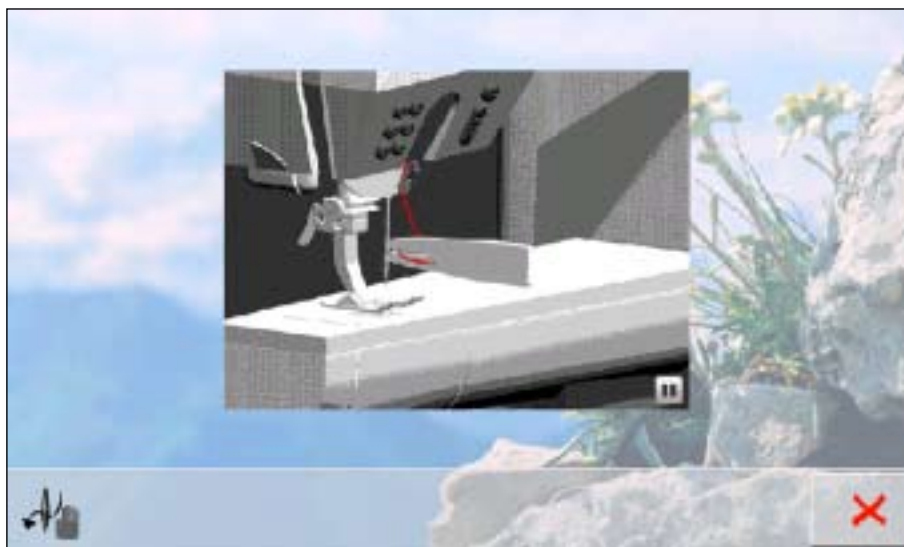
2.2 Manual threading

In some cases during manual threading, the thread swing support mechanism can be blocked. This update avoids this issue without performing any mechanical readjustments.

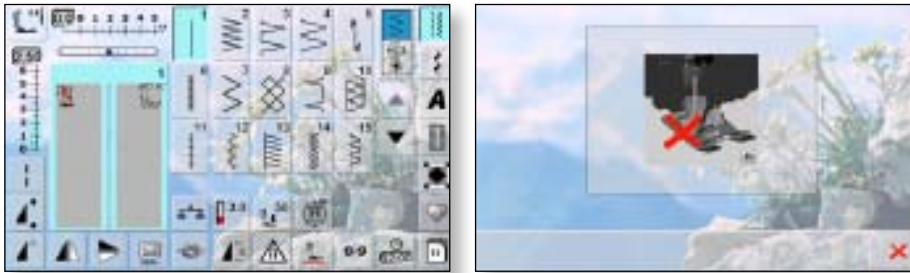
2.3 The use of straight stitch feet with thread cutting

The opening of the straight stitch foot is 0.4mm on both sides. The “tie on” stitch after cutting is 0.4mm to the left side. After thread cutting, the first stitch failed resulting in the animation “needle will penetrate presser foot” due to the narrow tolerance in the foot opening. This has been resolved.

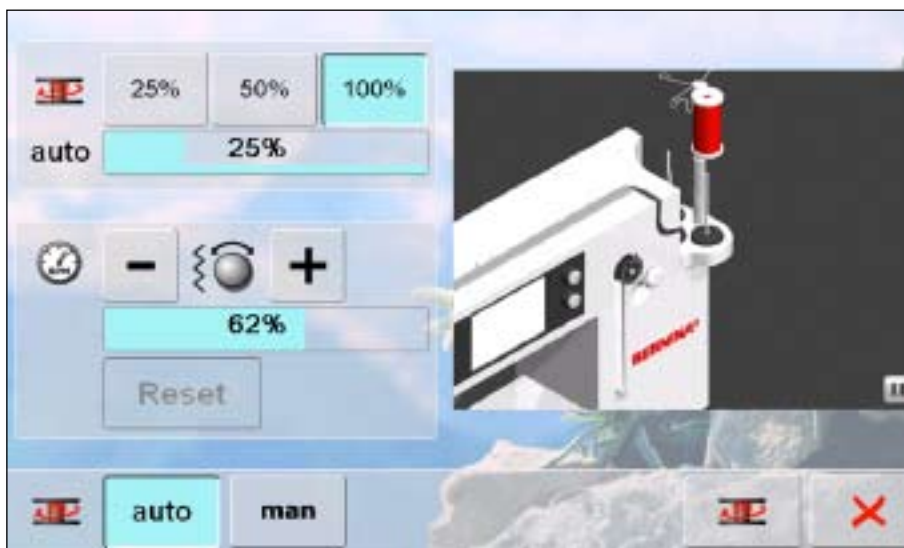
2.6 “Manual” winding of the lower bobbin thread

The filling process stops at a detection of 100% fill level. As a result of mechanical tolerances, it is possible that the bobbin does not fill to the maximum capacity.

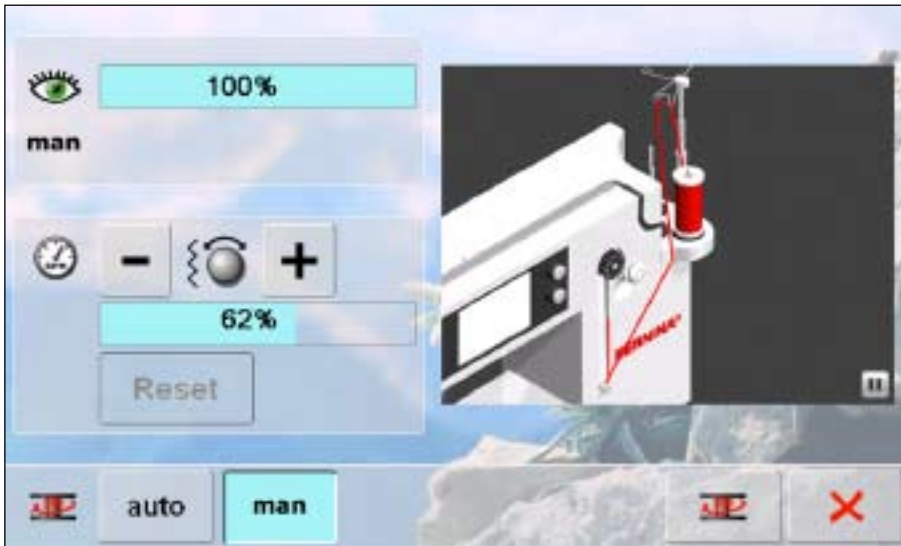
In addition to the "automatic" mode, an extended manual mode is implemented.

This mode gives the user the opportunity to start and stop the winding process by holding and releasing the winding button.

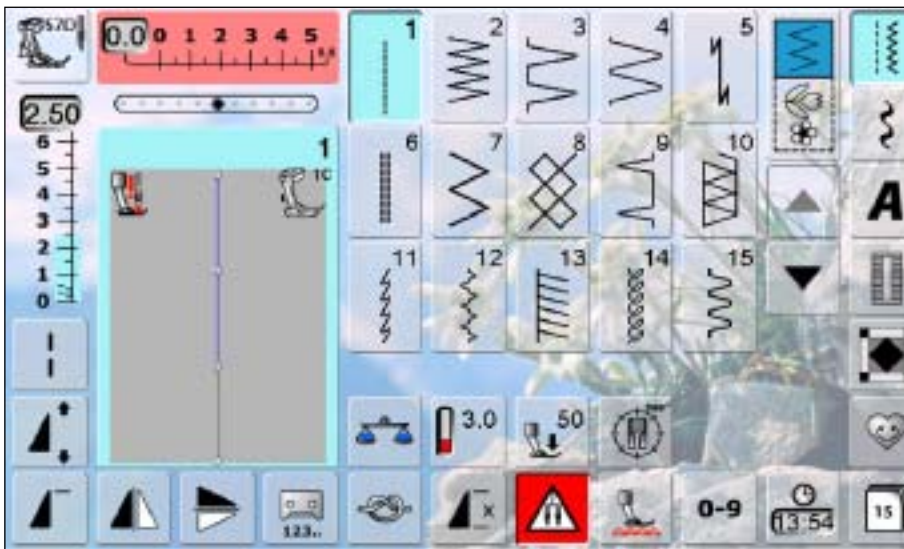
2.10 Problem with Foot #57D and straight stitch compatibility

Select stitch #1, attach and select the foot #57D (Patchworkfoot with guide). Open the securing function and select the straight stitch plate.

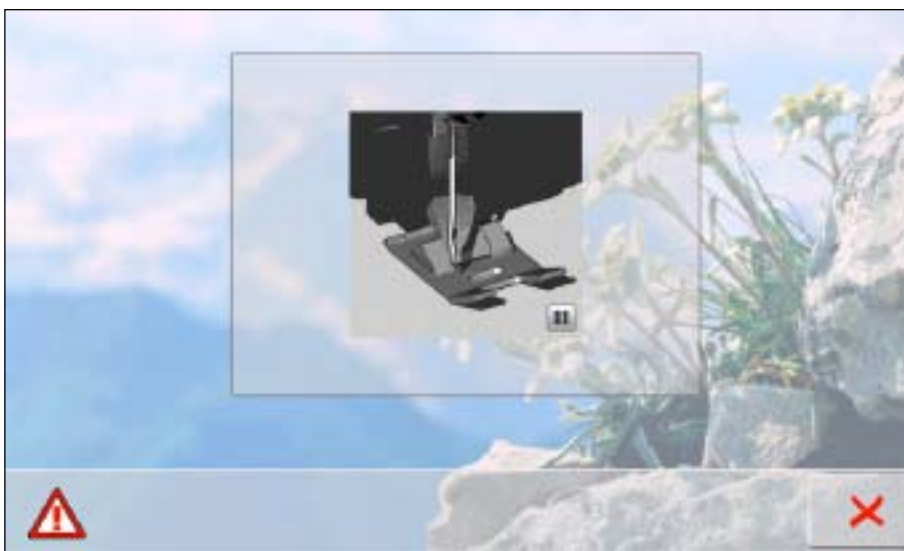
Now, it is possible to start the sewing process, without the warning message appearing:

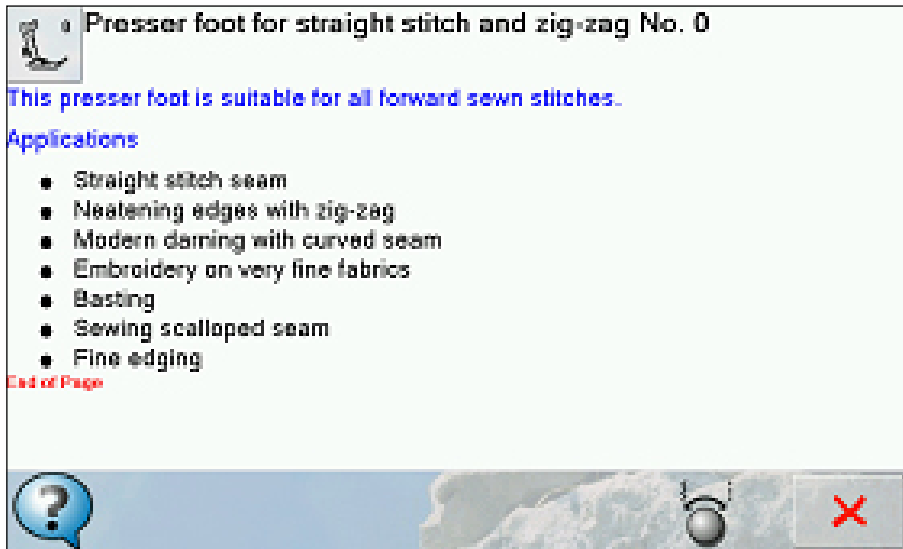
2.11 Presser Foot #0 can be used for automatic threading. With the "Walking foot" automatic threading is not possible

The original help text mentioned that the machine cannot be threaded automatically with foot attached. New help text implemented:

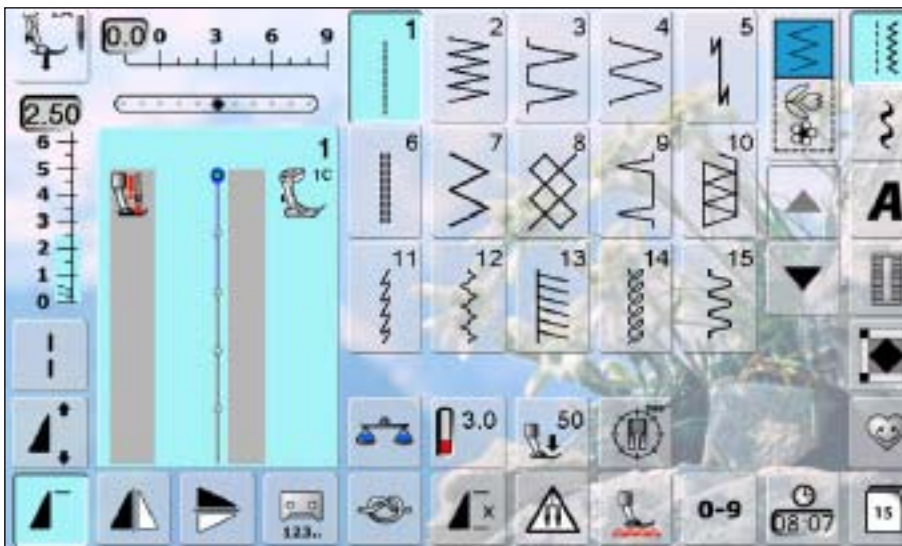
2.12 Information Foot #2a corrected

Data correction of the dimensions of the presser foot sole.

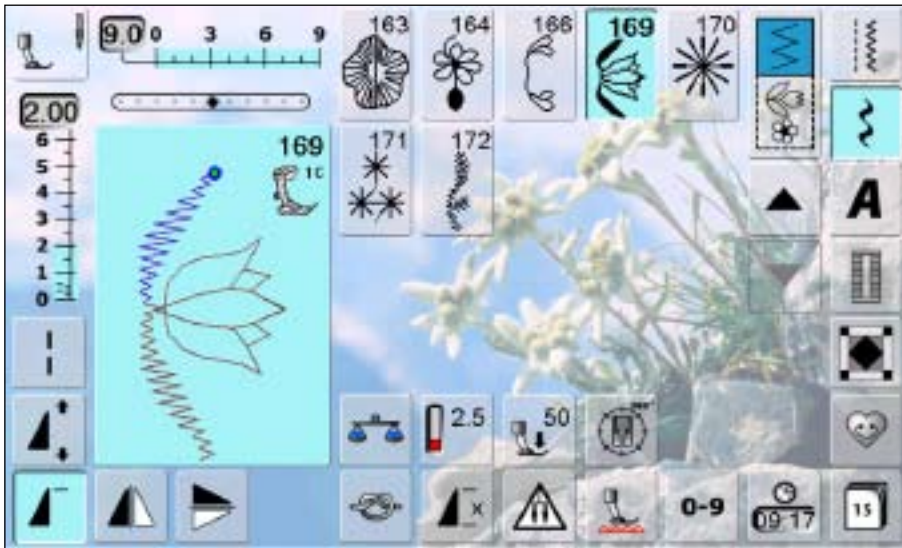
2.13 Pattern #169 improved

Elongation limited to a maximum value of two for optimal results.

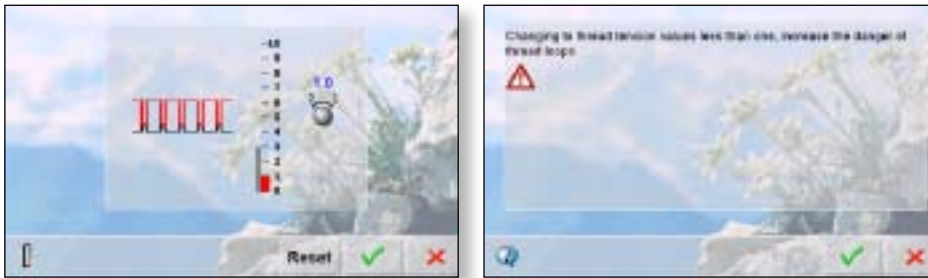
3.4 Thread tension can be changed to a minimum of 0.5

A new parameter controls the minimum thread tension range (between 0.0 - 1.0)

In the embroidery mode, the thread tension can be lowered to a minimum level of 0.5, instead of 1.0.

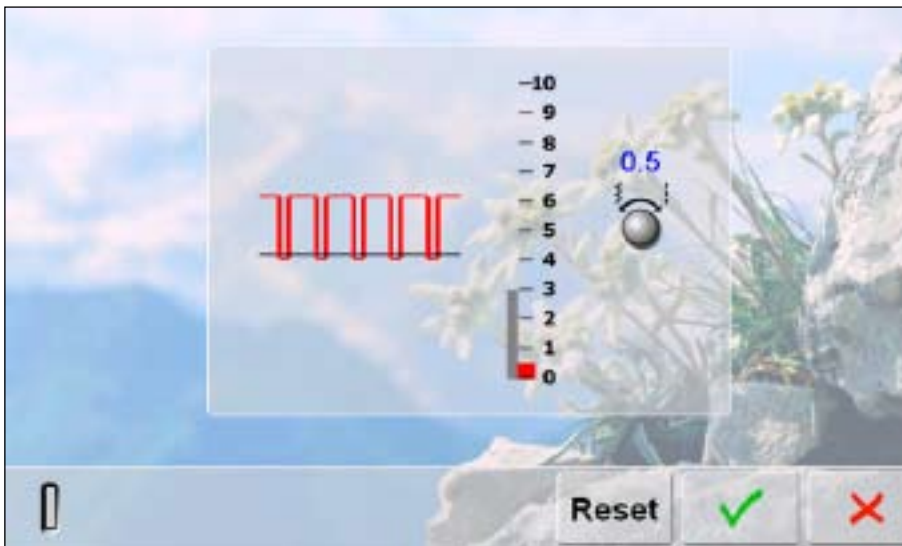
When decreasing the tension values to less than 1 a warning message appears. After confirmation, the minimum tension of 0.5 can be set.

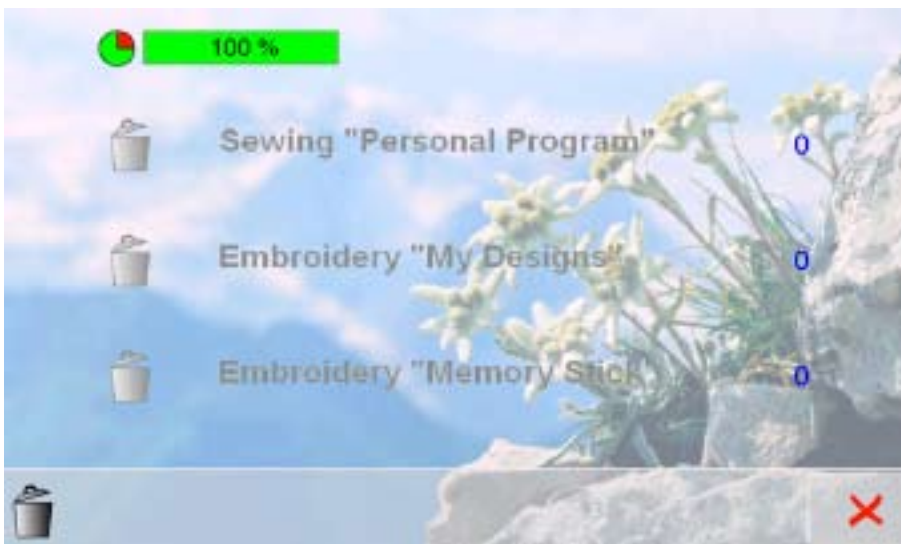
4.3 Free memory

If there is nothing stored on the sewing machine memory and the free memory counter does not show 100%, the software version has to be updated again (this will free all allocated memory not used).
