# HP LaserJet printer product update

March 2004 • Volume 23

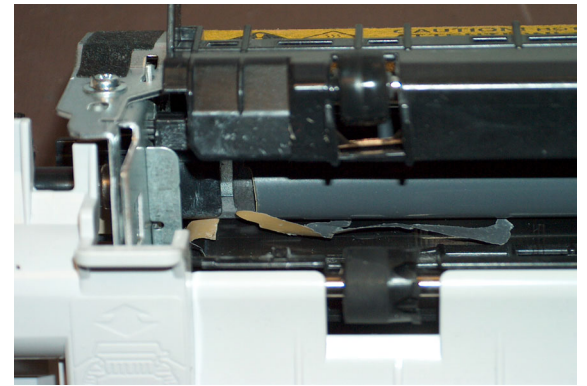
To determine if the fuser film is torn, lift the fuser tray guide and examine the film. Film in good condition appears as a solid gray roller, film in poor condition exhibits the film sleeve shifting to the left and shredded film pieces. If the film is torn, replace the fuser. When this issue occurs before the end of the fuser's 200,000-page life, customers are not charged for the fuser replacement.

Torn fuser film

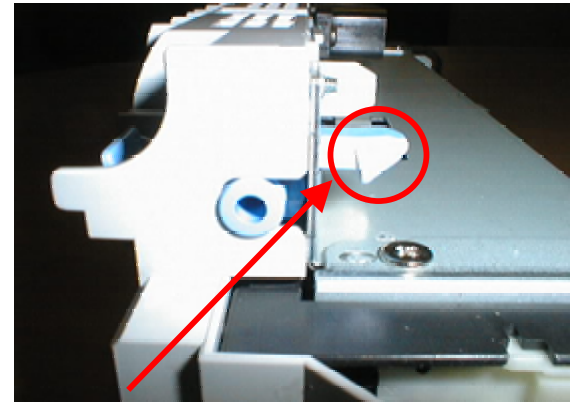
Fuser latches have been breaking before the end of the fuser’s life. The latches in question are the blue grasping latches at the back of the printer used to insert the fuser into position and lock it in place. The latch closest to the gear or drive side of the fuser is most commonly discovered to be broken. Symptoms associated with this issue are a noticeable crack on the latch (see picture, top right) and a resulting break that may cause a grinding noise and paper jams.

Cracked fuser latch

Please replace fusers that exhibit cracked or broken latches; part numbers are below:

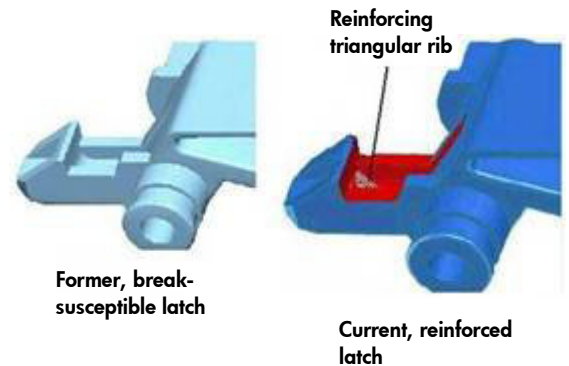
A production countermeasure, implemented in October of 2003, consists of a triangular tab in the middle of each latch to help reinforce the plastic in the stress area most susceptible to breaking (see diagram, bottom right). The part numbers have rolled.

Fuser latch countermeasure diagram

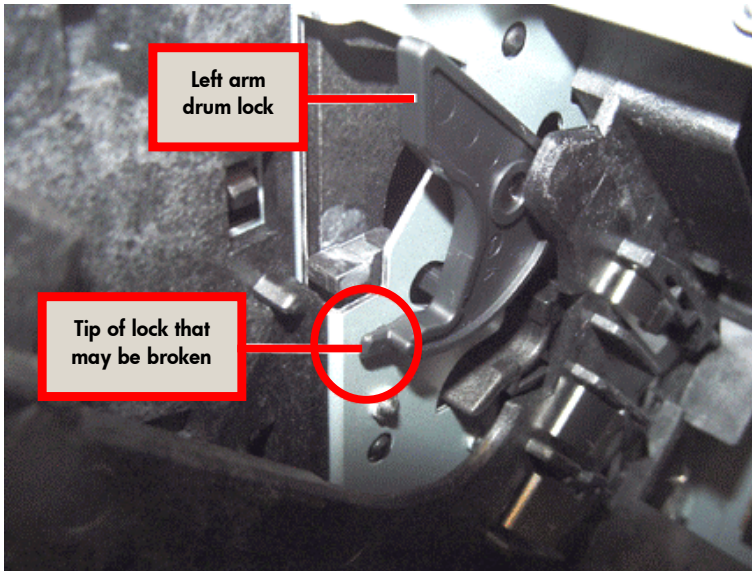
Left arm drum lock

- 5 Check the left arm drum lock in the upper left of the printer. If it is broken, it will be in the down position.

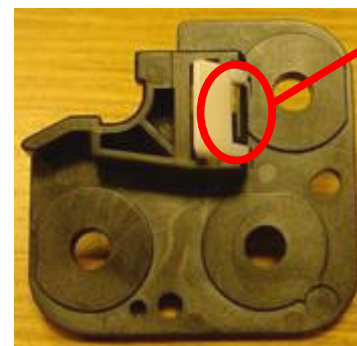
- 7 Check the cartridge alignment knobs on the left side of the printer. If the small white latch is missing, or the black piece immediately behind it is broken, the printer must be replaced. This part may not be replaced in the field due to the delicate alignment necessary to ensure correct cartridge positioning. If the piece is missing, the door may have some difficulty in closing and all of the cartridge shutters may not shut. If all the other steps have been taken and this piece is identified, the printer must be replaced.

Black piece that holds white latch in place

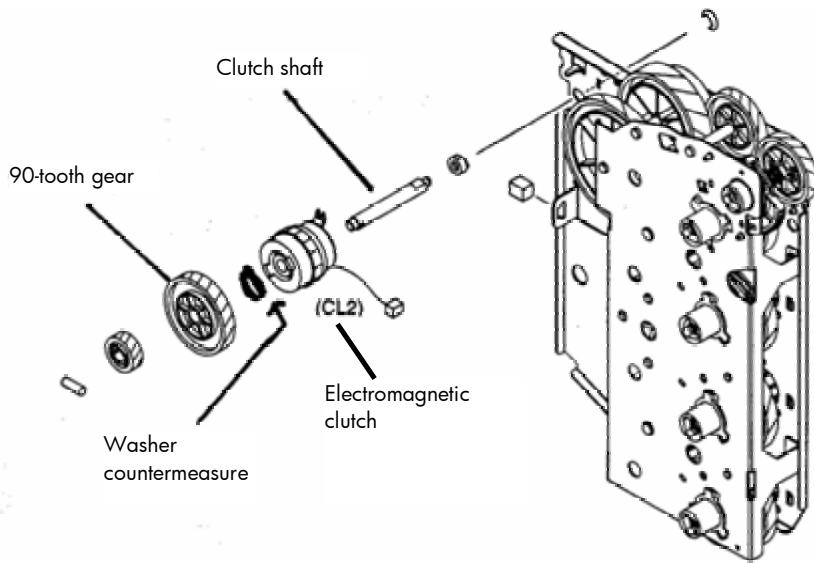
### Black toner cartridge drive assembly

The black toner cartridge drive clutch (CL2) may make a chattering sound that can occur early in a printer's life expectancy. In order to stop the chattering noise, insert the washer countermeasure as depicted below. The washer's part number is XD1-1108-229CN.

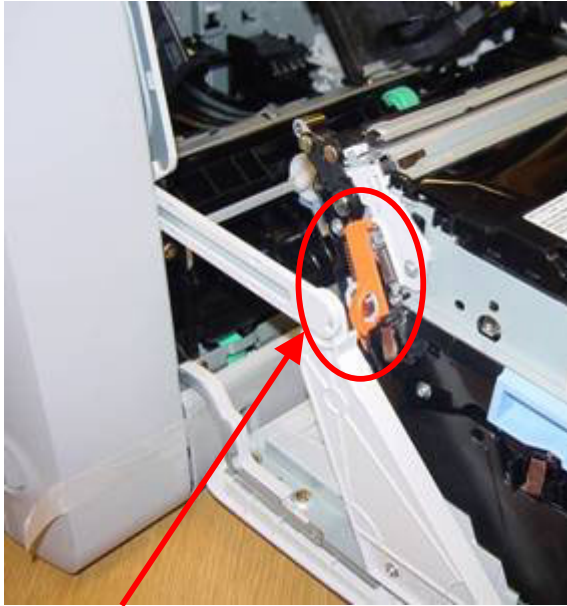
Left ITB shipping lock

If a new ITB (image transfer belt) has been installed and color plane registration problems occur, the shipping locks may not have been removed from the ITB. The photo below depicts the orange shipping lock on the left side of the ITB—there is another lock on the right side.

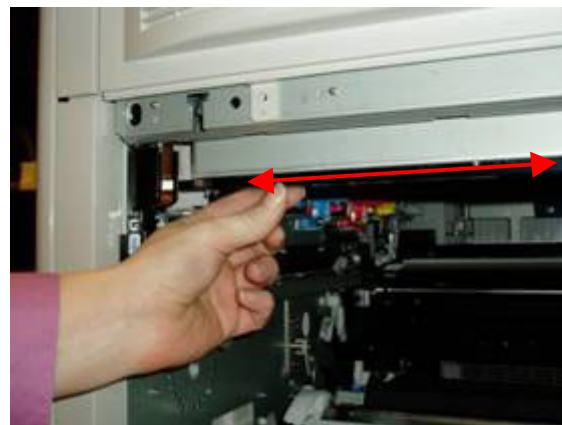
Calibration sensor shutter

- 4 With the ITB access door open, open and close the front, right door. As the door moves, check that the black shutter moves back and forth.
- 5 If the shutter does not move, make sure that the actuator arm located on the left side of the shutter is hooked into place.

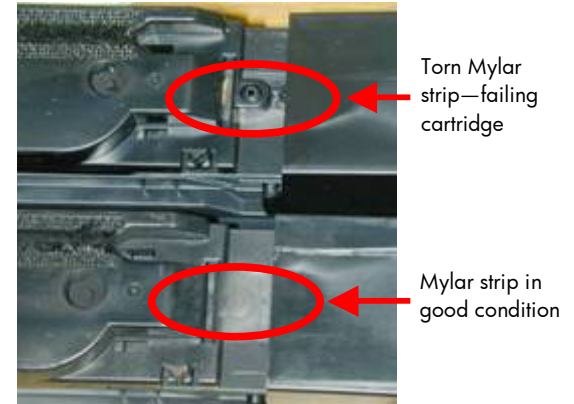
Please replace the print cartridge that is causing the error. Cartridges with lot code 3D23XX or earlier have been identified as having a defect which causes the automatic pull strip embedded in the cartridge not to release correctly when the cartridge is initially installed.

The image below shows what a typical failing cartridge pull strip looks like, compared with a good cartridge. The cartridge is shown with the shutter pulled back, in the installed position.

Print cartridge Mylar strip in poor and good condition

In addition, check the lot codes of the printer's remaining three print cartridges. If any of the cartridges have a lot code 3D23XX or earlier, check the clear plastic pull strip on the bottom of the cartridge, under the shutter, for damage. Replace any print cartridges with damaged pull strips. The error message is likely to appear for these cartridges as well when toner runs low in the image drum.
