**BOOM ARM MOWER**

# **INFORMATION & SERVICE BULLETINS**

Manual P/N 02980501  
(08/05)

**2005 Edition**

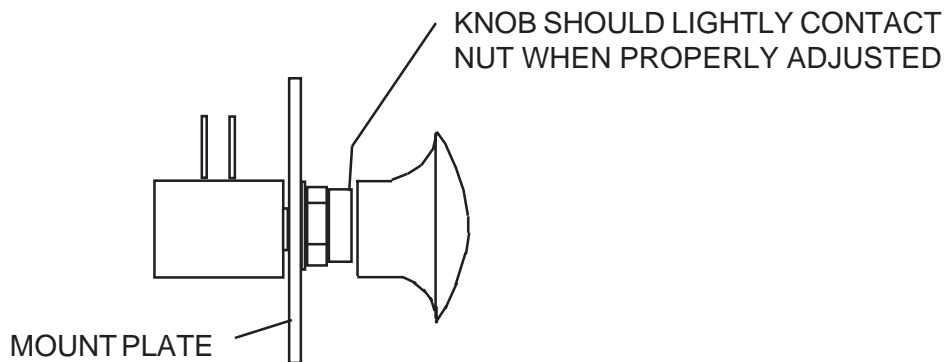
## ***TECHNICAL INFORMATION BULLETIN*** ***No. 092895***

### **Failures of the mower push-pull switch:**

Test performed on numerous switches indicates that the (b) failures are due to excessive force being applied to the knob when shutting off the mower. Specifically, the knobs are usually roughly slapped to turn the mower off. After internal parts of the switch are damaged, the rod can then be pulled out easily. The (a) failures are due to the knobs not being securely tightened.

To prevent these failures from occurring, or to replace a damaged switch, use the following procedure to adjust the travel of the switch. (See attached diagram).

6. Install the Knob, using Loctite or similar thread locking compound. Thread the knob on the rod all the way. Test to make sure that when the switch is "Off" (with rod pushed in) that the knob can not travel further into the switch.

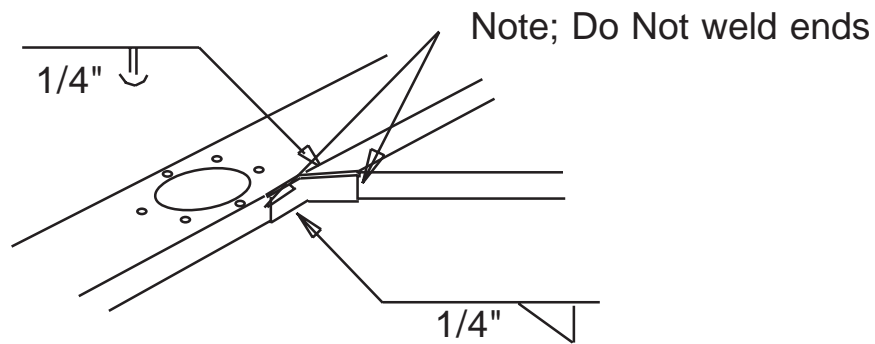
**TECHNICAL INFORMATION BULLETIN**  
**No. 121495**

If cracks appear in the welds at points "A" as shown above, use the following procedures to repair head.

1. Grind a groove at the site of the crack and clean the area to be welded.
2. Weld the crack making a 100% weld.
3. After repairing the cracks, prepare the sites for installation of the gussets.
4. Position the reinforcing bar gusset part no. 02970111 if 90° or part no. 02970112 if 48° over the X-Bar as shown in drawing next page. Weld with a 1/4" fillet weld on the bottom and an edge weld on top. DO NOT weld the ends.
5. Clean and paint the area.
6. Reassemble any parts that were removed.

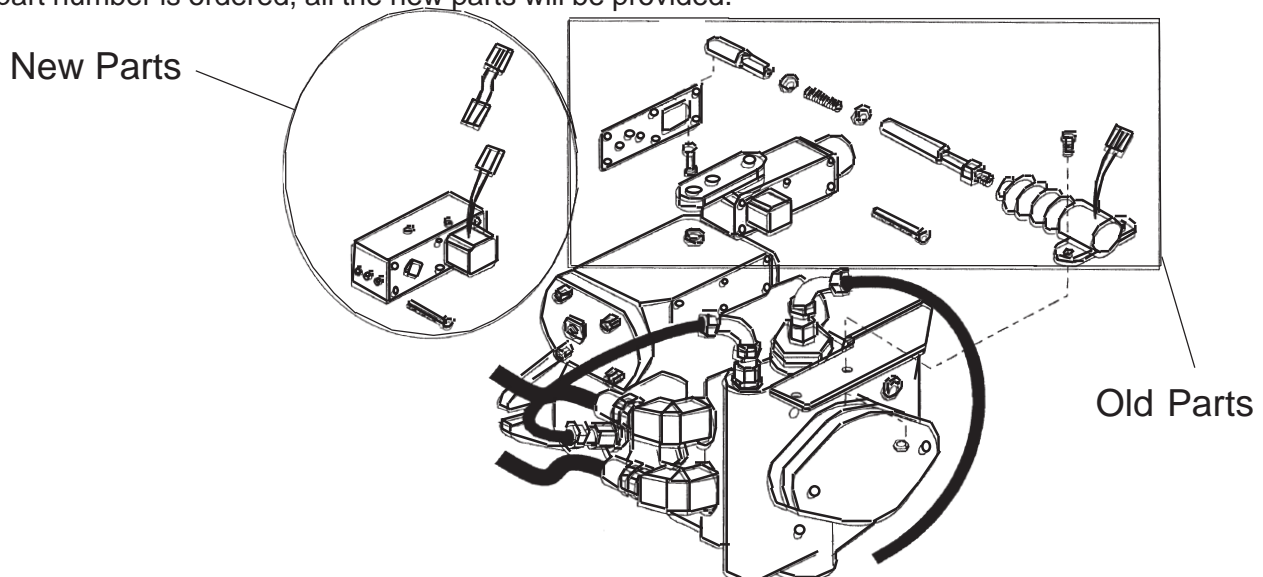
A new Pump is being used on all Machete Boom Mowers. The new pump utilizes a solenoid valve and manifold (New Parts) to control pump swashplate movement instead of the former (Old Parts) electric solenoid, Spool valve and adjustable linkage. All other parts of the pump remain the same. The new parts provide for more positive trouble free operation of the pump and do not require adjustment.

There will be a harness adapter required to connect the new two wire connector to the old three wire harness. Adapter and instructions are included in replacement parts. When the former (old part number is ordered, all the new parts will be provided.

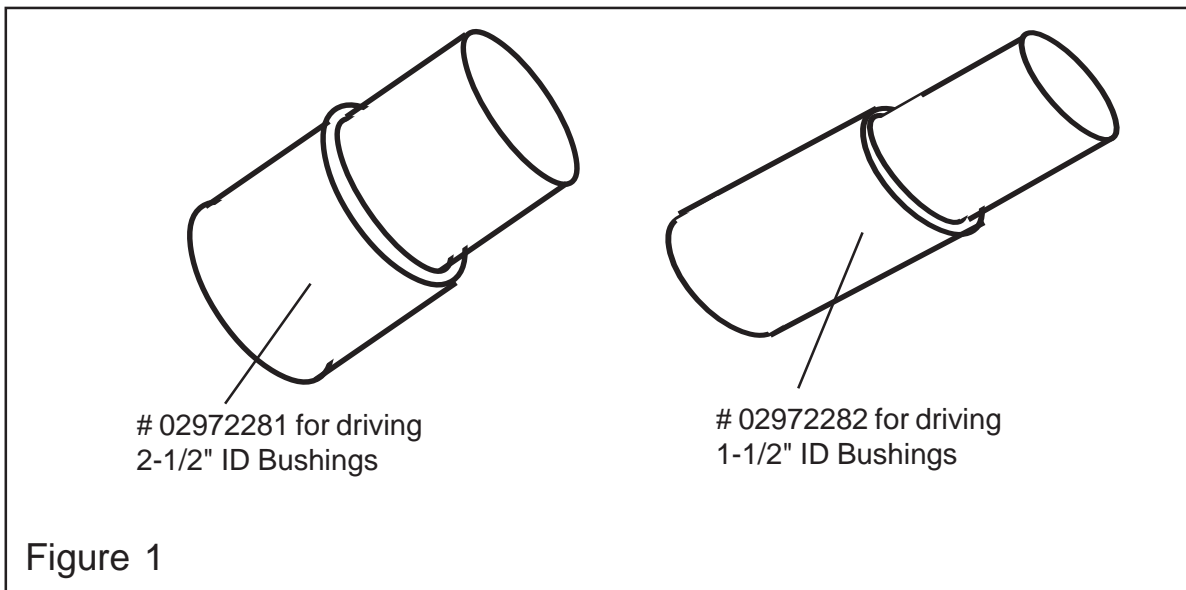
It is now possible to obtain the proper bushing driver to facilitate the installation of all bushings on the Machete Boom Assembly. The Large Driver (P/N 02972281) is used to install the King Pin Bushings in the frame, while the Small Driver (P/N 02972282) should be used to install all the bushings in the boom. These tools may be used to install bushings on several other Alamo Industrial Models such as Slope Mower and A-Booms. The proper use of the installation tools will help to prevent damage to the bushing surfaces during installation.

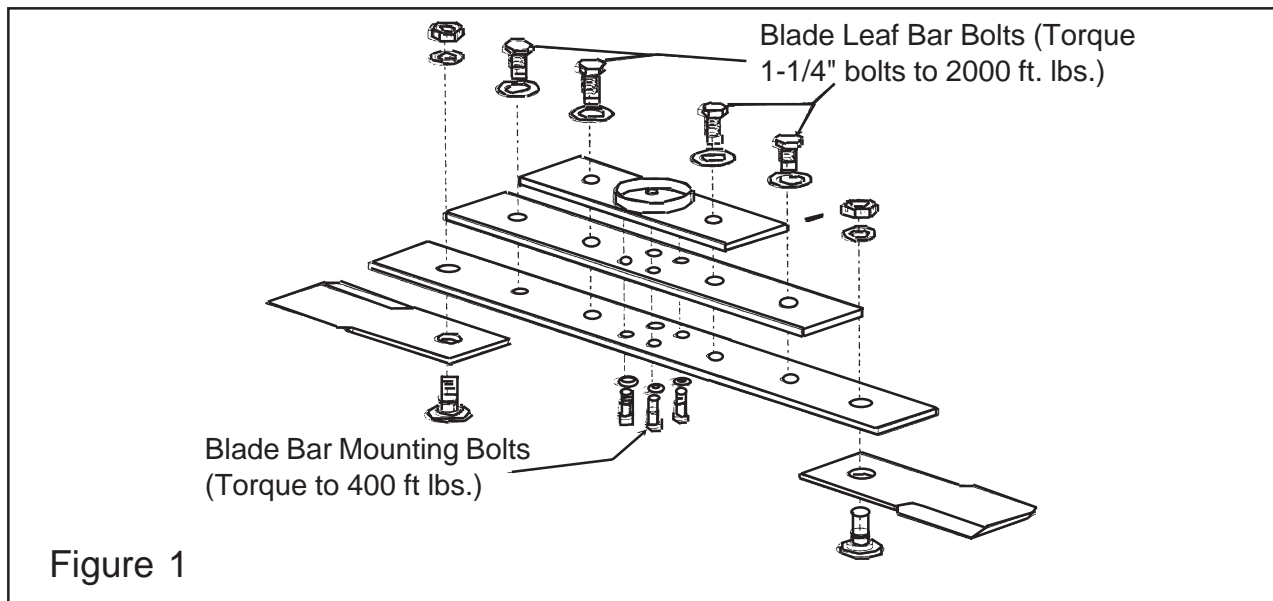
When ordering a replacement blade bar using the original number, the new blade bar design will automatically be sent. However, the 4 longer mounting bolts may not be included.

Therefore, when ordering a replacement blade bar, ensure that the proper length mounting bolts (P/N 02964861 which is a 4" Bolt) are also replaced. DO NOT attempt to mount the new style blade bar using the old shorter bolts. The best way is to always check the replacement bottom leaf thickness as compared to the bottom leaf that was removed. If the replacement is thicker then the new longer bolts will be needed. Another way to determine which one you have check the Leaf retaining bolt size.

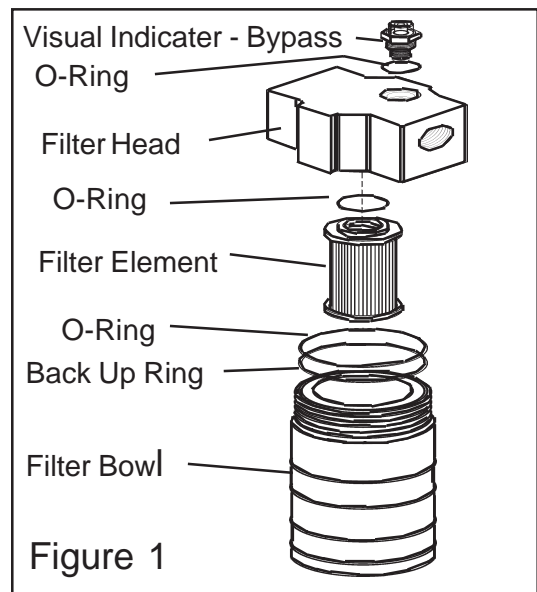
An indicator located on the top of the filter housing will indicate when the filter is bypassing thus requiring the replacement of the filter element. The element is a canister insert which is easily replaced by unscrewing the cannister.

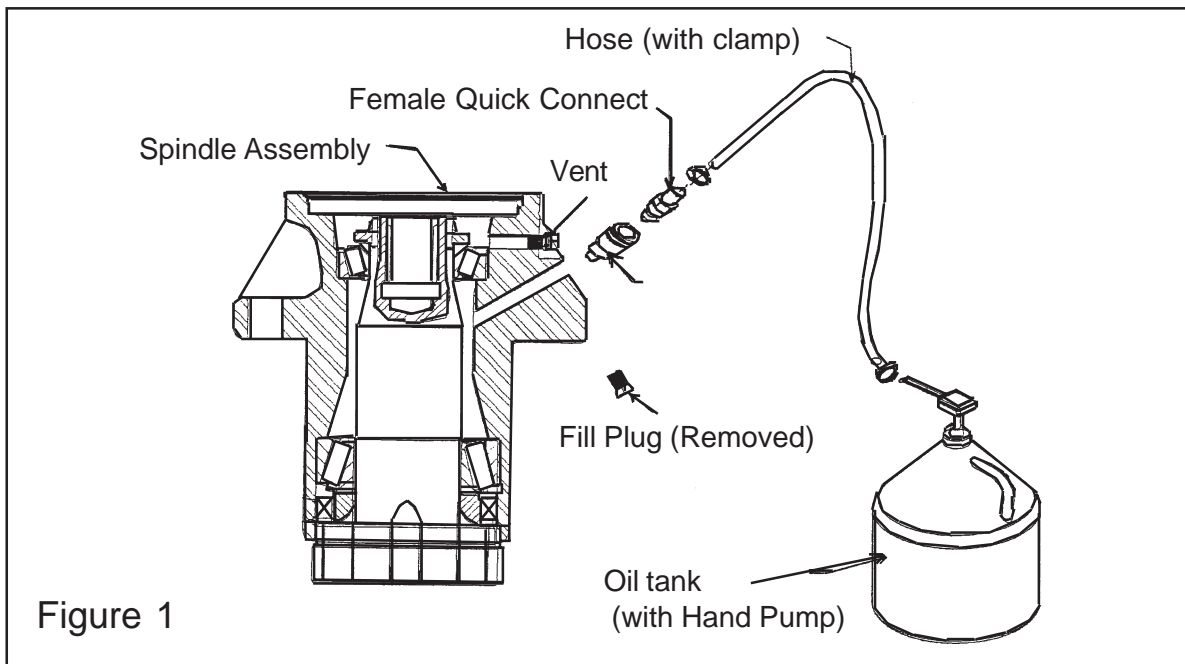
Utilization of this spindle fill kit should decrease maintance time and failures by providing accurate oil fill of the spindle assembly.

Installation requires the replacement of the fill plug with the female quick connect fitting. To fill the spindle. attach the hose and oil bottle to the spindle by utilizing the quick connect fittings. remove the vent plug and pump in the oil untill oil is seen at the vent plug opening. reinstall the vent plug and remove the bottle at the quick connect fitting. The female quick disconnect is designed to be left on the spindle in place of the fill plug.

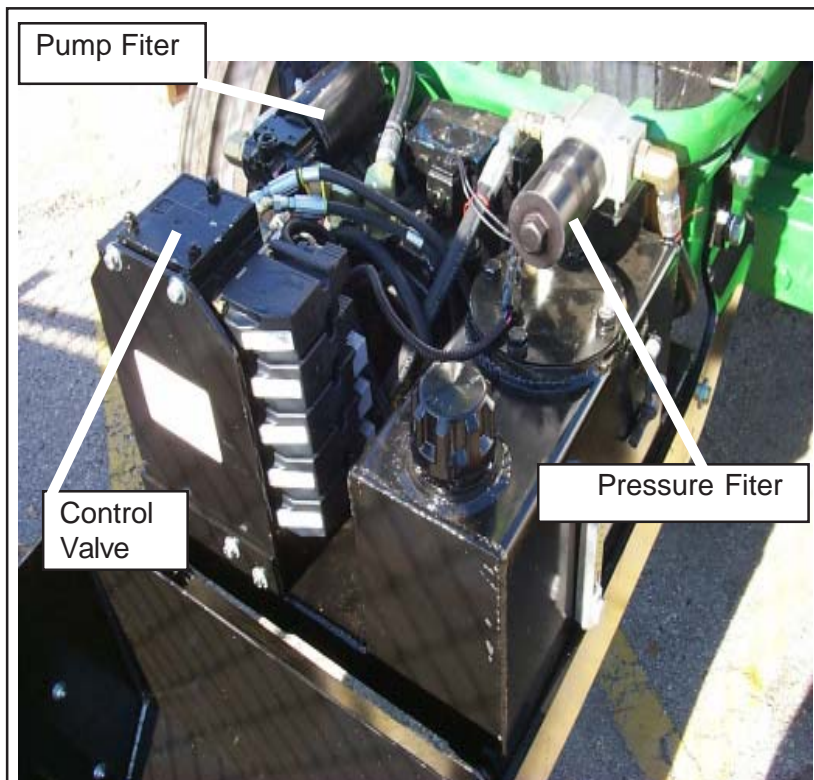
Figure 1

As you can see in figure 1, the valve is fastened to a plate that is mounted to the units hydraulic tank. The Pressure Filter was relocated to a bracket on top of the tank. Both the Pressure Filter and the Pump Filter are accessible and can be changed with minimal effort. Separate hose extension were used to extend the hose reach to the front of the tractor. If a hose connection is not easily accessible, then the valve and mounting plate can be unfastened and arranged to allow for room when servicing.

These Changes were made to better protect the valve and its components. These changes will only be seen on the new units after Jan. 2001 and is not intended for units already in use.

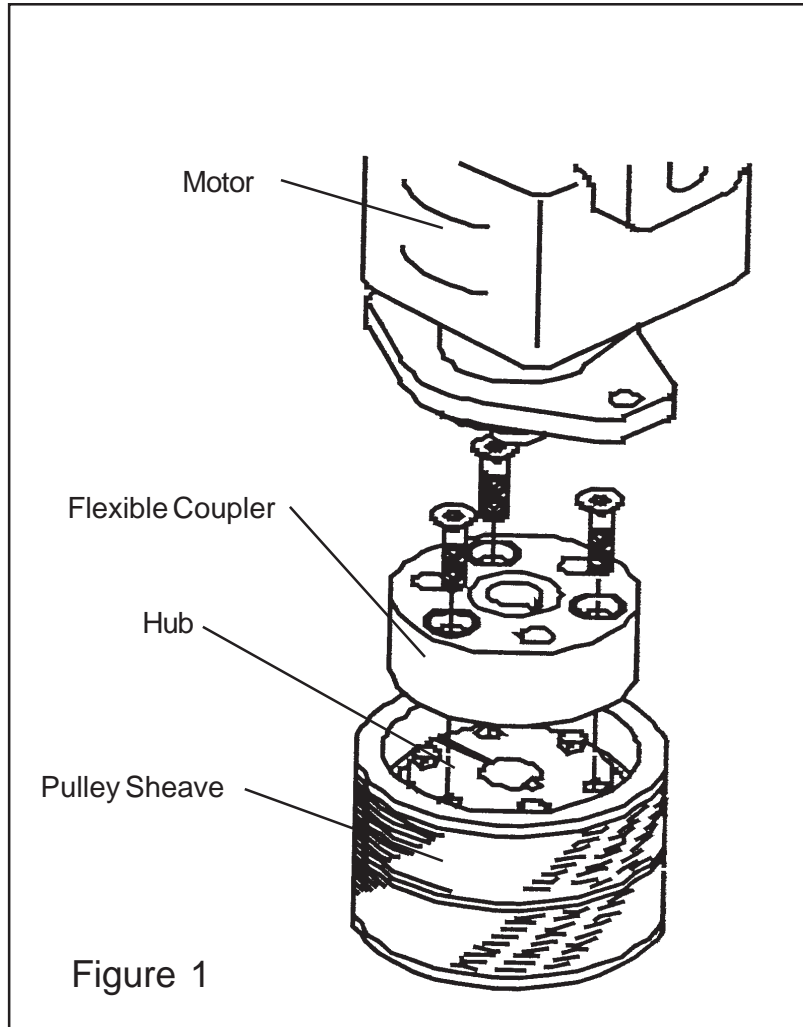
There has been a design change to the drive coupler assembly for the Buzz bar Cutting Head. If a flexible coupler, Alamo Industrial P/N 02974245 (for Machete) or P/N 02974246 (for A-Boom & Slopemower), are ordered they will be a different design. The new flexible coupler design will be molded rubber with metal inserts. The new molded rubber version will directly replace the machined design using the same part number. An installation drawing, that describes the assembly in detail, will be shipped if a new coupler is ordered. this bulletin is to inform you of the design change (see Figure 1) If there are further questions please contact Alamo Industrial's Technical Service Department. Also See Manual Insert Sheet P/N 02978337.

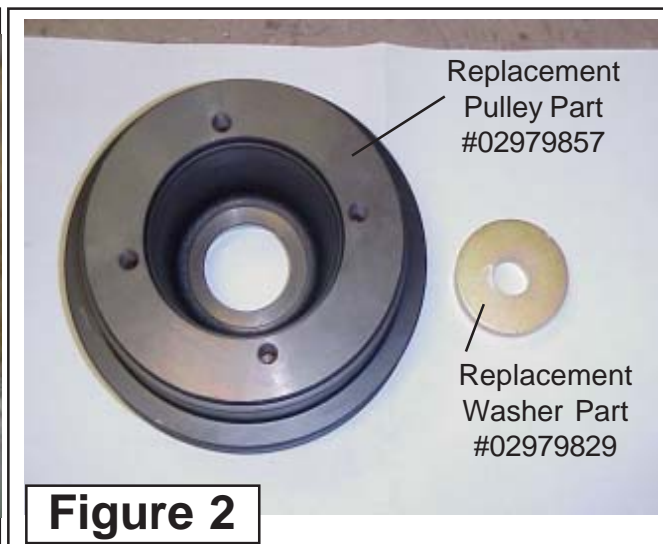
In an effort to comply with certain requirements in regard to Tier II Emission Standards, Deere and Company initiated a change to the crank shaft pulley on many of the new 6020 series tractors. This was a random change, which did not affect all tractors. In addition, a specific serial number break does not exist to identify the affected units.

The Tier II pulley can be identified as a 5 spoke design as indicated in the figure above (See Figure 1). This pulley must be changed to the tapered lock, solid cast pulley as shown to allow adaptation of the required front pump drive system used to power the Alamo Industrial products. (See Figure 2)

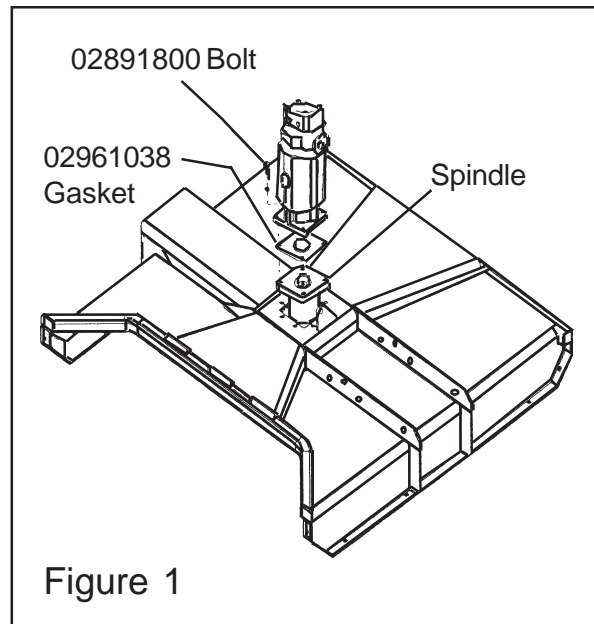
Figure 1

Replace motor to spindle bolts with longer bolts. Original Bolts may not keep Motor tight to spindle.

6. Remove the rag, and check to be sure that the spindle is properly lubed.
7. Apply a coating of silicone gasket material to the motor and spindle housing flanges.

8. Apply a small drop of Loctite to each of the four new bolts.
9. Install the motor and the four new bolts and tighten them to the proper torque (120 ft. lbs.).

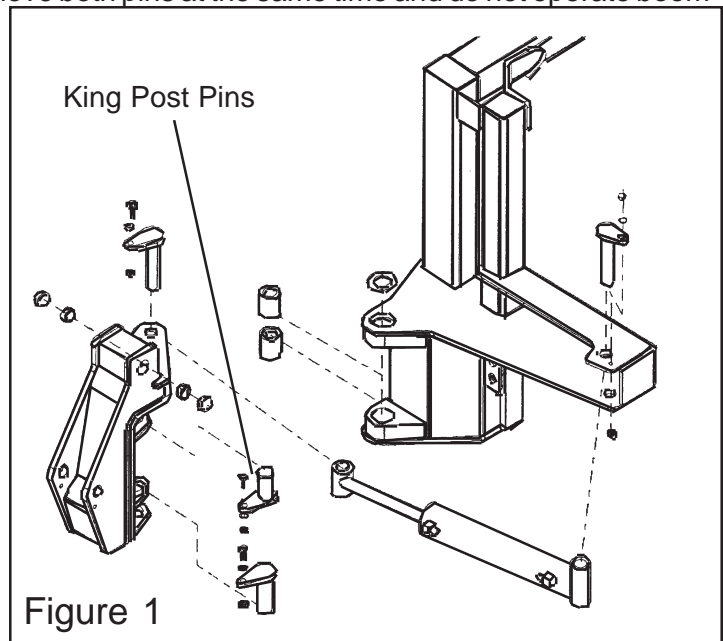
Replace King Post Pins with new longer pins

1. Measure the length of the bottom king post pin, this can be done without any disassembly.
2. If Pin measurement is 5-1/4" to 5-3/8", this procedure will not be required.
3. If measurement is 5" or less, replace the pins according to the correct replacement procedure as outlined in the operators manual and / or Service Manual.
4. Boom must be flat on the floor and boom must be supported with a Hoist. All Hydraulic pressure must be released for all cylinder. See Machete service manual for this procedure.
5. Remove the pins one at a time, do not remove both pins at the same time and do not operate boom or tractor until these jobs are finished. Install the new pin. It may be required to move boom to align pins. Moving boom can usually be done by using the hoist supporting the Boom
7. Do Not drive pins in with a Hammer to align pins, This will damage the component

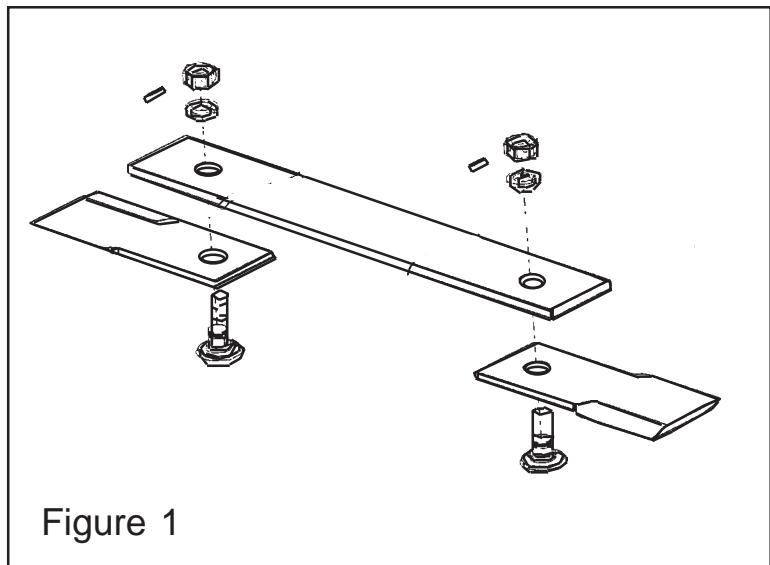
Figure 1

The Blade Bolt Nut Retaining Roll Pin Bore may be oversized and could allow the roll pin to become loose in the bore. The loose roll pin could therefore allow the blade bolt Nut to loose torque.

1. Visually inspect and check the fit of the roll pin. If it is loose or has come loose replace the Blade Bolt, Blade Bolt Nut and Roll Pin on the above listed serial numbered units.
2. Torque the Blade Bolt to 600 ft. lbs. before installing the new Roll Pin.

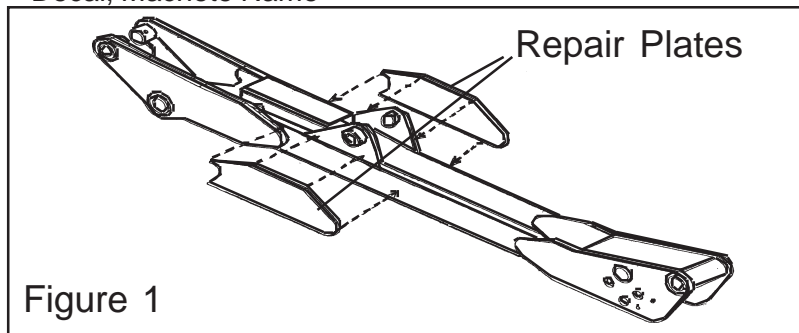
Figure 1

Loads and the resulting stress incurred during heavy to abusive operation of the Machete Boom may allow for fracture of the outer (Dipper) Boom at the welds which attach the base end mount of the Head Tilt Cylinder.

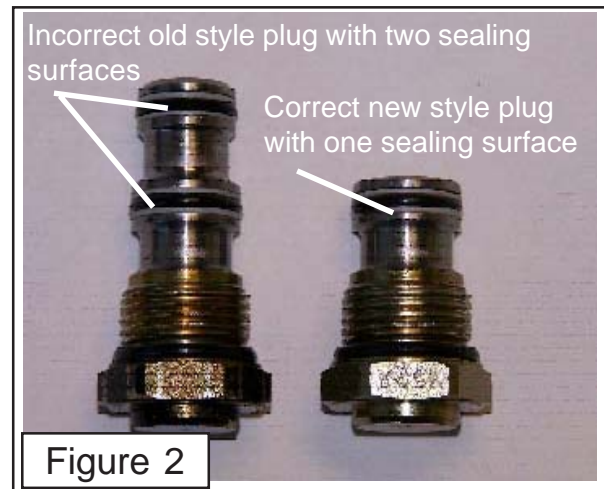
Figure 2

Once the plug is removed from the manifold, the incorrect plug can be identified by the secondary sealing surface and extended length as shown in figure 2.

Secure the tractor to facilitate safe repair. Thoroughly clean the top of the pump and around the port plug and solenoid valve to prevent contamination from be introduced to the hydraulic system. Remove the port plug as shown in figure 1 and replace with new port plug (P/N 02983170) as shown in figure 2. Run and test mower for operation and hydraulic leaks.
