Information on Software Update
BERNINA 8 Series, V29.39.00

Information on Software Update *BERNINA 830 / 820*

The Release Note V29.39.00 is in addition to the Release Note V29.21.40 (6/2009).

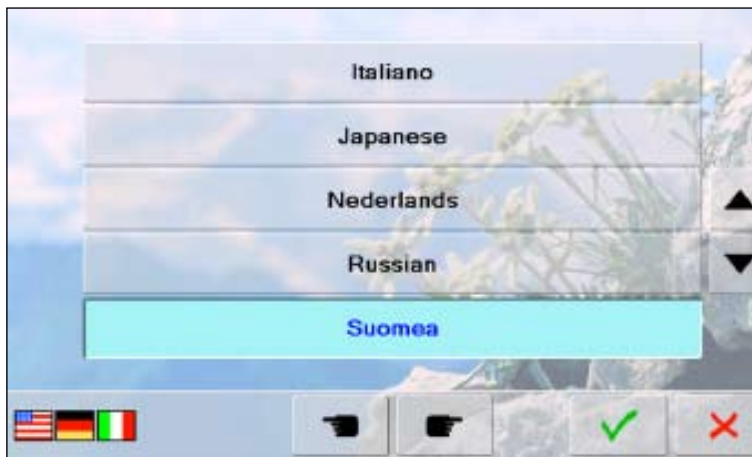
1.1 Language "Finnish" integrated

The following languages are now integrated: Danish, German, English, Spanish, French, Italian, Japanese, Dutch, Russian, Swedish, Turkish and Finnish.

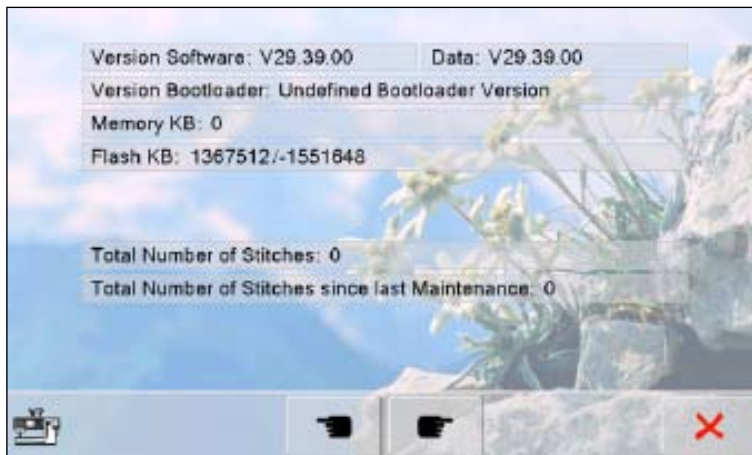
1.2 Display of data version number

In "Setup-Program/Information/Version", the version of the data is visible. Data contains all sewing and embroidery stitches.

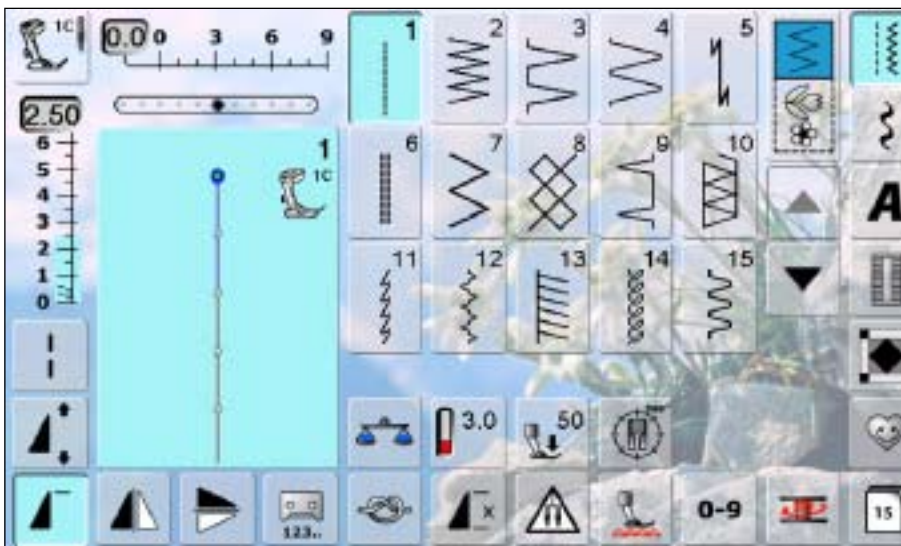
2.7 Winding indicator during sewing/embroidery

When closing the winder menu during winding, the clock symbol changes to the winding symbol and allows switching back to the winding menu.

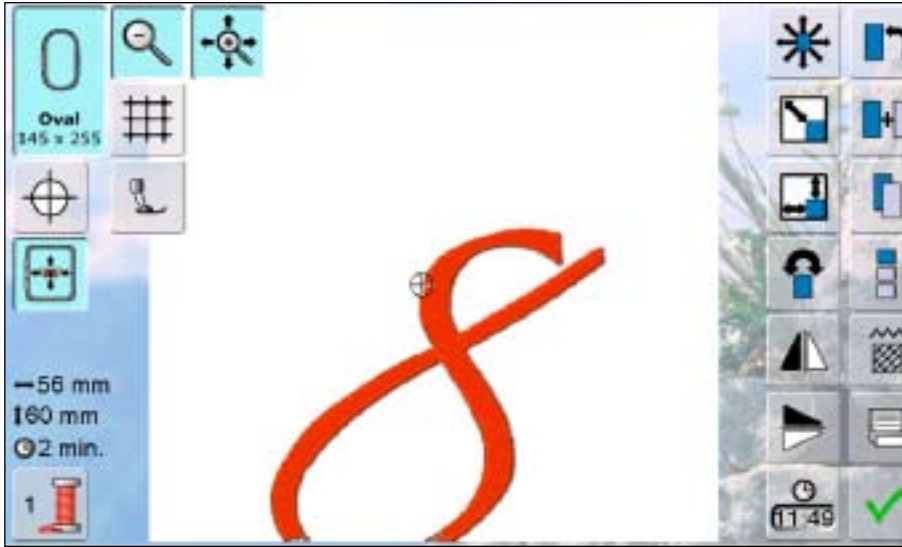
3.2 Using zoom option with panning

When using the zoom option, only the view of the design will be moved. The hoop position relative to the design will not be changed.

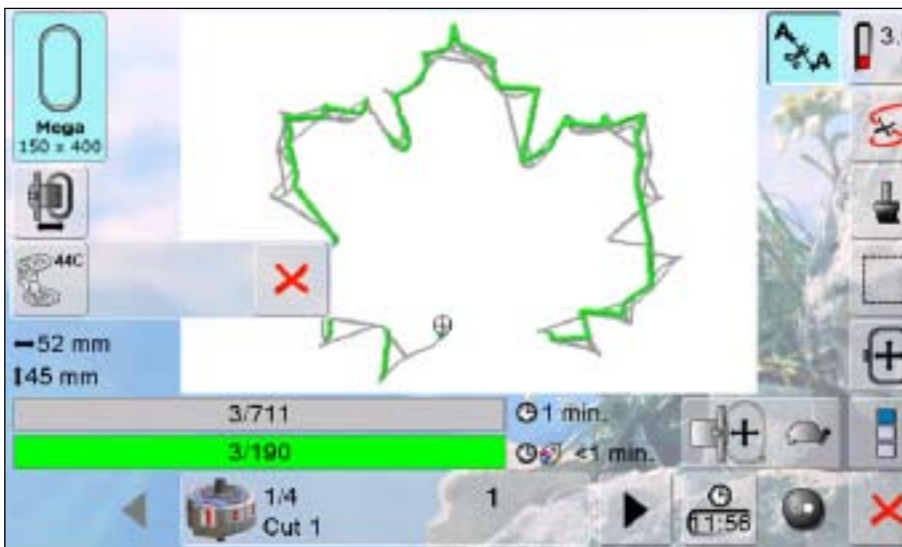
3.3 Using Foot #44C (The new CutWork & Echo quilting foot)

Developed for the CutWork tool, this foot can also be used for quilting.

For designs with "cut" and "normal" embroidery layers, the foot #44C can be selected in the stitch out mode. The outlines for the selected foot will be immediately set. The position of the design will not change.

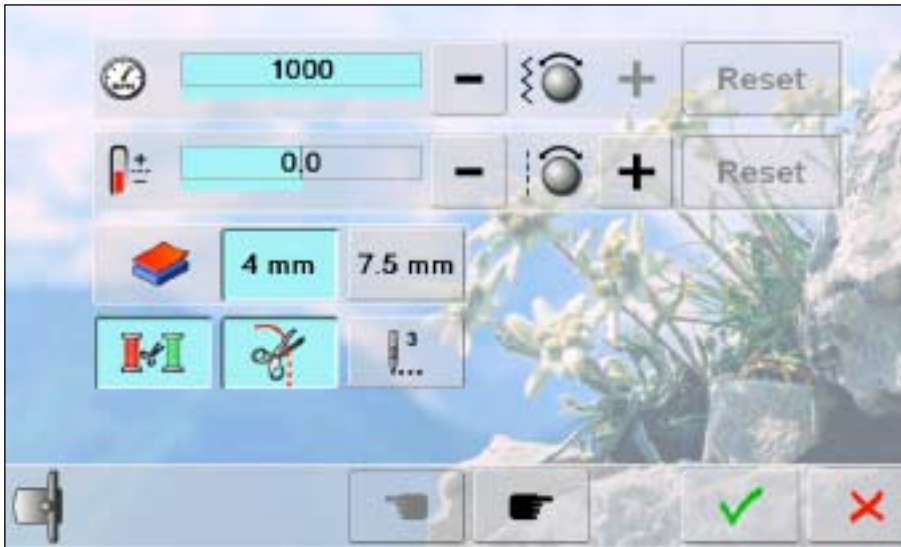
3.5 Stop for manual cutting can be switched off

Deselecting of the scissor symbol, will disengage the stop sequence for manual cutting at the beginning of a design or color.

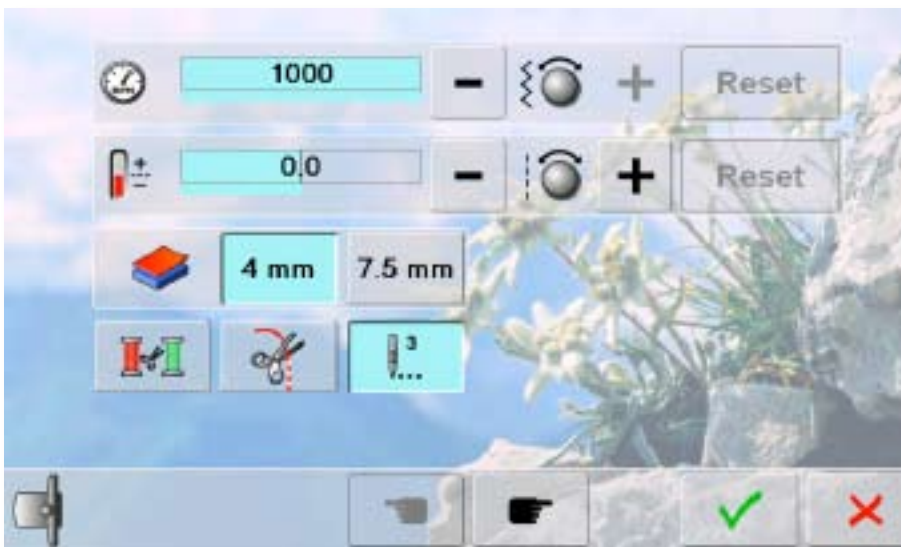
3.6 Manual "tie on" for embroidery

Disabling of the "tie on" button will disengage the automatic tie on. User brings up the lower thread manually and during the first stitches the thread must be held.

Attention: If "tie on" is deactivated, the setting for jump stitches will be ignored and the cutting of jump stitches is NOT possible.

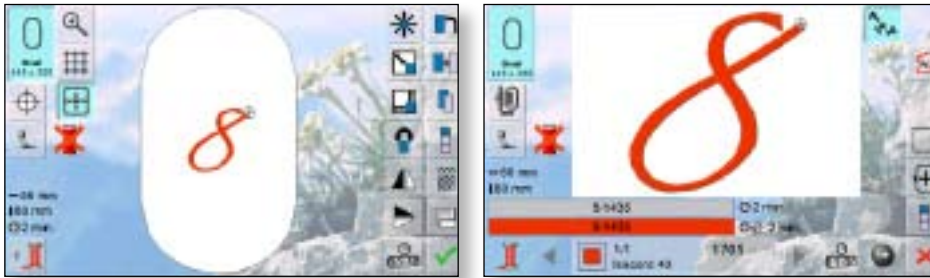
3.9 Stitching "without thread", is displayed in embroidery mode

As is in sewing mode (in setup), the selected "no thread" mode will be displayed.
