82543GC Gigabit Ethernet Controller Specification Update

Revision 2.1

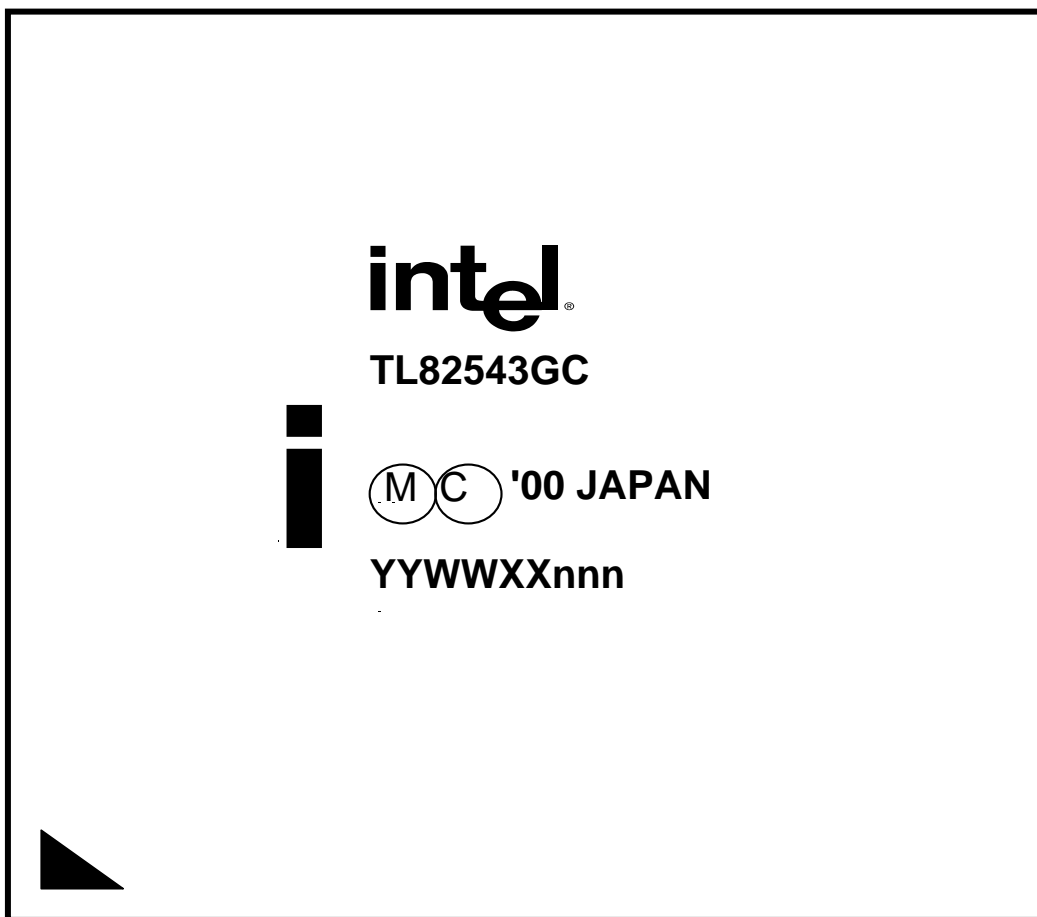
82543GC COMPONENT MARKING INFORMATION

The legend for the manufacturing code is as follows:

- YY = Assembly input year
- WW = Assembly workweek
- XXnnn = Complete lot traceability code (use for issue reporting)
- XX = Mask/assembly spec
- nnn = Lot history code
