Kawasaki

**D SERIES CONTROLLER
TROUBLESHOOTING AND
COMPONENT REPLACEMENT
MPVDCONTV113E-3**

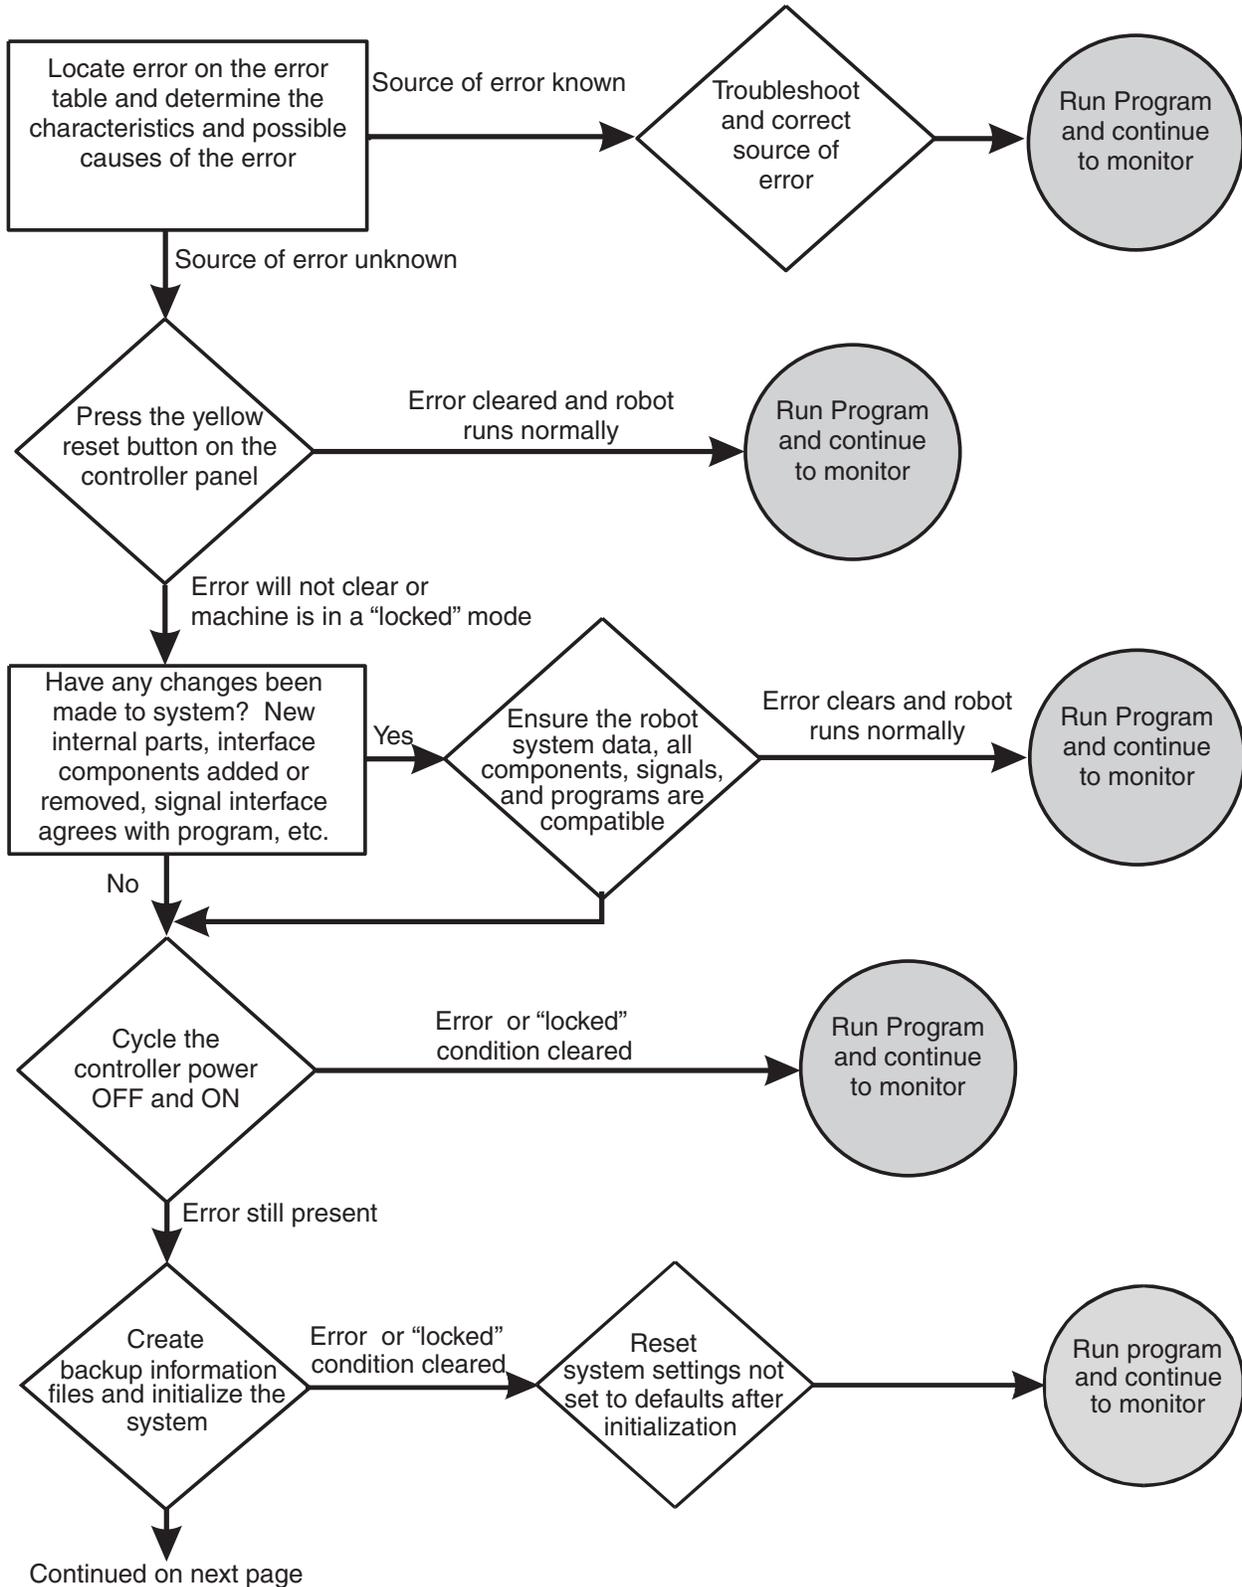
Figure 1-1 Troubleshooting Process

Figures 1-1 and 1-2 show troubleshooting processes that may be helpful if the controller becomes unresponsive to commands or an error code has been encountered that cannot be cleared. Troubleshooting should begin with confirmation of basic integrity of the system: ensure that the power supply is on and meeting supply requirements, all cables are correctly attached, all circuit boards are properly installed and fully seated, all peripheral equipment is wired correctly, software is properly configured, etc.

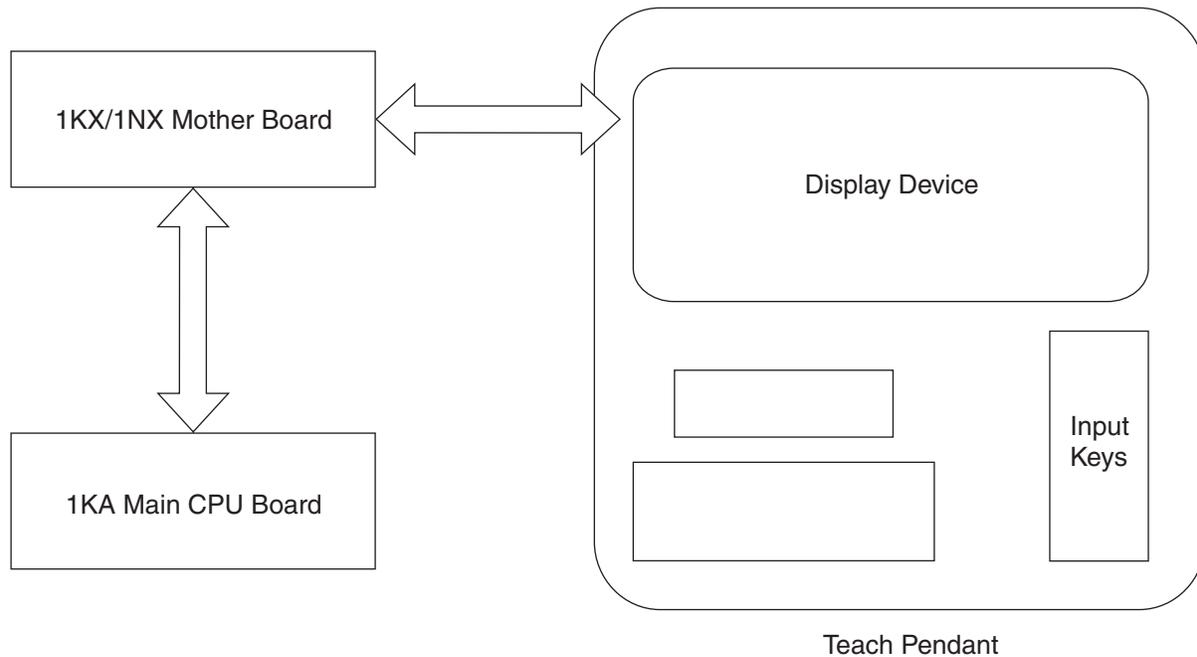
Figure 1-3 1KA/Teach Pendant Communication

This condition occurs when key input and AS Language commands do not reach the 1KA board or data from the 1KA board does not reach the teach pendant.

Data is transmitted between the 1KA board and the teach pendant as shown in figure 1-3.

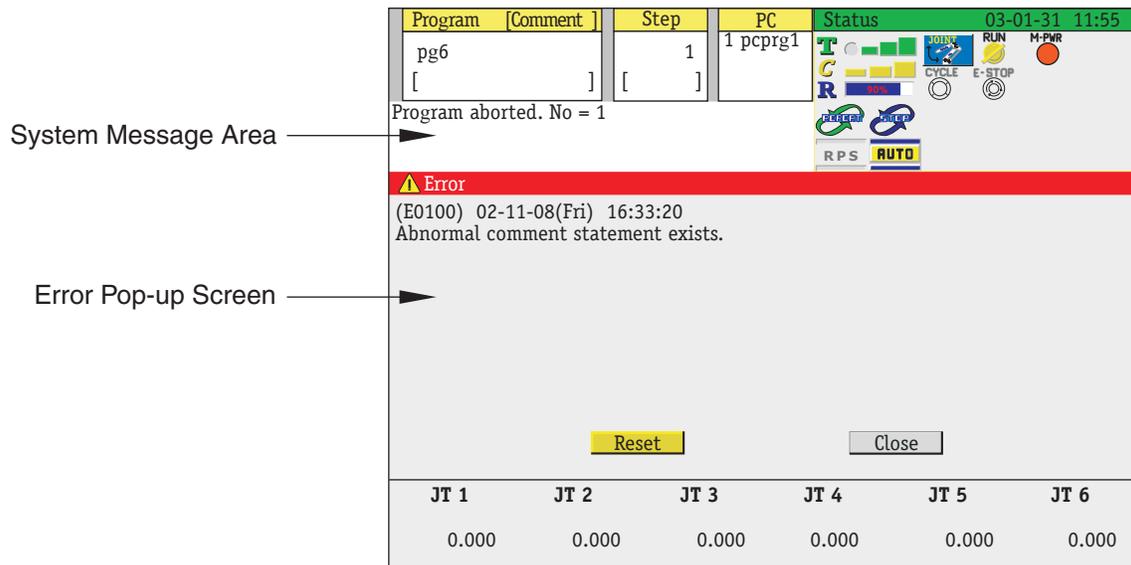
Figure 1-4 Teach Pendant Error Screen Display

The teach pendant LCD screen displays operation errors (P errors) in the system message area and other error messages are shown in a pop-up screen display (Figure 1-4).

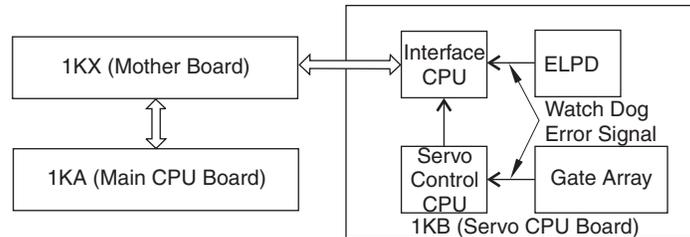
ERROR CODE D1004 [ARM CTRL BOARD] watch dog error of servo control software.

The watch dog circuit on the 1KA board or 1KB board has detected a software problem. This is caused by a defective 1KA main CPU board or 1KB servo CPU board or a problem with the servo software.

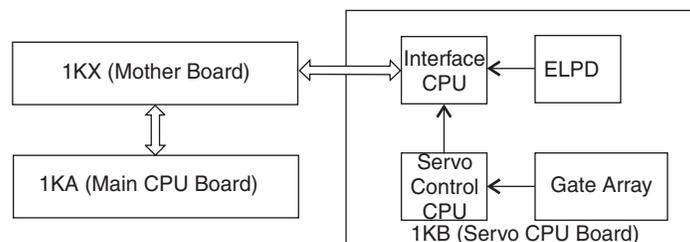
ERROR CODE D1005 Servo board command error. (xx)

Servo software returned an error code, other than a servo system error, to the AS software after receiving an unrecognized command from the 1KA board.

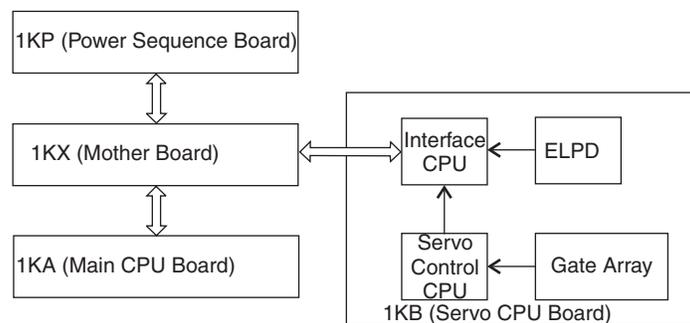
When a servo error signal (SVER) is sent from the 1KB board (servo CPU board) to the 1KP board (power sequence board) motor power is shut down. The error notification is sent to the AS software via the EPLD. The error information from the 1KB board is sent through the command line and the corresponding error code(s) is/are displayed after D1006.

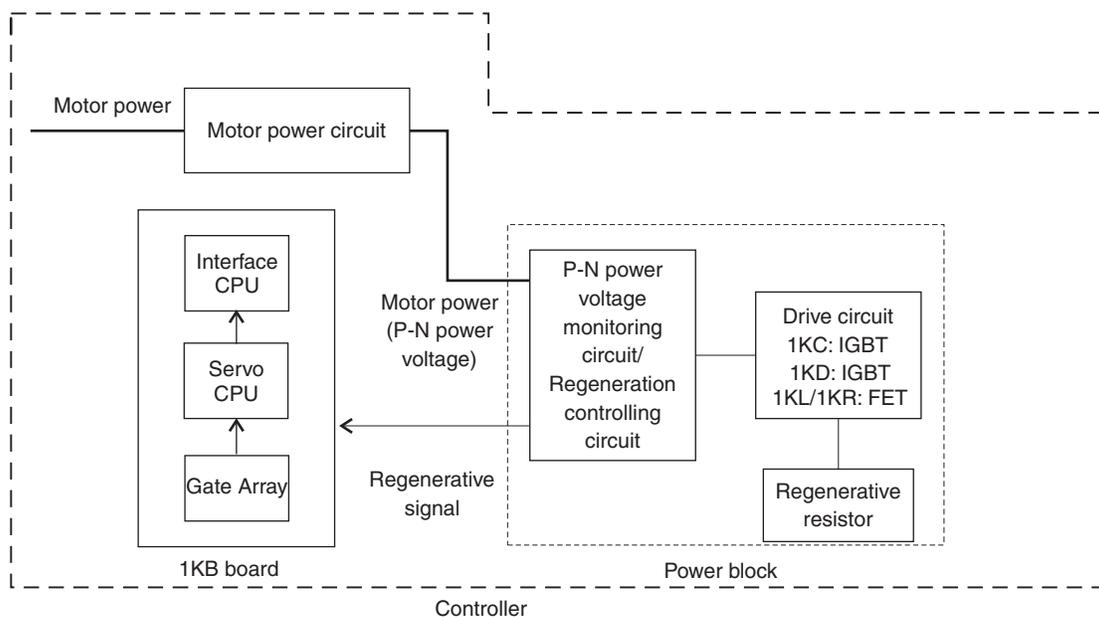
This error occurs when current is sent to regenerative resistors for six or more consecutive seconds.

When the robot decelerates, the motors enter the power generation state to absorb the inertia energy from the arm. When the P-N power voltage exceeds the rated value (390 VDC), the current is split from the power block to the regenerative resistor. When the voltage drops to a safe level (365 VDC) the resistor is removed from the circuit.

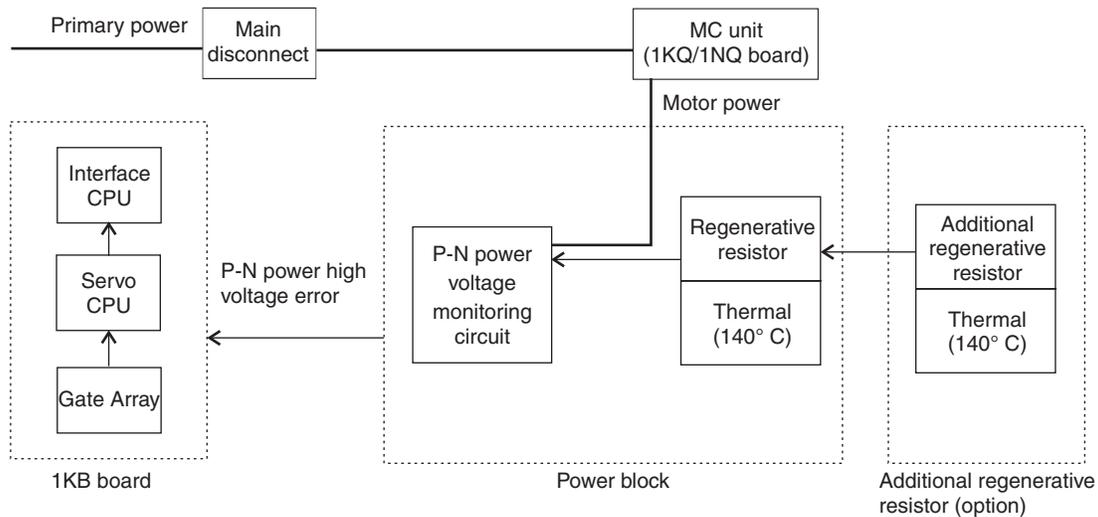
ERROR CODE D1009 P-N- high voltage [XX].

The voltage between P-N supplied to the power block exceeded 410 VDC.

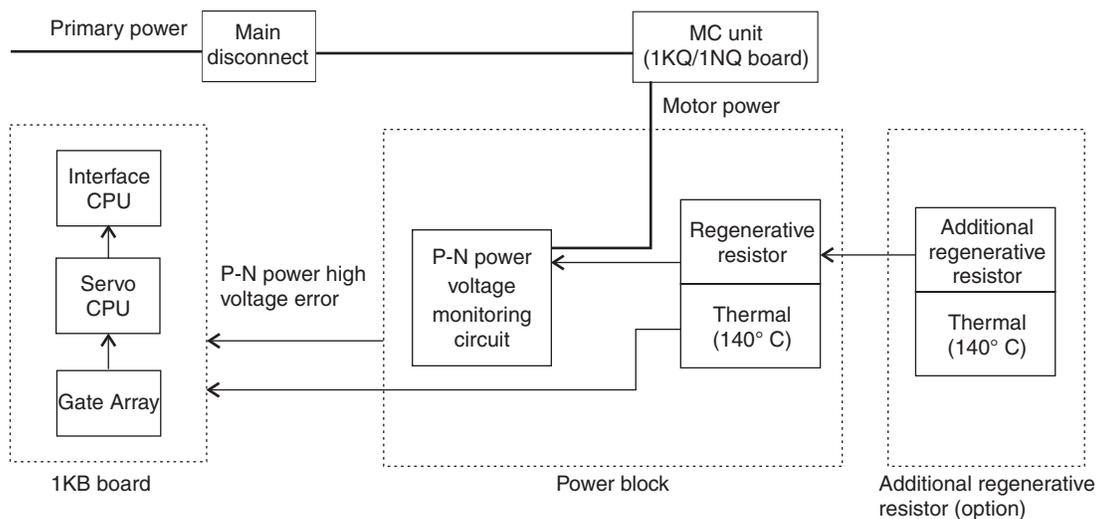
ERROR CODE D1010 Regenerative resistor over-heat [XX].

The thermal switch for the power block regenerative resistor unit, or the optional regenerative resistor unit reached 140° C (284°F), or the heat sink thermal switch reached 90° C (194°F), or the controller cabinet thermal switch reached 70° C (158° F). The thermal switches are wired in series and the AS software cannot distinguish which thermal switch is activated. For D7X controller, if the heat exchange fan is inoperative (X207 disconnected) this error is generated.

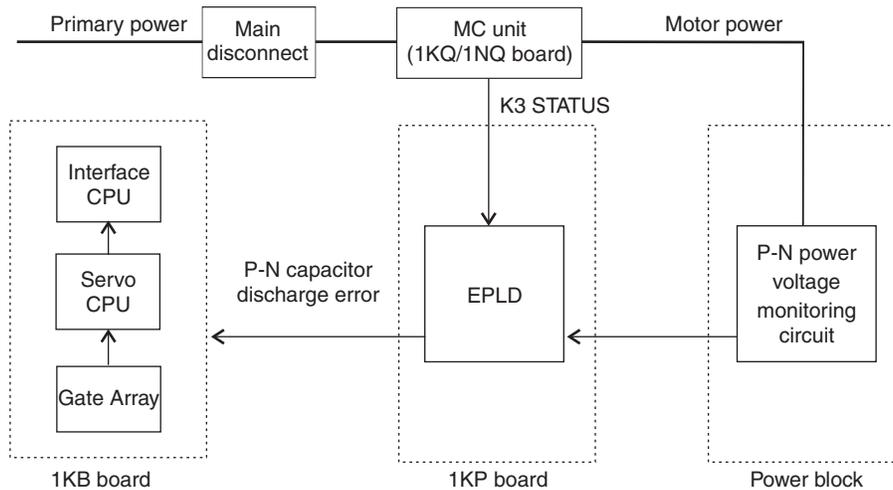
ERROR CODE D1013 P-N capacitor is not discharged.

This error occurs when motor power is OFF for a period of time and the P-N power voltage does not decrease to 60 VDC or less.

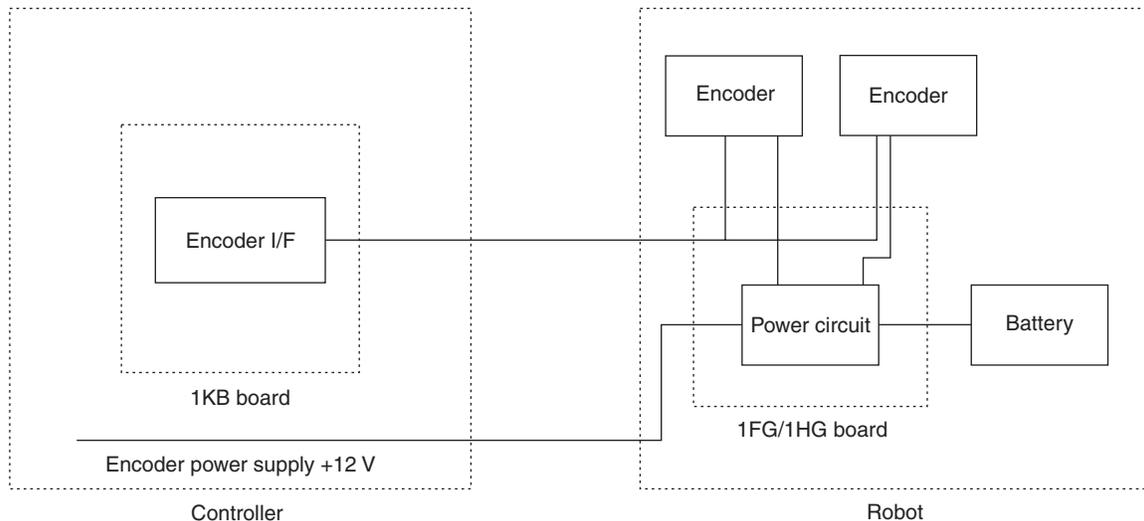
TROUBLESHOOTING**ERROR CODE D1500** Encoder misread error JtXX.

Immediately after control power on, steady encoder data is not able to be read. This error is caused by a disconnected encoder signal line or a short circuit, or a defect in the main body of the encoder.

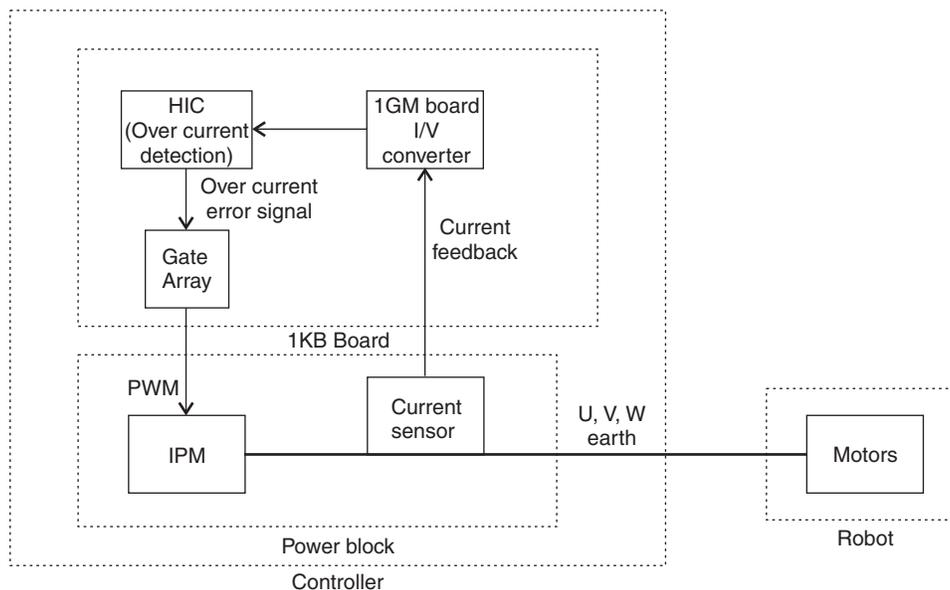
ERROR CODE D1502 Amp over current JtXX.

The feedback current from a current sensor in the power block exceeded 150% of the maximum instantaneous motor current rating.

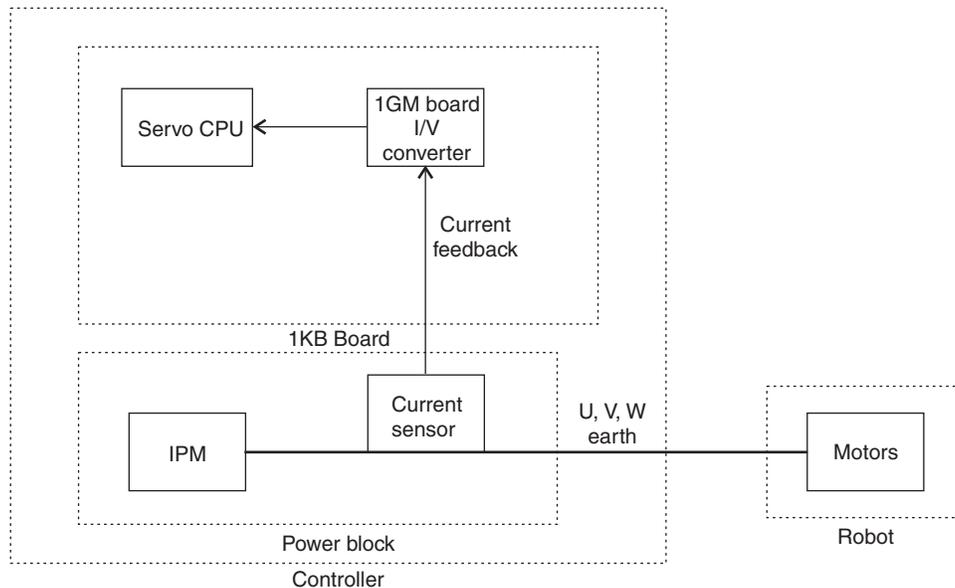
ERROR CODE D1504 Abn. curr. feedback Jt XX. (Amp fail, pwr harness disconnect).

This error occurs if the current feedback value is near 0 from the time the servo is turned ON until the brake is released, even if the commanded current value meets or exceeds the expected current.

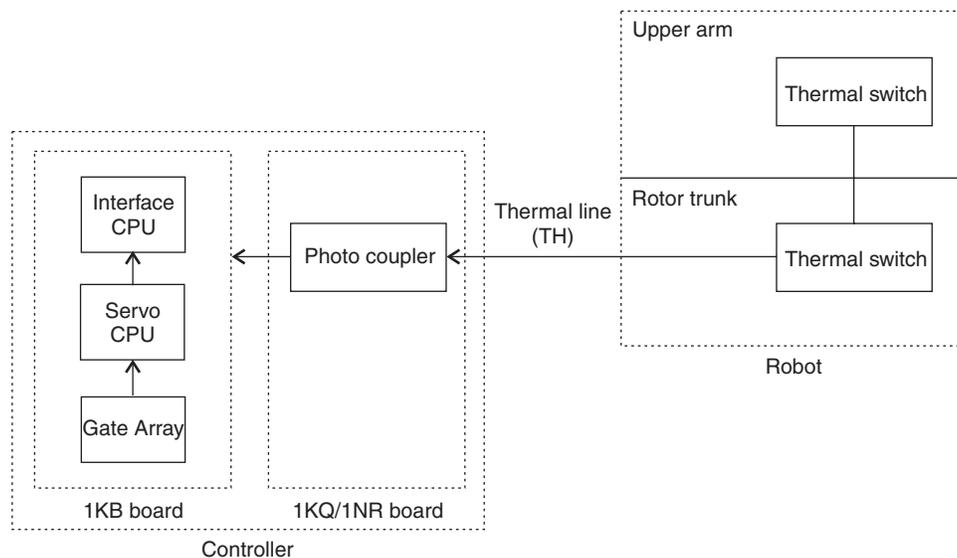
ERROR CODE D1505 Motor harness disconnected or over heat. (XX)

Motor thermal circuit is open due to motor overheat or harness problem. Not all robot models utilize thermal switches in the motors. Some robot models may have multiple thermal switches connected in series (see diagram below). The FS03/06/10/20 robot models have the thermal switch mounted near JT1 motor. The FS03 model is calibrated to 55° C and FS06/10/20 models are calibrated to 65° C

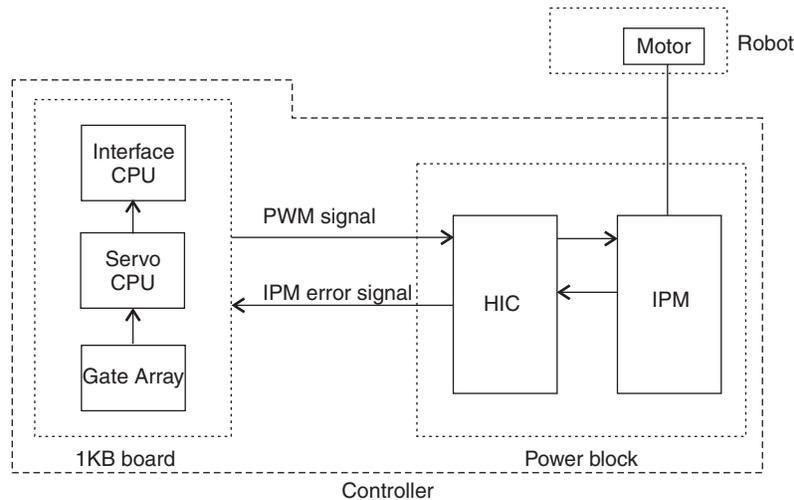
ERROR CODE D1506 Power module error JtXX.

An error signal from the IPM module in the power block is detected by the 1KB board.

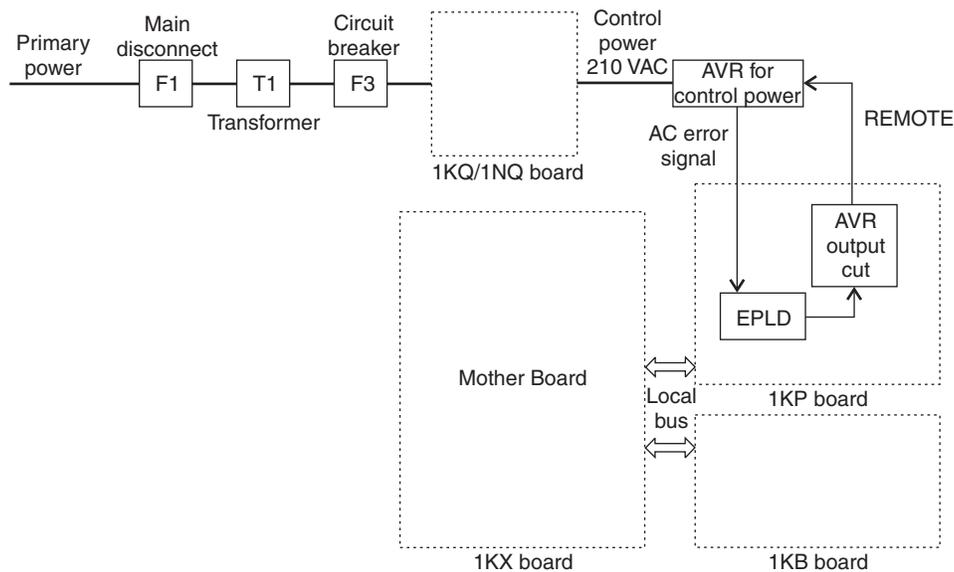
ERROR CODE D1507 AC primary power OFF.

This error occurs when there is an instantaneous decrease in the primary power to the AVR for control power supply (130–145 VAC or less for 20–30 msec).

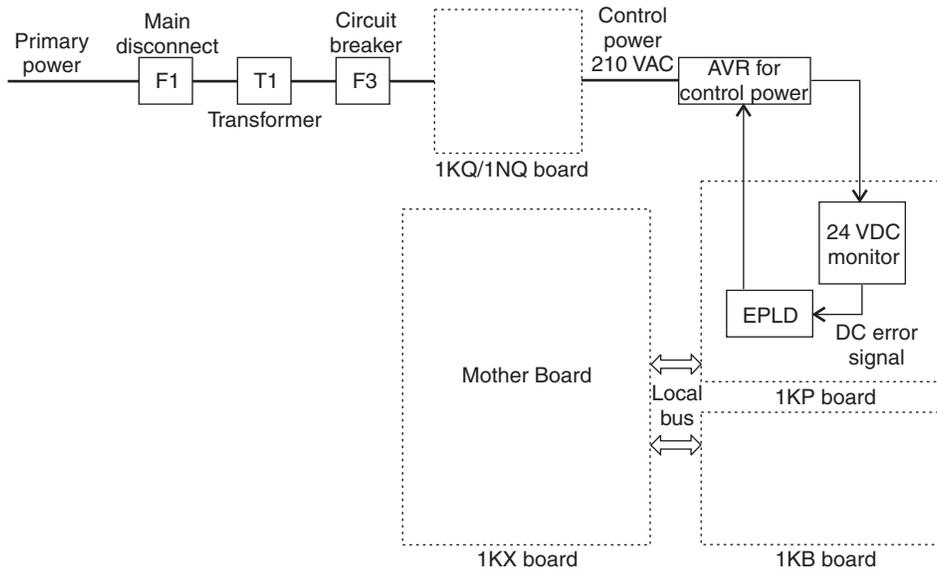
ERROR CODE D1508 24VDC power source is too low.

24 VDC to the power sequence board has dropped to +21.6 VDC or less.

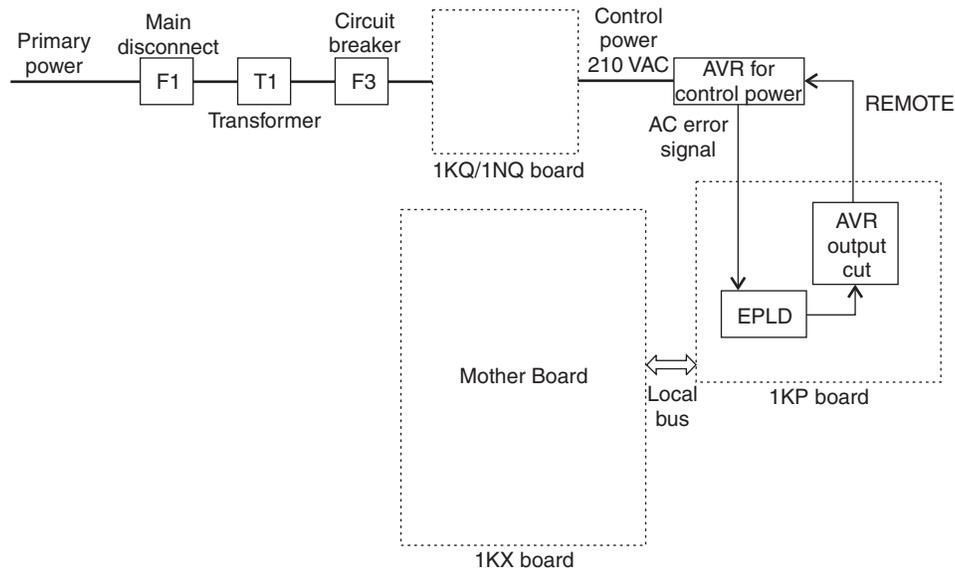
ERROR CODE D1509 Primary power source is too high.

Voltage level of the AVR for the control power supply is too high (267-277 VAC or more for 1-2 sec.).

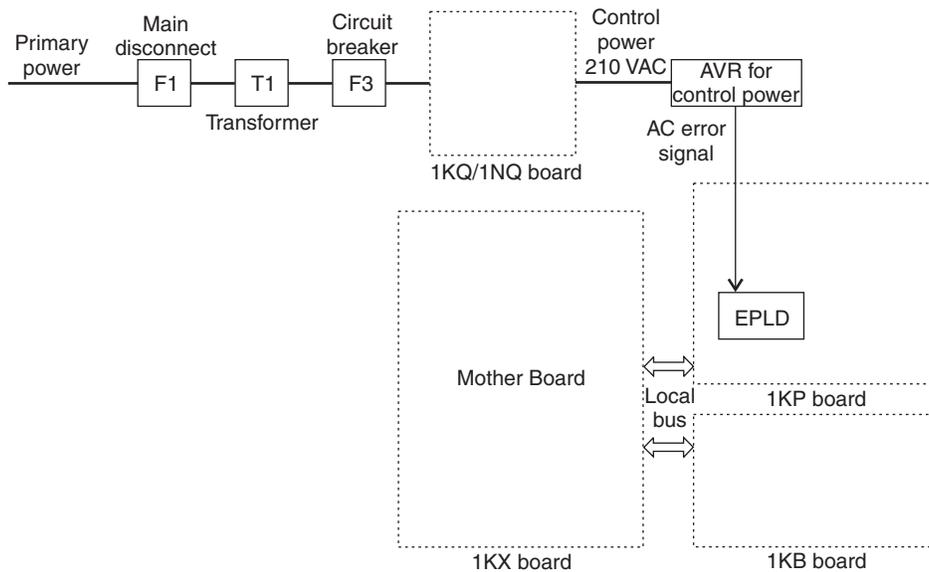
TROUBLESHOOTING**ERROR CODE D1510** Primary power source is too low.

Voltage level of the AVR primary power supply is too low (150-158 VAC or less for 1-2 sec.).

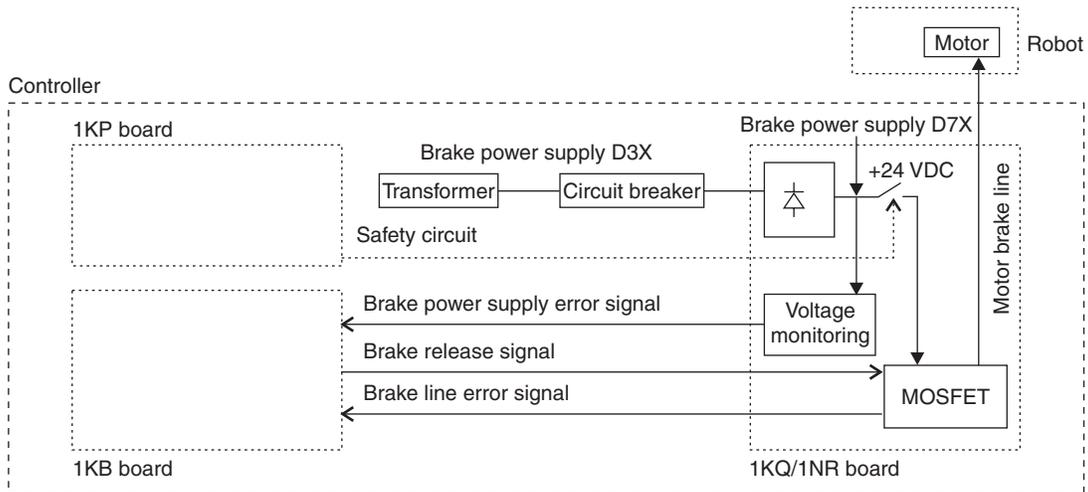
ERROR CODE D1512 Brake line error for JtXX.

This error occurs when the 1KB board detects an error signal sent from the brake release control MOSFET on the 1KQ/1NR board.

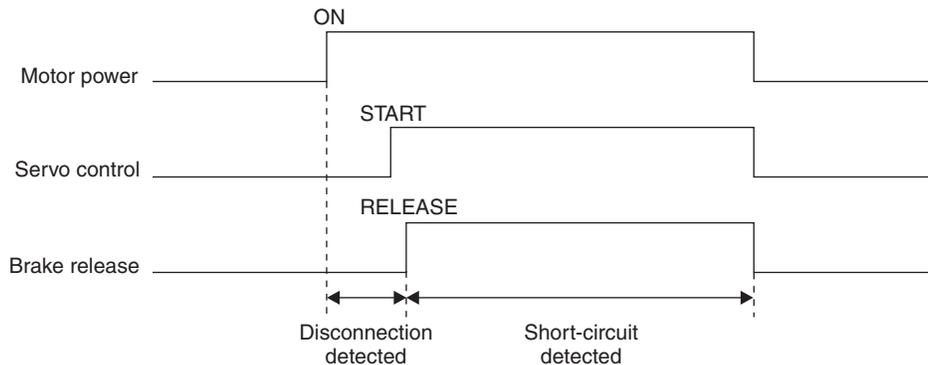
Brake line errors are not detected during motor power OFF. Brake line disconnection is not detected during automatic operation. Brake line error detection timing is shown in the diagram below.

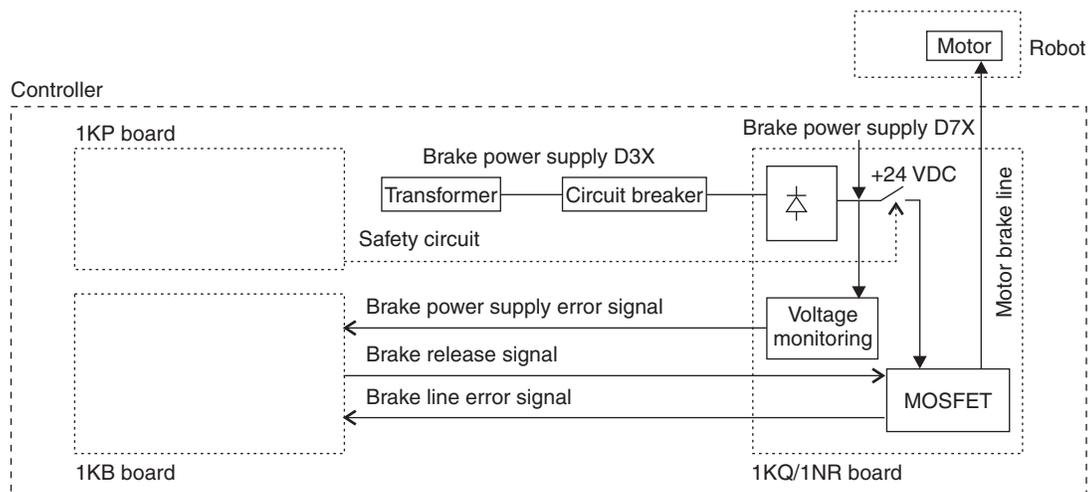
ERROR CODE D1513 Brake power is abnormal. (XX)

This error occurs when the 1KB board detects an error signal sent from the brake power supply, voltage monitoring circuit, on the 1KQ/1NR board.

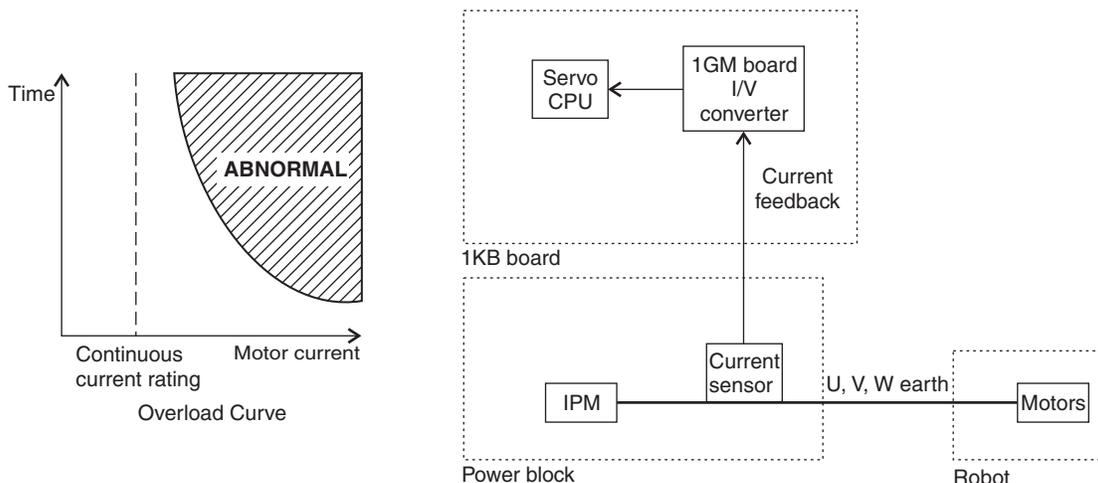
ERROR CODE E1028 Jt XX Motor overload.

The current feedback from the power block exceeded maximum continuous ratings longer than the time allowed.

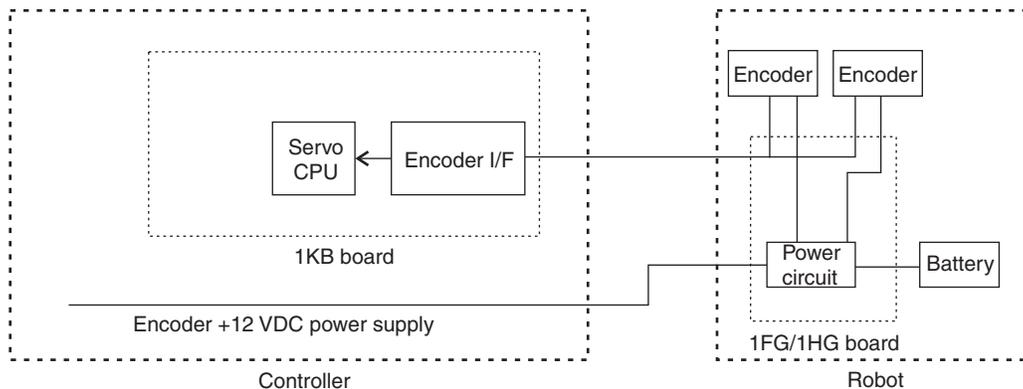
TROUBLESHOOTING**ERROR CODE E1029** Encoder rotation data is abnormal. (Jt XX)

Occurs when there is a difference (+2 rotations or more) between the rotation data in the serial encoder data and the rotation data calculated using the incremental technique.

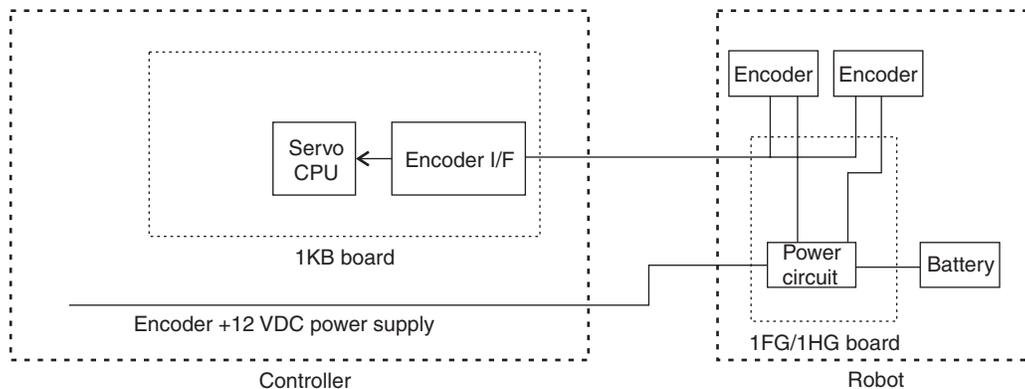
ERROR CODE E1030 Encoder data abnormal. (Jt XX)

When control power is switched ON, the current encoder value is compared to the stored encoder value when the power is turned OFF. If the difference is more than the value set in AUX 0504 Encoder Error Range, or by the ENCCCHK_DATA command, this error occurs.

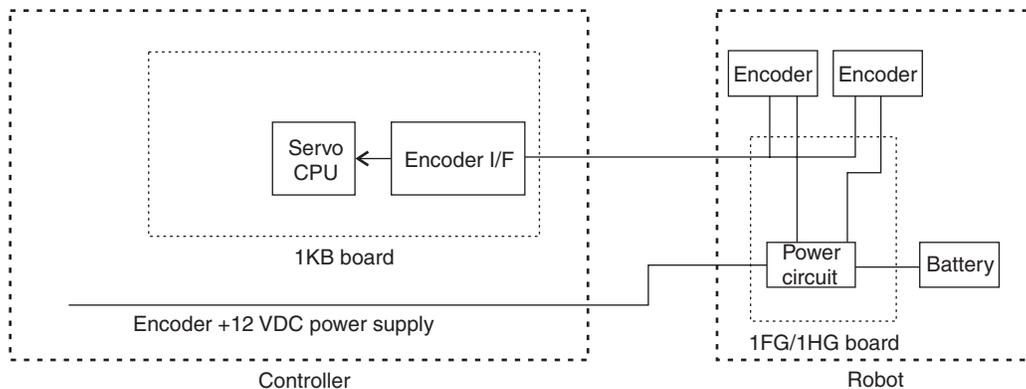
ERROR CODE E1032 Mismatch ABS and INC encoder data (Jt XX).

Occurs when there is a large difference between the value in the serial encoder data and the calculated data using the incremental technique.

Main causes include:

1. Defective encoder or encoder harness.
2. Defective 1KB board.
3. Noise related malfunction.
4. Defective 1FG/1HG board.
5. Servo spot weld gun.
 - Loose connection at tool changer.
 - Defective tool changer harness.

⇒ *Interrupt the 460 VAC to the main disconnect (circuit breaker F1) set the controller main disconnect to ON. Using an ohm meter check for a short circuit between these points:*

R and S, S and T, T and R, R and FG, S and FG, T and FG (FG=frame ground)

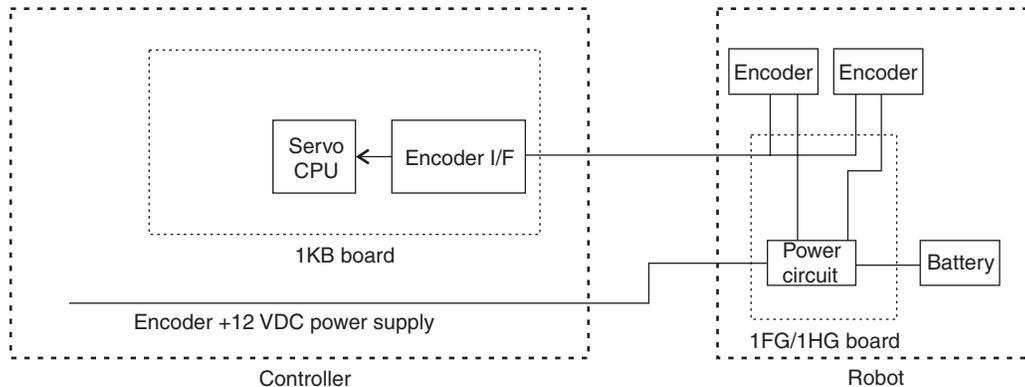
TROUBLESHOOTING**ERROR CODE E1034** Encoder initialize error (Jt XX).

The encoder is not able to read the absolute position at control power on. The scanning of absolute data begins immediately after a shift from the state of non-operation, or back-up operation, to normal encoder operation. BUSY=1 is output until the absolute position has been determined.

1. Encoder rotated at 300 RPM or more at controller power-up (including conveyor encoder).
2. Defective encoder or encoder harness.
3. Defective 1KB, 1KQ/1NR, or 1GF/1HG board.
4. Defective manual brake release.

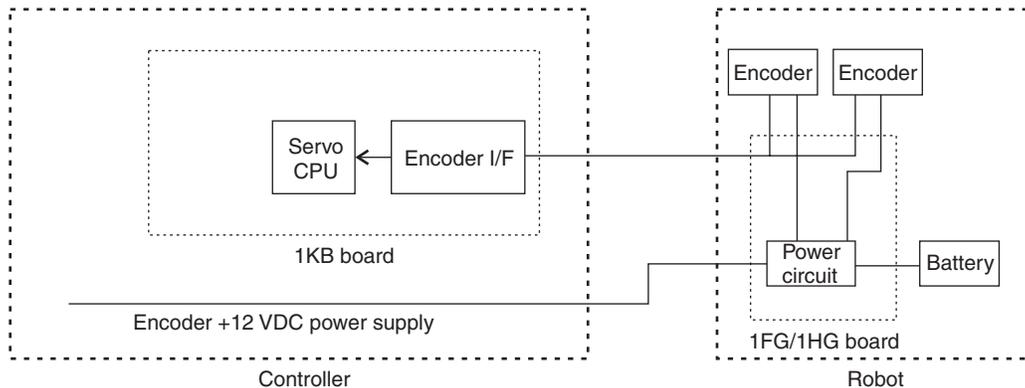
ERROR CODE E1035 Encoder response error (Jt XX).

Occurs when the encoder does not respond, or response is slow, to data request signal from the 1KB board.

1. Defective encoder or encoder harness.
2. Defective 1KB or 1FG/1HG board.
3. Noise related malfunction.
4. Servo spot weld gun.
 - Loose connection at tool changer.
 - Defective tool changer harness.

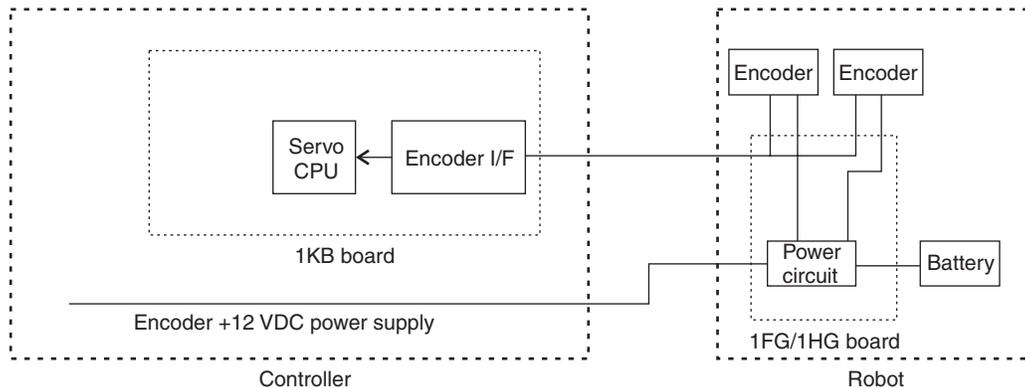
ERROR CODE E1036 Encoder communication error. (Jt XX)

Cyclic redundancy check (CRC) fault or framing error is detected in communication with the encoder.

1. Noise related malfunction.
2. Defective encoder or encoder harness.
3. Defective 1KB or 1FG/1HG board.
4. Servo spot weld gun.
 - Loose connection at tool changer.
 - Defective tool changer harness.

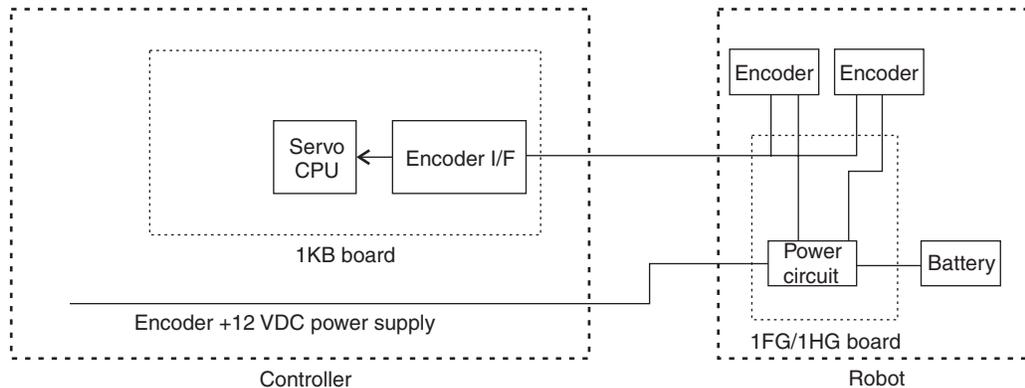
TROUBLESHOOTING**ERROR CODE E1037** Encoder data conversion error. (Jt XX).

This error is caused by abnormal encoder absolute position data.

1. Noise related malfunction.
2. Defective encoder or encoder harness.
3. Defective 1KB or 1FG/1HG board.
4. Servo spot weld gun.
 - Loose connection at tool changer.
 - Defective tool changer harness.

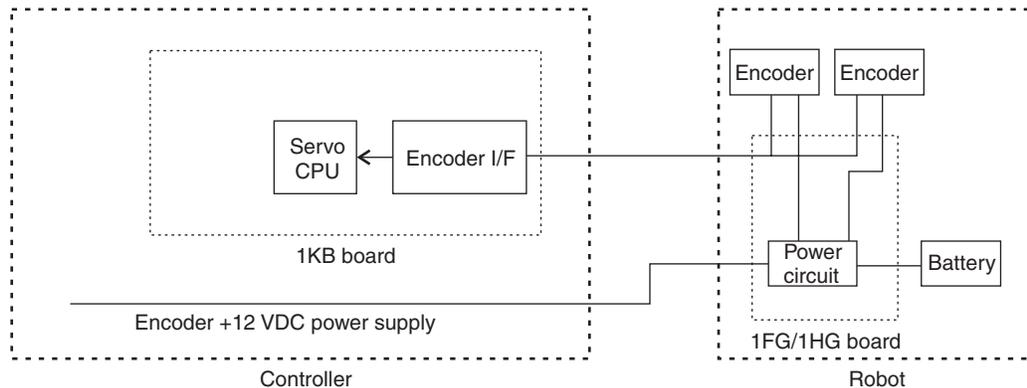
TROUBLESHOOTING**ERROR CODE E1038** Encoder ABS-track error. (Jt XX)

The absolute data and the incremental data in the encoder are different. ABSALM=1 is output from the encoder when this error occurs.

1. Noise related malfunction.
2. Defective encoder or encoder harness.
3. Defective 1KB or 1FG/1HG board.
4. Servo spot weld gun.
 - Loose connection at tool changer.
 - Defective tool changer harness.

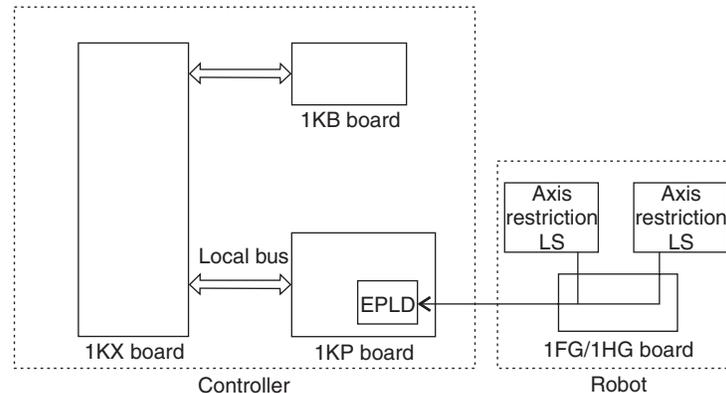
This error occurs when the robot moves beyond the set working range (restricted space) and activates the axis restriction limit switch.

The mechanical stopper and the axis restriction limit switch are optional and the axis they are installed on varies with machine type and configuration.

1. Software limits are set incorrectly in AUX 0507.
2. Axis is moved using the manual brake release and the limit switch is turned ON.
3. The limit switch is turned ON by overshoot from inertia.
4. Incorrect zeroing data.
5. Defective axis restriction limit switch or signal harness.
6. Defective 1KP board.

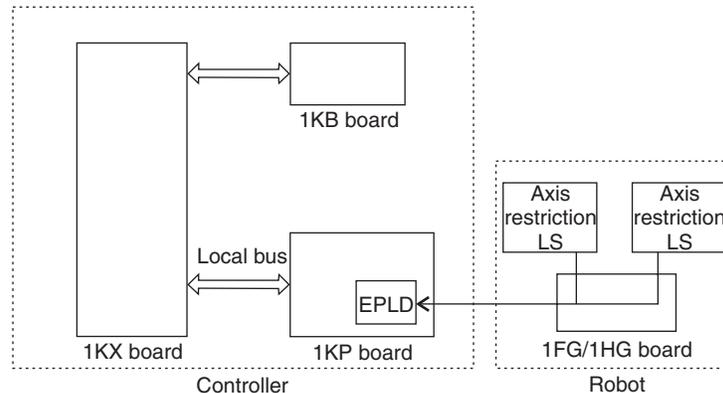
This error occurs when the axis restriction limit switch is activated and the robot did not move beyond the set working range (restricted space).

The mechanical stopper and the axis restriction limit switch are optional and the axis they are installed on varies with machine type and configuration.

1. Axis restriction limit switch activated by brake release or unexpected robot motion.
2. Axis restriction limit switch installed inside motion range set in AUX 0507.
3. Incorrect zeroing data.
4. Defective axis restriction limit switch.
5. Defective signal harness.
6. Defective 1KP board.

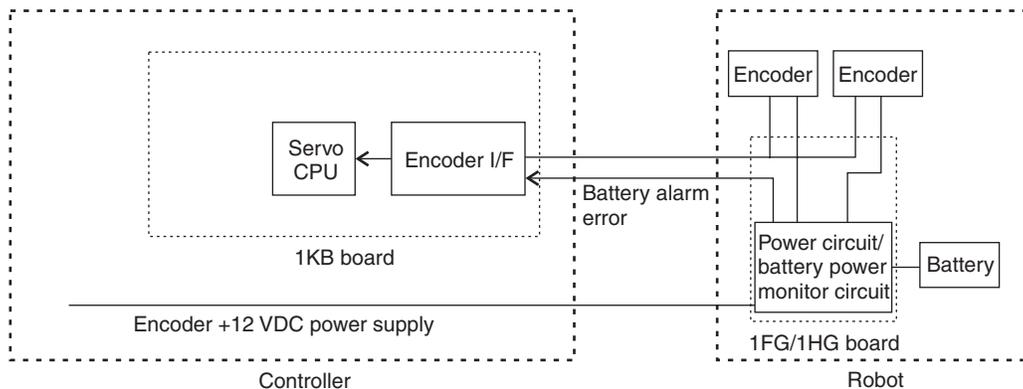
ERROR CODE W1013 Encoder battery low voltage [Servo (XX)].

Voltage of the encoder back up battery on the 1FG/1HG board decreased to 3.3 volts or less, or the encoder battery alarm signal (BAL_AL) is disconnected. This error is only detected at control power on or motor power on.

1. Discharged batteries.
2. Defective encoder battery board (1FG/1HG board).
3. Defective encoder.
4. Short in the harness from the encoder battery backup board to the encoder.
5. Short in the harness or defective encoder causing increased battery discharge.
6. Battery alarm signal line from the 1FG/1HG board is disconnected.
7. Defective servo board (1KB board).

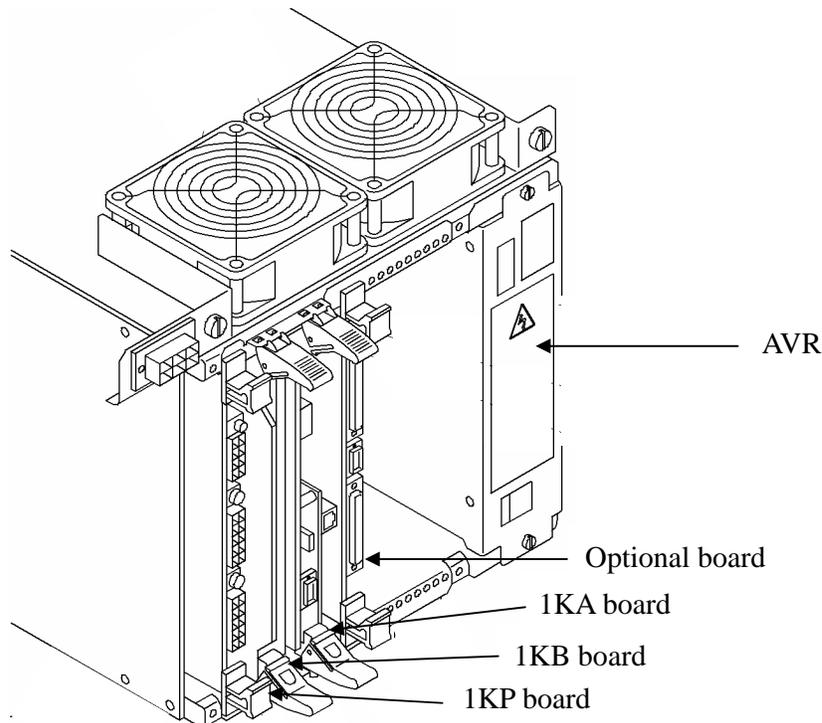
In the card rack of D3x controller, the 1KP board (power sequence board), 1KB board (arm control board), 1KA board (user I/F board), optional board, and the AVR are housed from the left as shown below. For D7x controller, the 1NR board (brake control board) is housed in the leftmost of the card rack.

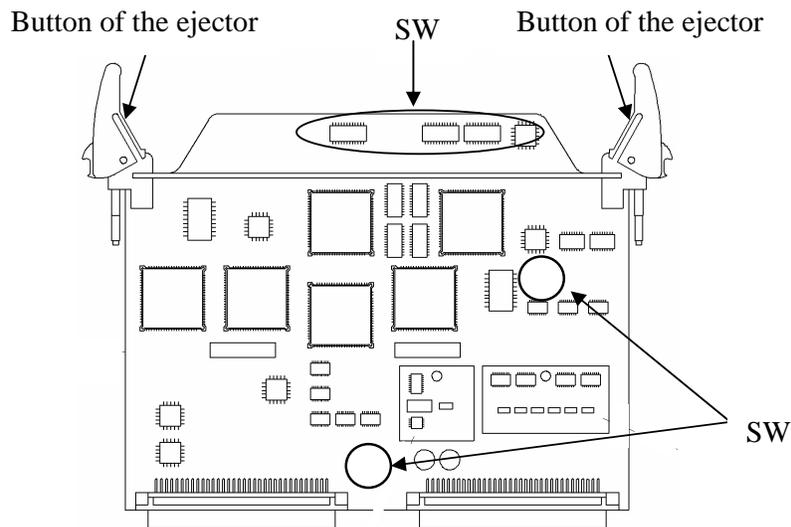
Overview of the 1KB board

1. Turn OFF the control power.
2. Press the red button on the ejector of the 1KB board to release the lock, and pull out the 1KB from the card rack by extending the ejector up and down.
3. Confirm that settings for SW1 to SW8 and SW10 on the new 1KB are the same as before board replacement. Then, insert the new 1KB to the card rack and set it in the mother board.

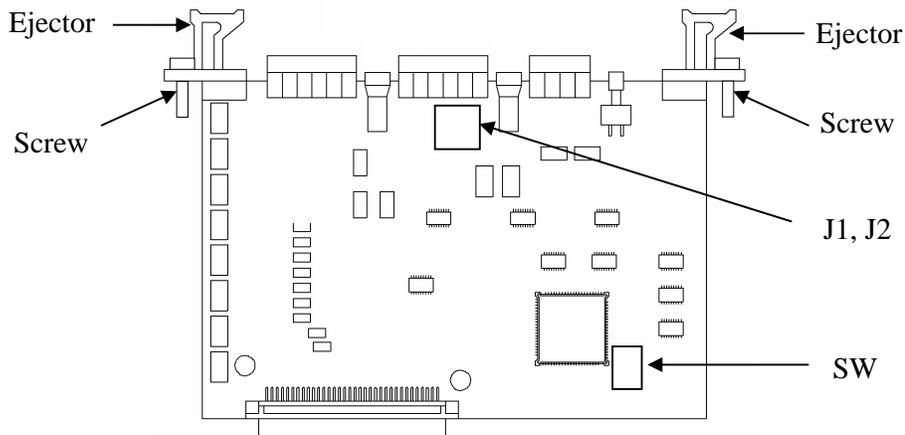
Overview of the 1KP board

1. Turn OFF the control power.
2. Loosen the screws on top and bottom of the 1KP board, and pull out the 1KP from the card rack by holding the ejectors at both ends of the board. If wired to the front connector, remove the connector first.
3. Confirm that settings for SW, J1 and J2 on the new 1KP are the same as before board replacement. Then, insert the new 1KP to the card rack and set it in the mother board.
4. Fasten the screws on top and bottom of the 1KP.

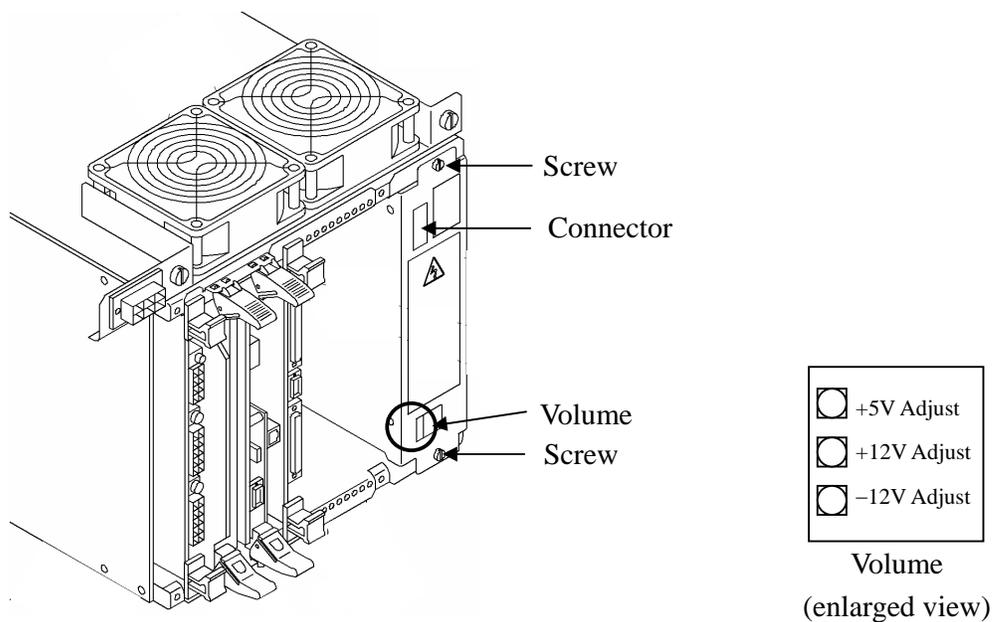
Overview of the AVR

No.	Color	Standard	Allowable range	If the voltage is out of allowable range,
TP1	White	+24.0 V	+23.9 V~ +24.7 V	Replace the AVR.

7. If there is no abnormality in the controller after checking voltage, paint lock each adjust volume of the AVR.
