Kawasaki

**D SERIES CONTROLLER
TROUBLESHOOTING AND
COMPONENT REPLACEMENT
MPVDCONTV113E-3**

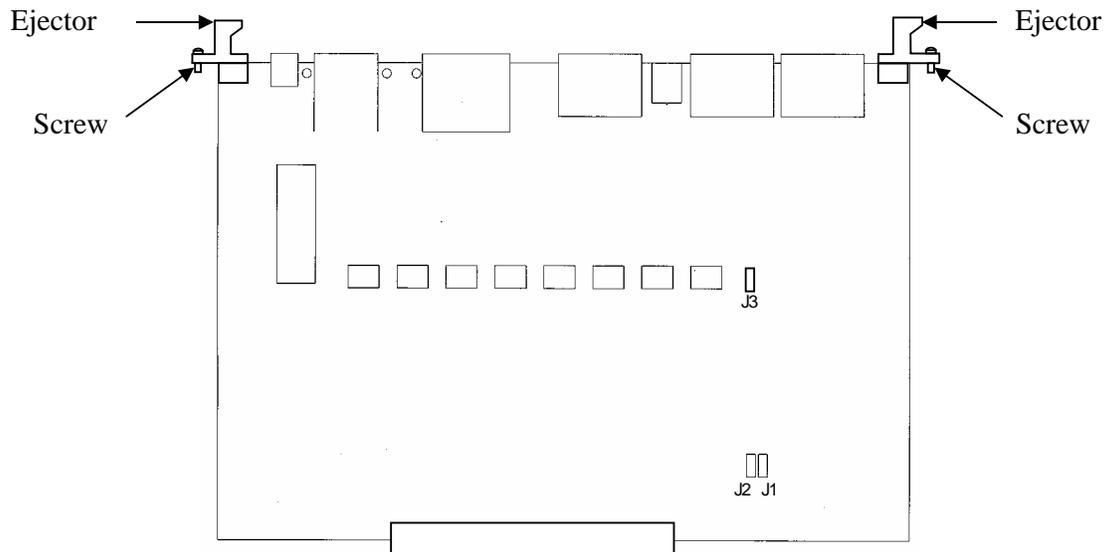
Overview of the 1NR board

1. Turn OFF the control power.
2. Loosen the screws on top and bottom of the 1NR board, and pull out the 1NR from the card rack by holding the ejectors at both ends of the board. If wired to the front connector, remove the connector first.
3. Confirm that settings for J1, J2 and J3 on the new 1NR are the same as before board replacement. Then, insert the new 1NR to the card rack and set it in the mother board.
4. Fasten the screws on top and bottom of the 1NR.

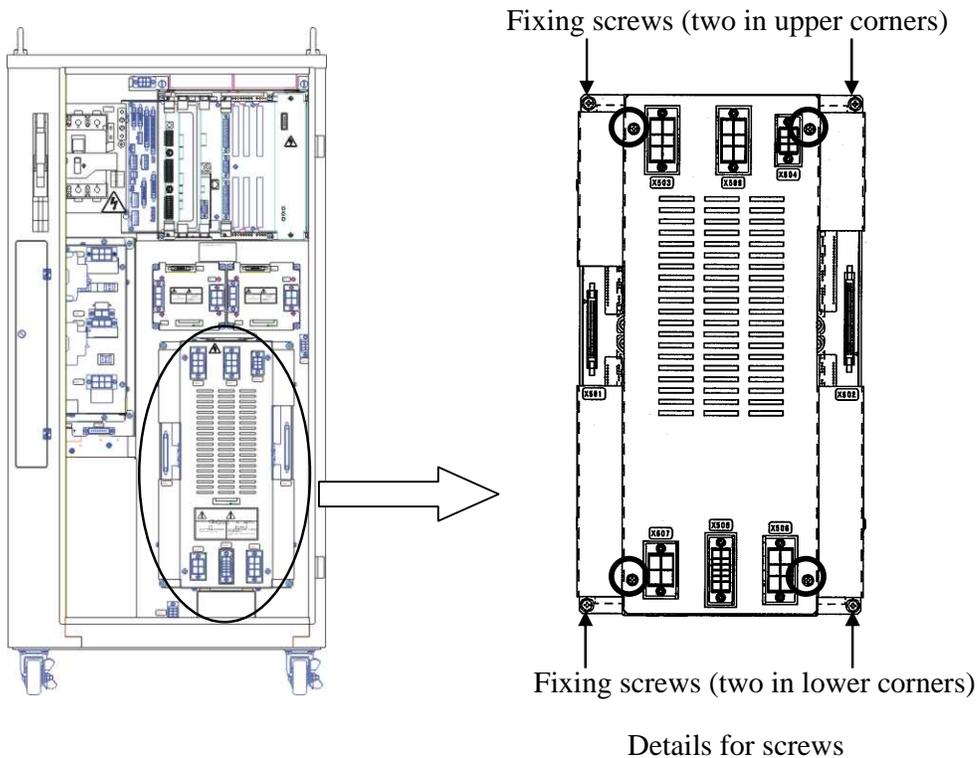
1. Remove all connectors connected to the power block unit.
2. Loosen the four screws fixing the power block unit to the controller so that the power block unit can be removed from the controller. (These screws are not removed from the power block unit.)
3. To remove the power block unit, pull it out by sliding on the fulcrum. To be safe, hold the handle on top with one hand.
4. Place the new unit on the fulcrum, and set it in by holding the handle on top with one hand. Then, attach it to the controller by fastening the four screws correctly.
5. Restore the connectors removed in step 1.

○ : Screws on the front of power block unit
(Do not touch any of these screws.)

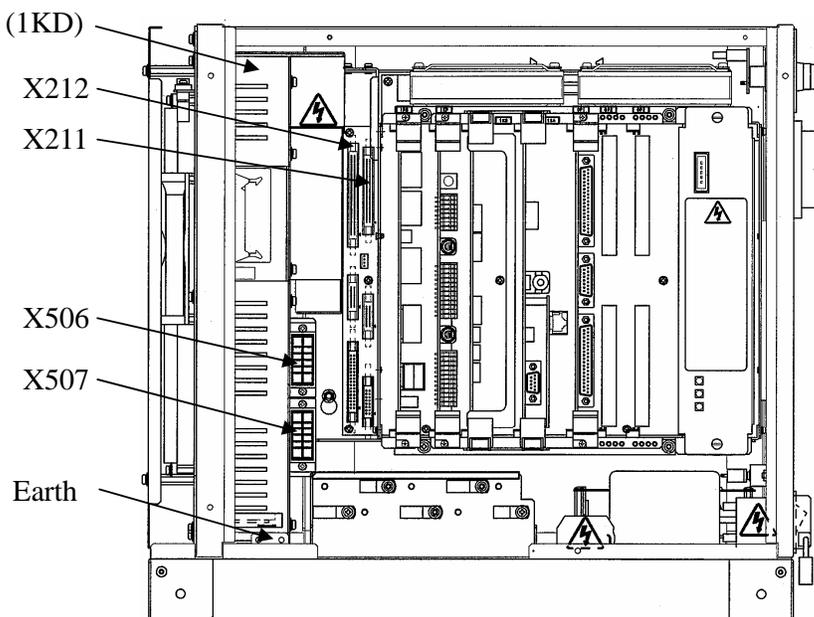
Power block unit (1KD)

1. Remove the controller cover.
2. Remove the connectors X506 and X507 connected to the power block unit.
3. Remove the screw fixing the earth wired from the power block unit.
4. Remove the four screws fixing the power block unit to the controller.
5. Pull out the power block unit by sliding backward on the fulcrum.
6. Remove the connectors X302 and X311.
7. Remove the connectors X211 and X212.
8. Remove the power block unit.
9. Attach the new unit to the controller in reverse order of removal.

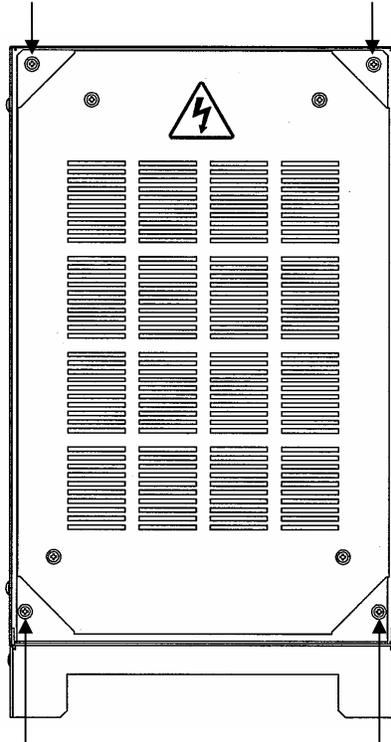
Fixing screws (two in lower corners)

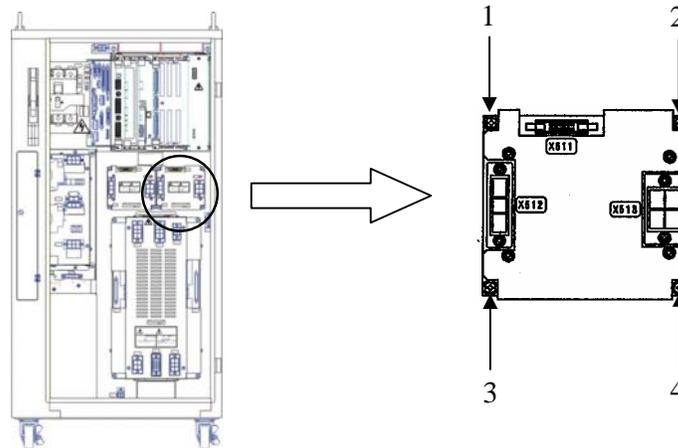
1. Remove all connectors connected to the power block unit.
2. Loosen the four screws fixing the power block unit to the controller (1 to 4 in figure below) so that the power block unit can be removed from the controller. (These screws are not removed from the power block unit.)
3. Remove the power block unit.
4. Attach the new unit to the controller by fastening the four screws removed in step 2 correctly.
5. Restore the connectors removed in step 1.

The replacement procedure for the 1KR is same as that for the 1KL.

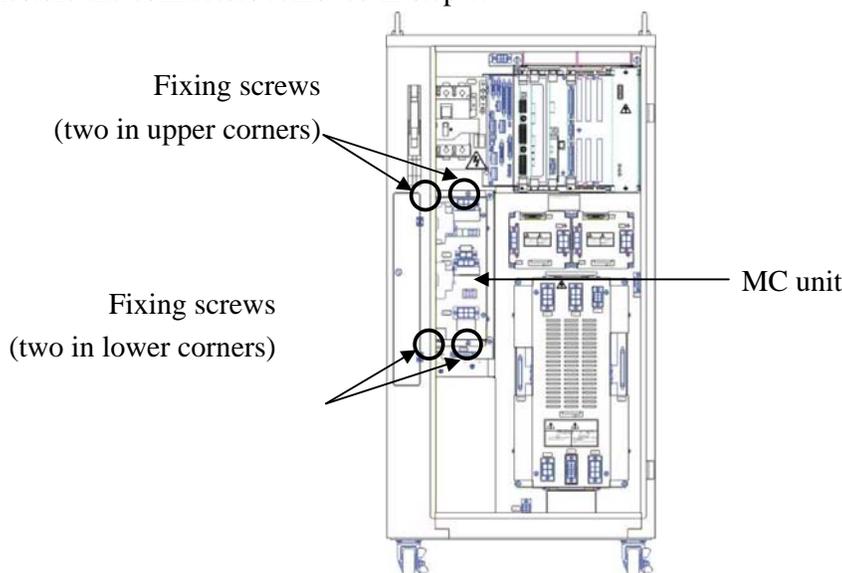
NOTE** Be careful not to let the washers/screws fall under the MC unit.

MC unit weighs approx. 6kg. Be careful not to cut or squeeze the tips of your fingers when replacing MC unit.

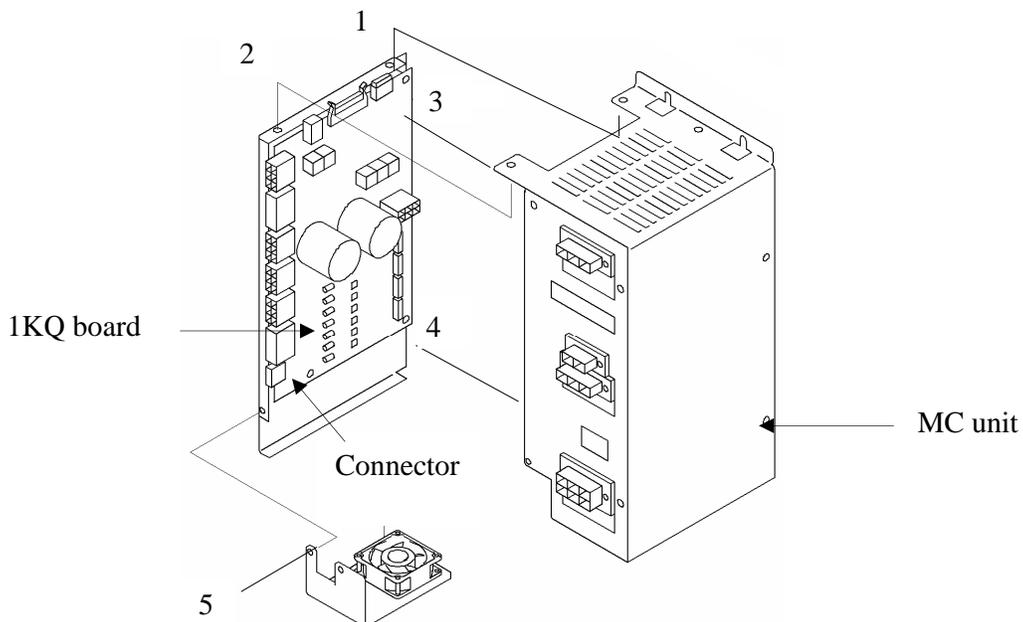
1. Remove the MC unit. For details, refer to 2.4.1 MC Unit.
2. Remove the four screws fixing the 1KQ board assy to the MC unit (1 to 4 in figure below), the one screw fixing the fan unit of the MC unit (5 in figure below), and the connector for the fan. Then, pull out the 1KQ board assy.

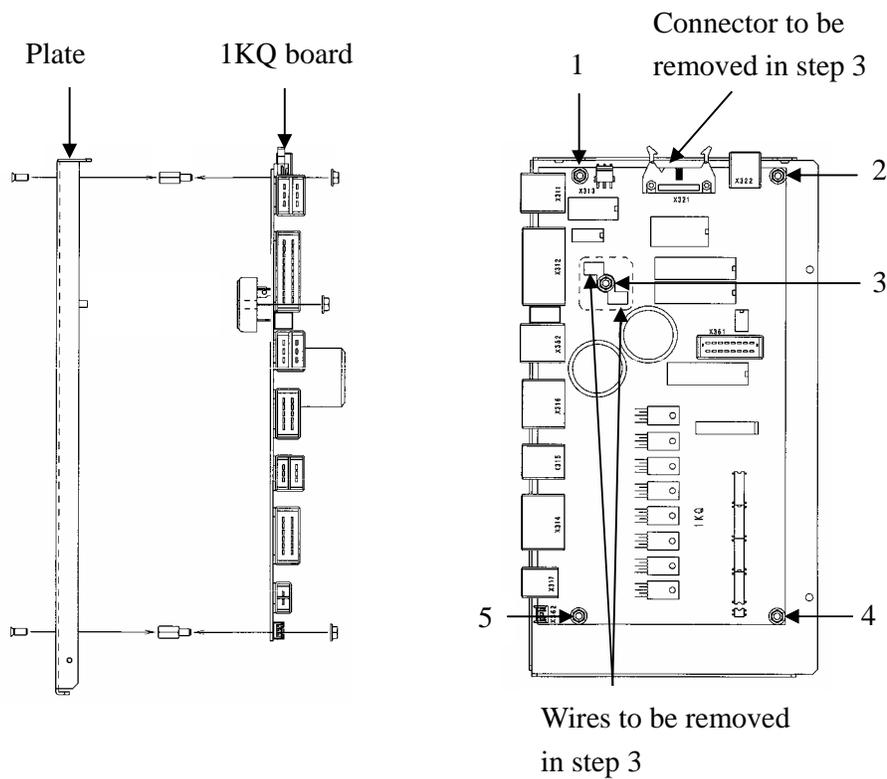
4. Loosen the five nuts fixing the 1KQ to the plate (1 to 5 in figure below), and remove the 1KQ.
5. Attach the new 1KQ to the plate with the five nuts removed in step 4.
6. Restore the connector and two wires removed in step 3 to the assy assembled in step 5.
7. Refasten the screws and connect the connector removed in step 2.
8. Attach the MC unit to the controller. For details, refer to 2.4.1 MC Unit.

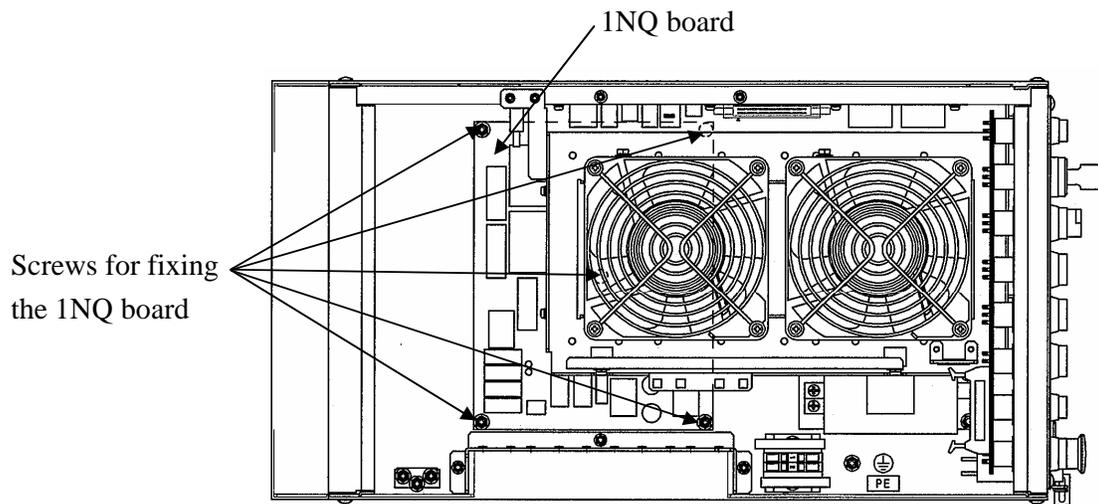
2.5 REPLACEMENT PROCEDURE FOR 1NQ BOARD (FOR D7X CONTROLLER)

1. Turn OFF the control power.
2. Remove the power block unit. (For the procedure, see 2.3.3 1KD Power Block Unit (for D7x Controller).)
3. Remove the 1NR, 1KP, 1KB, and 1KA boards in the card rack.
4. Remove all connectors connected to the 1NQ board.
5. Remove the five screws fixing the 1NQ board.
6. Remove the 1NQ board from back side.
7. Attach the new 1NQ board by fastening the five screws.
8. Restore the connectors removed in step 4.
9. Restore the boards removed in step 3.
10. Restore the power block unit to the controller.

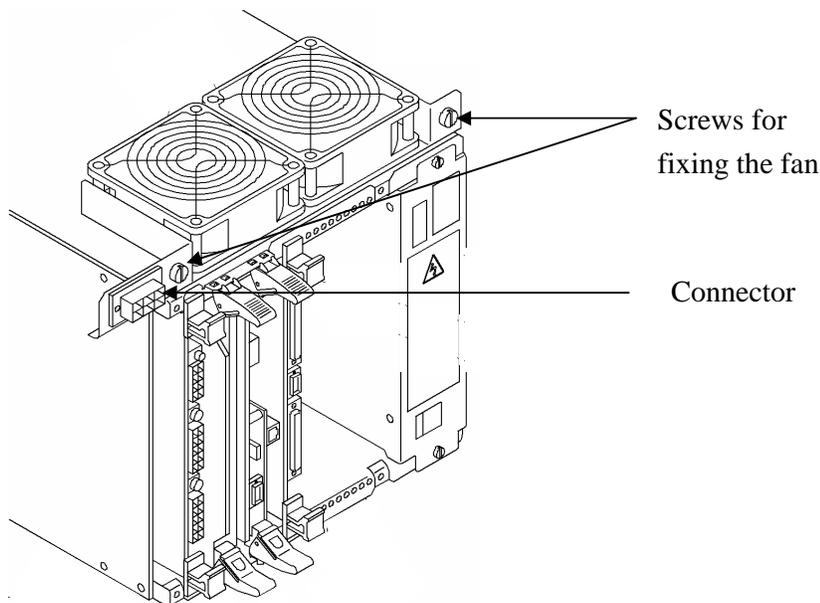
2.6.1 FAN FOR CARD RACK

1. Turn OFF the control power.
2. Remove the connector connecting the fan to the card rack. Then, loosen and remove the two screws fixing the fan unit.
3. Remove the power line and the earth wire connected to the fan. Loosen the four screws fixing the fan, and then remove the fan.
4. Attach the new fan with the four screws, and restore the power line and earth wire removed in step 3. Be sure to reattach the fan correctly; wind blows top to down.
5. Attach the fan unit to the top of the card rack, and fasten it with the two screws.
6. Restore the connector removed in step 2.

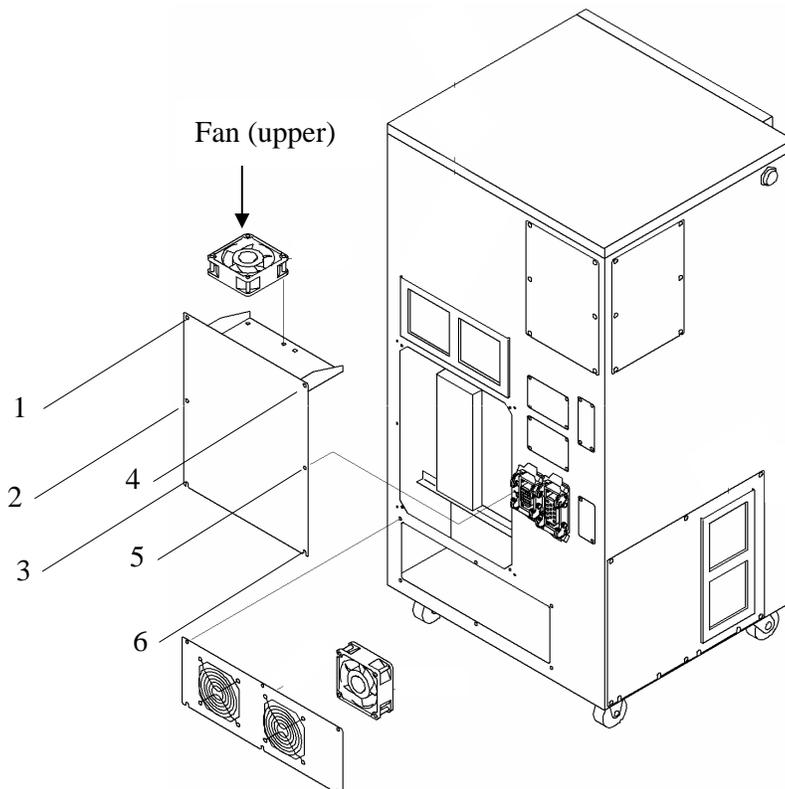
2.6.2.1 UPPER FAN ON BACK OF CONTROLLER

1. Turn OFF the control power.
2. Remove the six screws fixing the plate on the controller back (1 to 6 in figure below).
3. Pull out the plate, remove the connector connected to the controller, then remove the plate.
4. Remove the power line and the earth wire connected to the fan. Loosen and remove the four screws fixing the fan, and then remove the fan.
5. Attach the new fan to the plate with the four screws, and restore the power line and earth wire removed in step 4. Be sure to reattach the fan correctly; wind blows top to down.
6. Restore the connector removed in step 3, and reattach the plate with the six screws.

This section describes the replacement procedures for the two fans mounted on the controller back. The upper fan cannot be seen from outside.

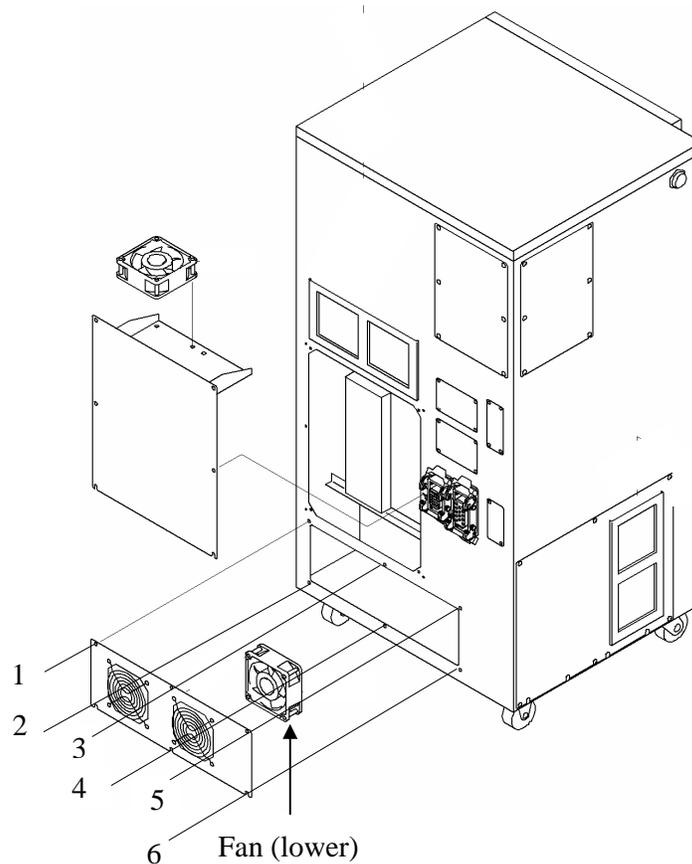
2.6.2.2 LOWER FAN ON BACK OF CONTROLLER

1. Turn OFF the control power.
2. Remove the six screws fixing the plate on the controller back.
3. Pull out the plate, remove the connector connected to the controller, and remove the plate.
4. Remove the power line and the earth wire connected to the fan. Loosen and remove the four screws fixing the fan, and then remove the fan.
5. Attach the new fan to the plate with the four screws, and restore the power line and earth wire removed in step 4. Be sure to reattach the fan correctly; wind blows from inside to outside.
6. Restore the connector removed in step 3, and reattach the plate to the controller with the six screws.

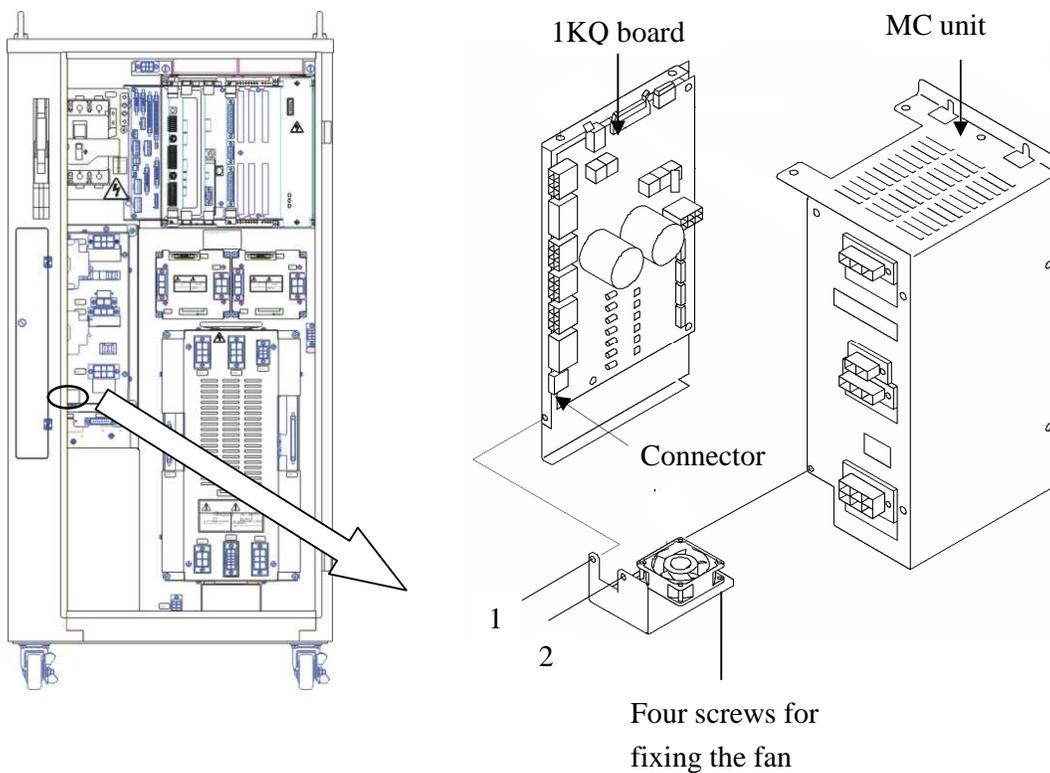
2.6.3 MC UNIT FAN

1. Turn OFF the control power.
2. Remove the two screws at the bottom of the MC unit (1 and 2 in figure below) and pull out the plate. Remove the connector connected to the 1KQ board and remove the fan unit.
3. Remove the four screws fixing the fan and remove the fan.
4. Attach the new fan to the plate with the four screws. Be sure to reattach the fan correctly; wind blows top to down.
5. Restore the connector removed in step 2, and attach the plate to the MC unit with the two screws.

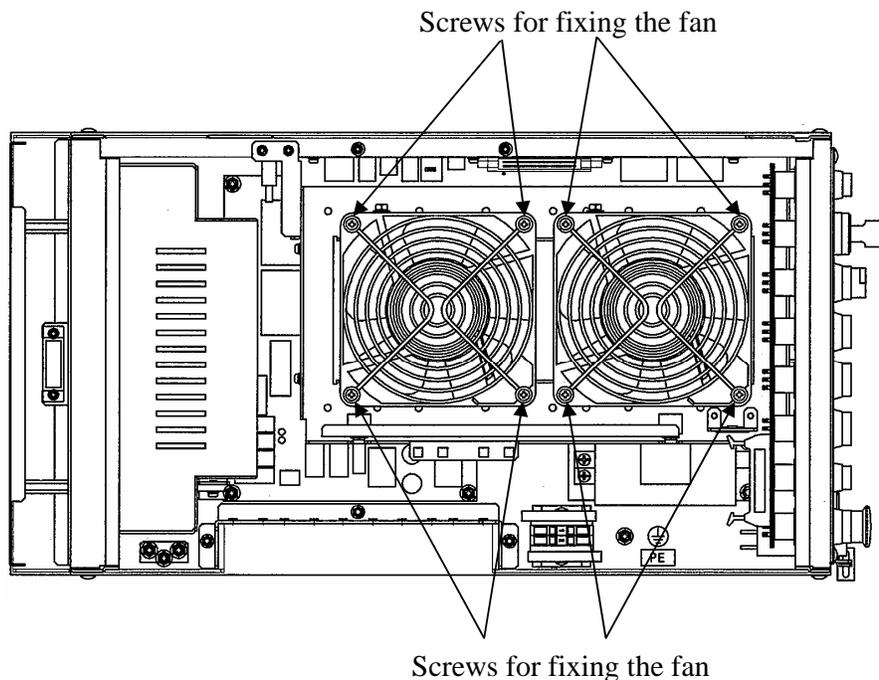
2.7.1 FAN FOR CARD RACK

1. Turn OFF the control power.
2. Open the controller cover.
3. Remove the four screws fixing the fan.
4. Remove the power line and the earth wire connected to the fan, and then remove the fan.
5. Restore the power line and earth wire removed in step 4 to the new fan.
6. Fix the fan with the four screws. Be sure to reattach the fan correctly; wind blows top to down.

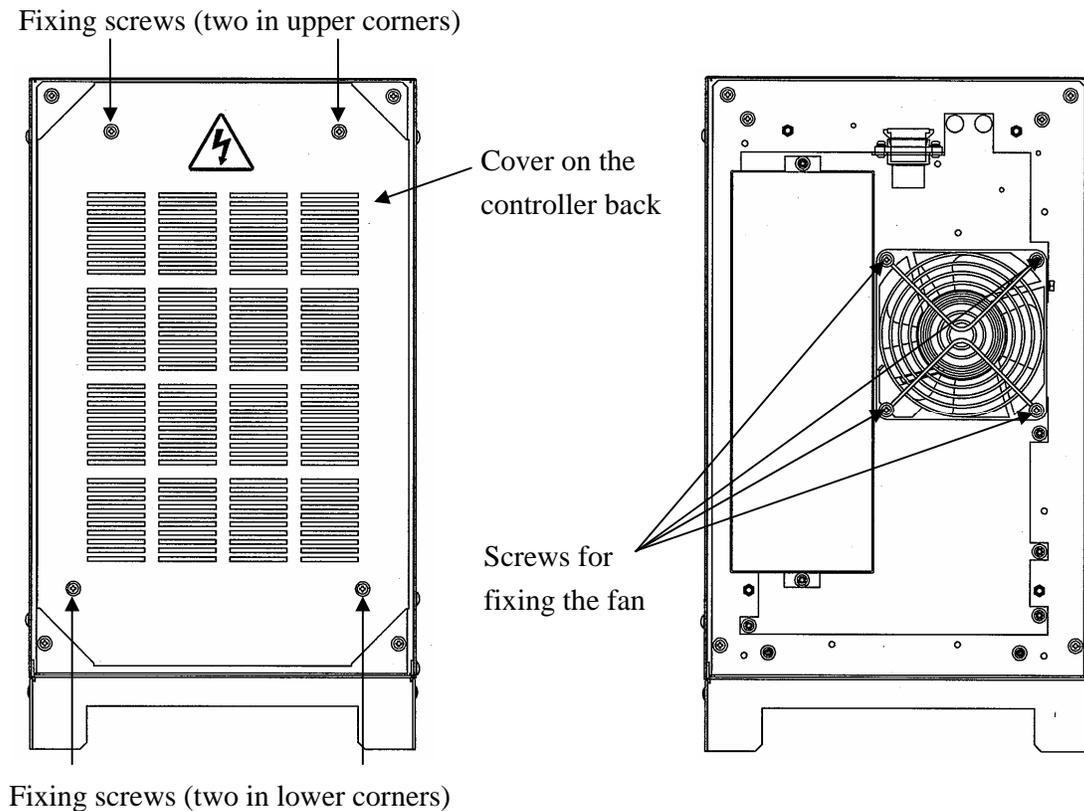
2.7.2 FAN FOR POWER BLOCK UNIT

1. Turn OFF the control power.
2. Remove the four screws fixing the cover on the controller back, and then remove the cover.
3. Remove the four screws fixing the fan.
4. Remove the power line and the earth wire connected to the fan, and then remove the fan.
5. Restore the power line and earth wire removed in step 4 to the new fan.
6. Fix the fan with the four screws. Be sure to reattach the fan correctly; wind blows from outside to inside.
7. Restore the cover on the controller back with the four screw.

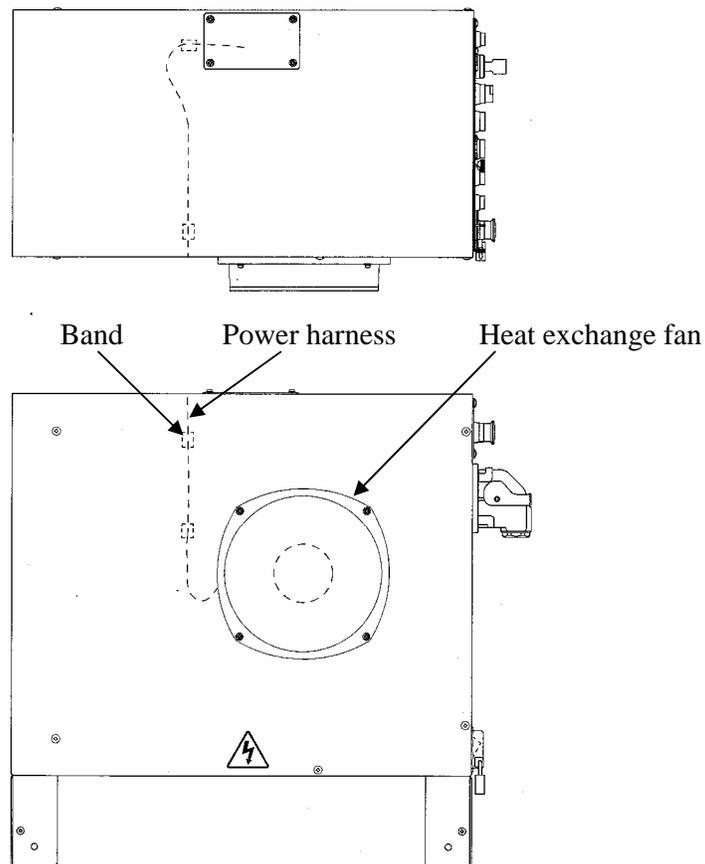
2.7.3 HEAT EXCHANGE FAN (FOR D71/74/77 CONTROLLER)

Heat exchange fan is installed on the left side of the controller cover.

1. Turn OFF the control power.
2. Remove the controller cover.
3. Remove the power harness from the bands which fix the harness.
4. Remove the four screws fixing the fan, and then remove the fan.
5. Attach the new fan with the four screws. Be sure to reattach the fan correctly.
6. Restore the power harness removed in step 3 with the bands.
7. Restore the controller cover.

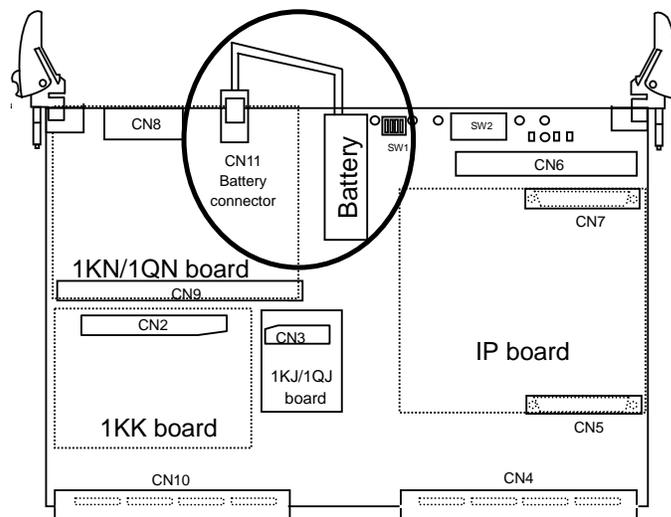
As backup power supply for SRAM and RTC (Real Time Clock), the 1KA board is equipped with a lithium battery and an emergency super capacitor for use during battery replacement.

1. Before replacing the battery, confirm that the new battery has +3.6V or more voltage.
2. Turn OFF the control power.
3. Remove the battery connector of the 1KA and pull out the battery from the holder. When it is hard to work on, pull out the 1KA. For more details about pulling out the board, refer to 2.2.1 1KA Board (User I/F Board).
4. After installing the new battery to the holder, connect the battery connector. If the 1KA was pulled out, put it back to the original place.

When on-board battery is removed, fully charged super capacitor can provide backup power for only 15 minutes. Therefore, battery should be replaced immediately once the control power is cut OFF.

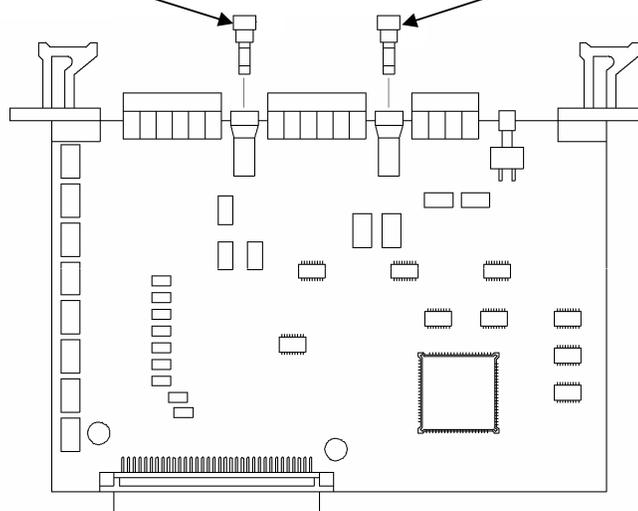
Overview of the 1KP board

1. Turn OFF the control power.
2. Push the fuse on the front of the board and turn it 90 degrees to the left. Then pull it out and remove the fuse from the board.
3. Push in the new fuse, and turn it 90 degrees to the right to install.

Fuse2 (Machine valves: 1A) Fuse1 (E-Stop: 315 mA)

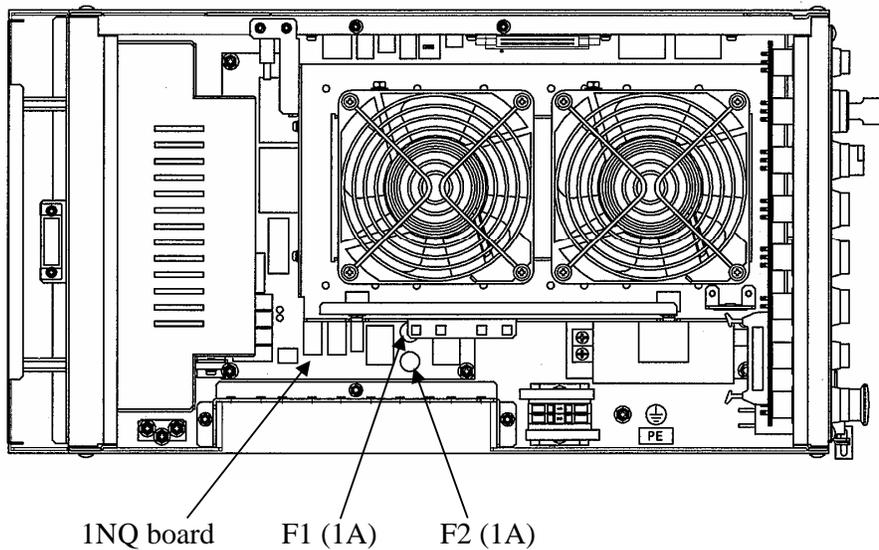
2.9.2 FUSES ON 1NQ BOARD (FOR D7X CONTROLLER)

1. Turn OFF the control power.
2. Remove the controller cover.
3. Turn the fuse 90 degrees to the left. Then pull it out and remove the fuse from the board.
4. Push in the new fuse, and turn it 90 degrees to the right to install.
5. Restore the controller cover.

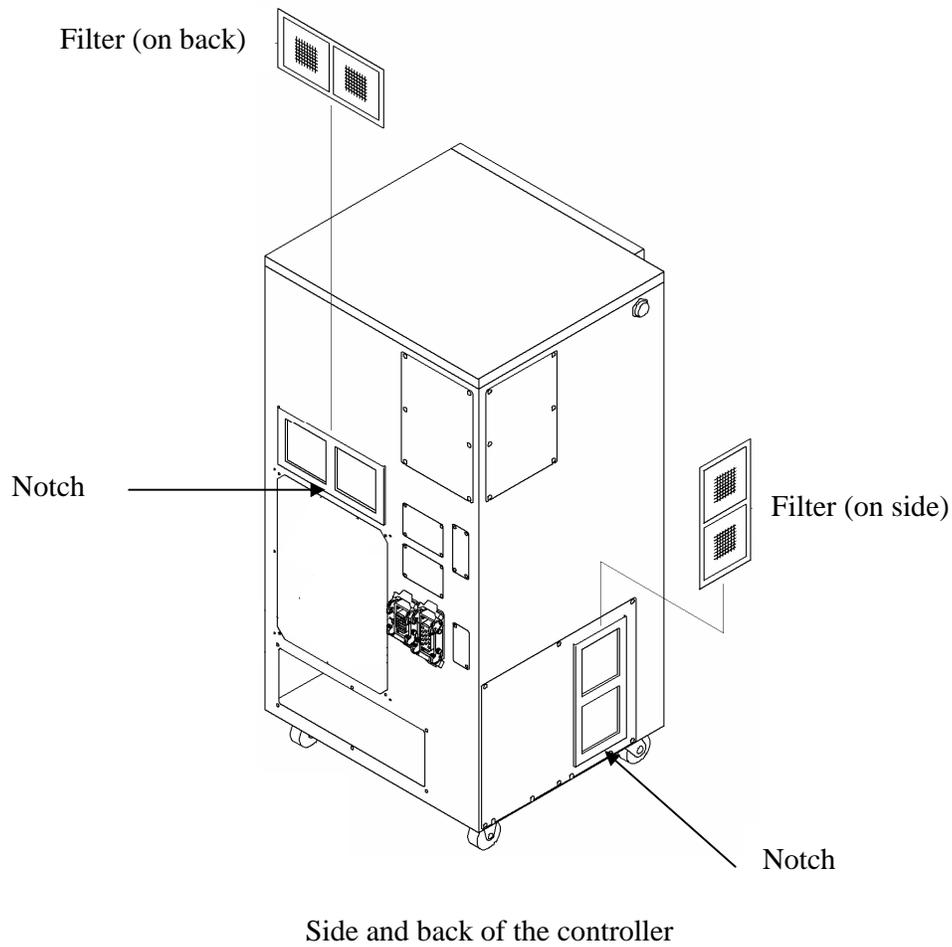
2.10 REPLACEMENT PROCEDURE FOR FILTER

Filters are located on the side and back of the controller. Take the same procedure to replace these filters.

1. In the center, bottom of the holder for the filter there is a notch. Insert something tube shaped into the notch, and push up the filter. Be careful not to damage the controller face.
2. Pull up the raised filter.
3. Insert the replacement filter into the holder.

Wash filters periodically to keep them clean. For replacement, follow the replacement procedure described below.
