(2)- (MAYTAG) TOP LOAD WASHER LID SWITCH KIT  
#12001908.

# Instruction Sheet

**REPAIR PART NO.:** 12001908 (MPN 6 2306250)

**DESCRIPTION:** LID SWITCH KIT

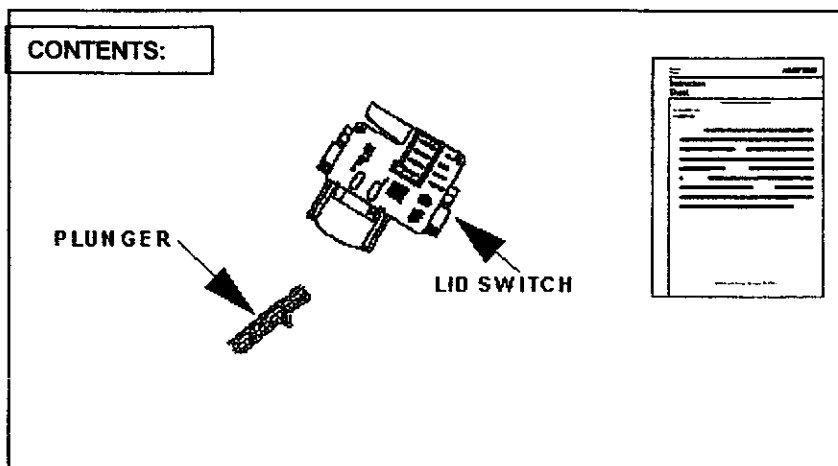
The purpose of this instruction is to inform you of changes made to the switch, making the switch no longer adjustable. The lid switch mechanism is designed to shut off the machine if the lid is lifted no more than 1-7/8" and will allow the machine to start when the lid is less than 1/4" high. The plunger is only used with Atlantis washers.

**Note:** The new lid switch (identified with a grey button) is now non-adjustable. You cannot adjust by pulling on the lid switch button.
