SPHEREON 4300

McDATA®
Sphereon™ 4300 Fabric Switch
Installation and Service Manual

P/N 620-000171-030
REV A

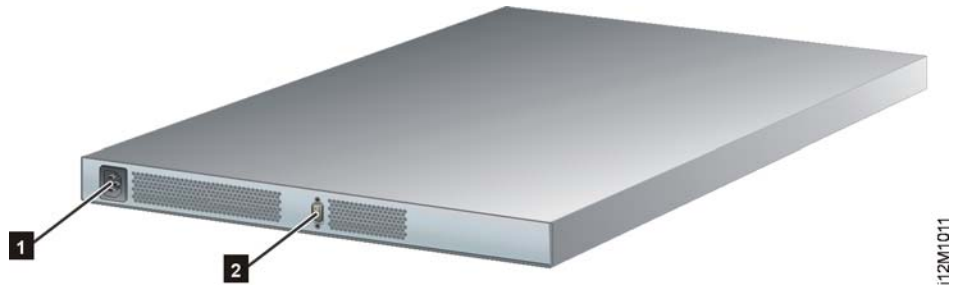
Figure 1-2 illustrates the rear of the switch and shows the:

1. AC power receptacle.
2. RS-232 maintenance port.

Figure 1-2 Sphereon 4300 Switch (Rear View)

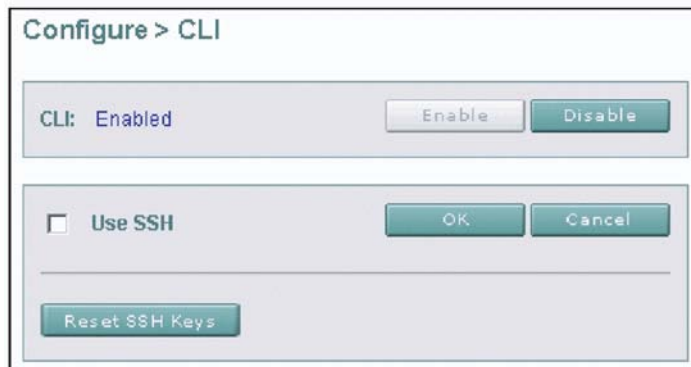
i24M1137

1. Select *CLI* from the *Configure* menu at any view. The *CLI View* displays (Figure 2-9).
2. Perform one of the following:
 - Click *Enable* to activate the CLI.
 - Click *Disable* to deactivate the CLI.
3. Click (check) the *Use SSH* check box to enable secure shell (SSH) protocol. The protocol controls CLI access to the product and provides software-enforced encryption.
4. Click *OK* to save and activate changes.

Figure 2-9 CLI View

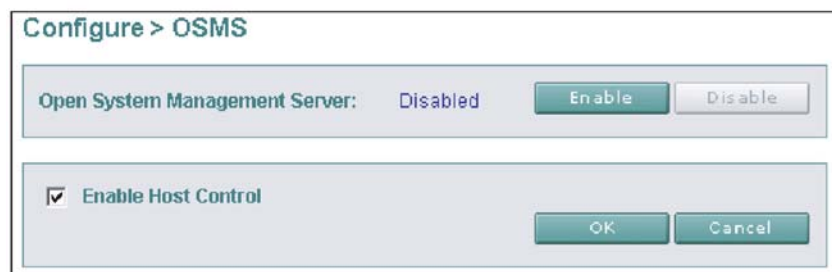
i24M1138

1. Select *OSMS* from the *Configure* menu at any view. The *OSMS View* displays (Figure 2-10).

Figure 2-10 OSMS View

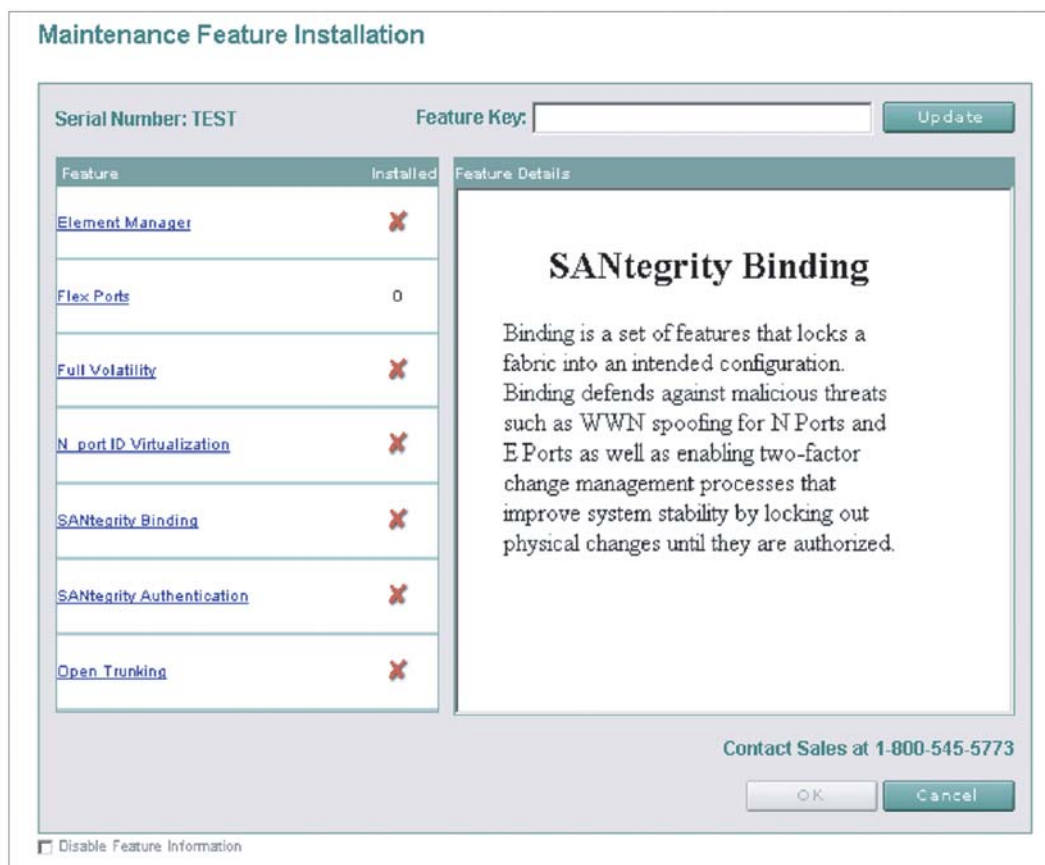
i24MT1147

1. Select *Upgrade Options* from the *Configure*, *Maintenance*, or *Security* menus at any view. The *Maintenance Feature Installation View* displays (Figure 2-12).

Figure 2-12 Maintenance Feature Installation View

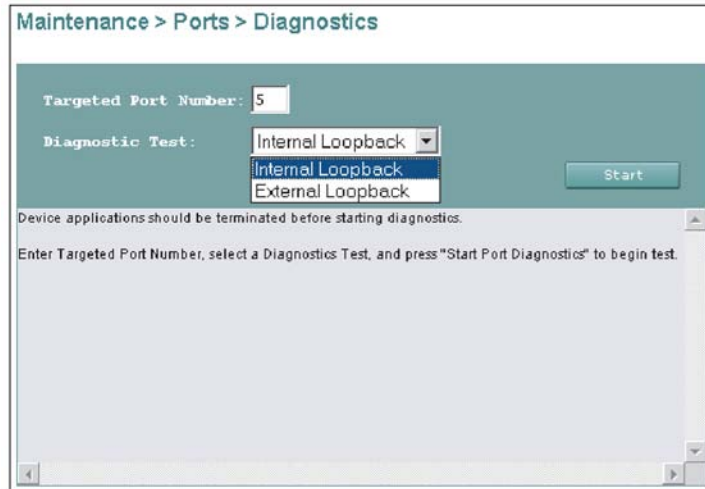
116M2008

2. At the EFCM Basic Edition interface, select *Ports* and *Diagnostics* from the *Maintenance* menu at any view. The *Diagnostics View* displays (Figure 4-4).

Figure 4-4 Diagnostics View

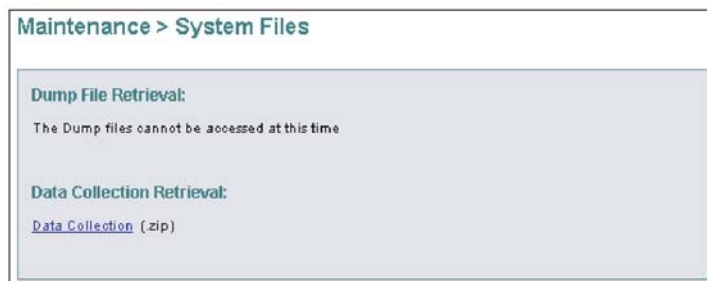
116M2009

1. At the EFCM Basic Edition interface, select *System Files* from the *Maintenance* menu at any view. The *System Files View* displays (Figure 4-5).

Figure 4-5 System Files View

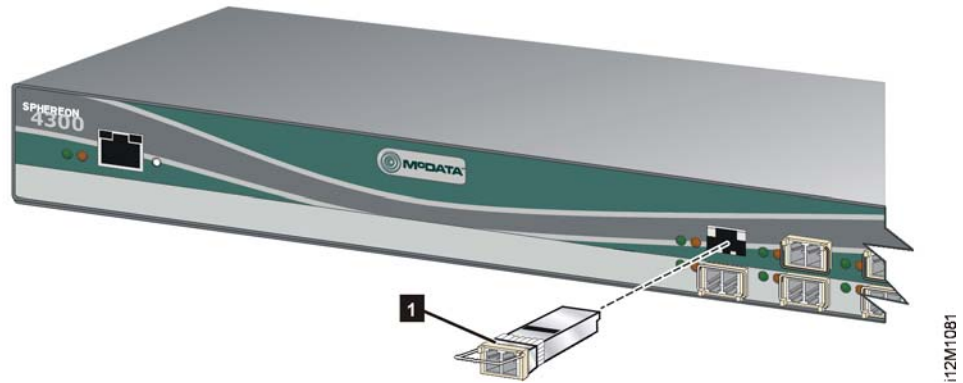
Figure 6-1 illustrates front-accessible FRUs. Table 6-1 is the associated FRU parts list. The table includes reference numbers to Figure 6-1, FRU part numbers, descriptions, and quantities.

Figure 6-1 Front-Accessible FRUs
