Patch Release Note

Patch sr264-03 for AT-8600 series switches

This patch release note lists the issues addressed and enhancements made in patch sr264-03 for Software Release 2.6.4 on existing models of AT-8600 series switches. Patch file details are listed in Table 1.

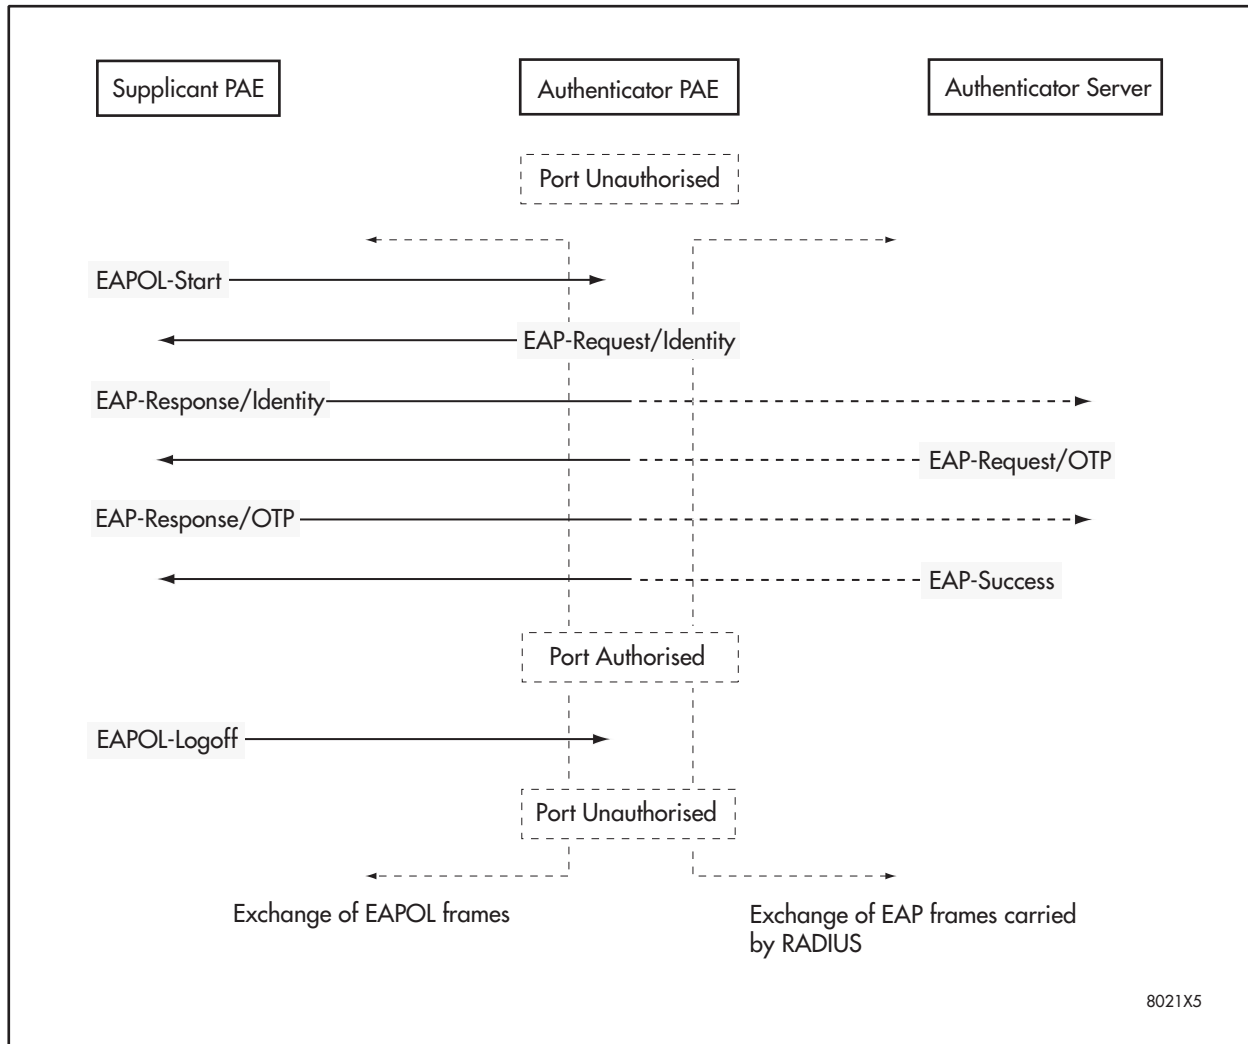
Figure 1: Authentication Messaging Exchange Initiated by the Supplicant.

To minimise the risk of denial-of-service attacks by issuing EAPOL-Logoff messages to an Authenticator Port Access Entity (PAE) from a third party device, we recommend that 802.1x not be used in a shared media LAN.
