SWA2801z REPAIR MANUAL

These instructions are intended to help restore any ailing SWA2801z Active Subwoofer back to factory working conditions. They show how to remove and replace the drivers and the amplifier assembly.

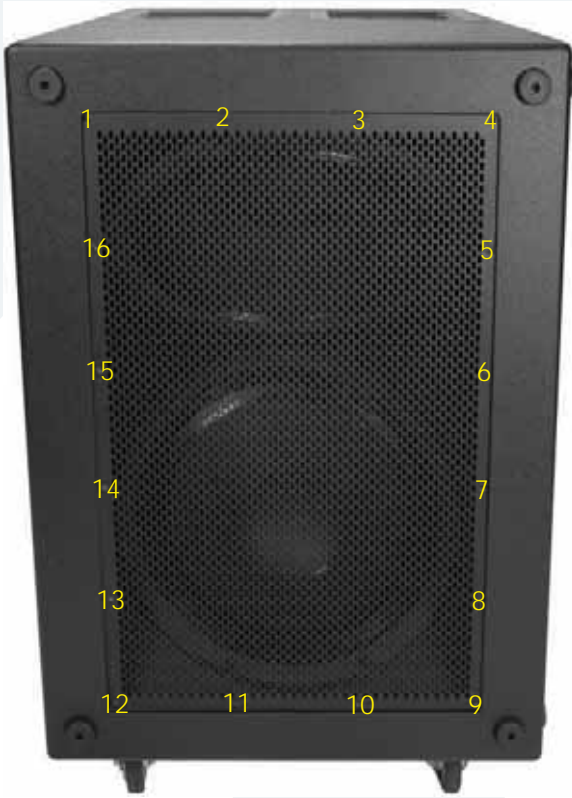
1 Sixteen screws need to be removed from the grill using the phillips head screwdriver. Make sure the front of the cabinet is facing upwards and the wheels are facing down.

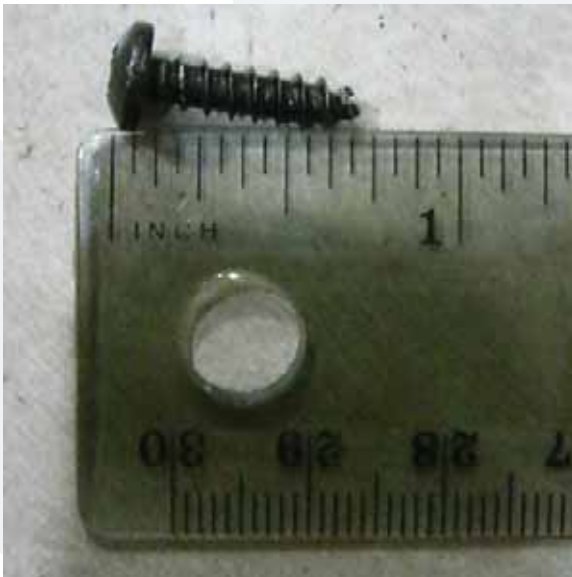
2 Keep the sixteen screws in a safe place.

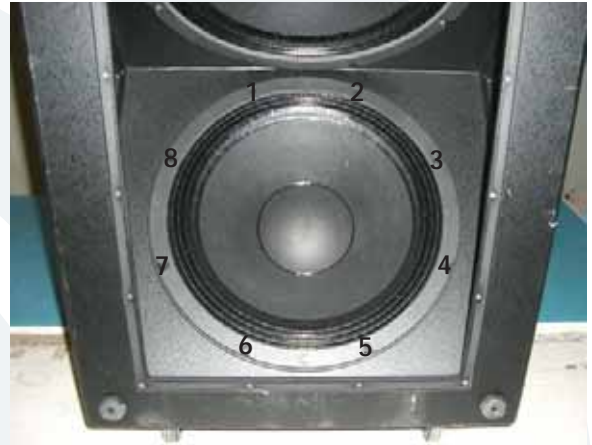
3 Eight screws need to be removed from the woofer using the 4mm allen wrench.

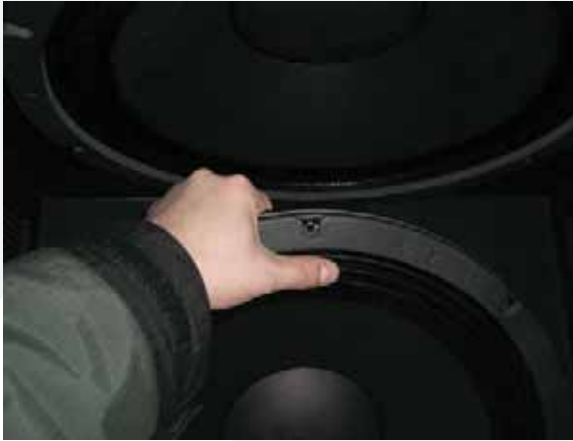
- 5** Carefully begin to remove the woofer. It may be easier to start at the top so the weight remains rested on the bottom until a firm grip of the entire woofer can be made.

Caution: The woofer is approximately 20 pounds with the weight unevenly distributed.

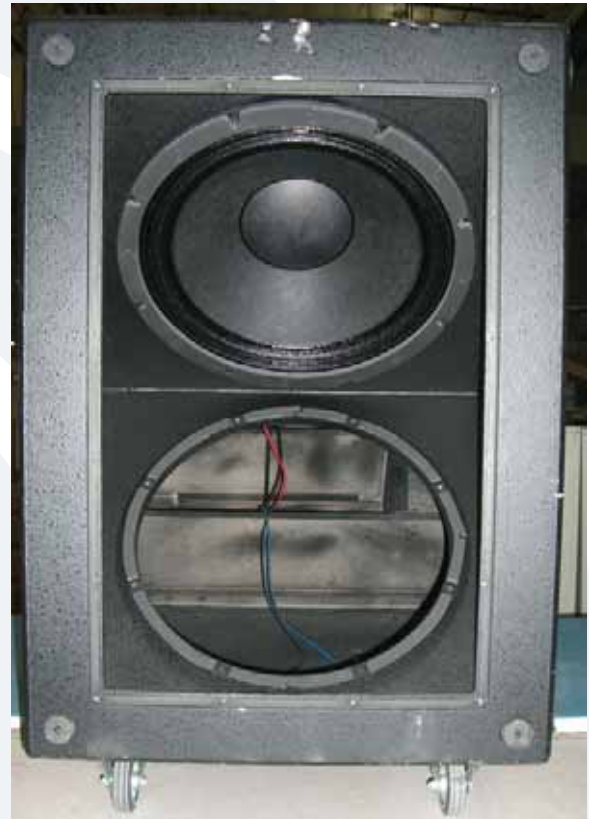
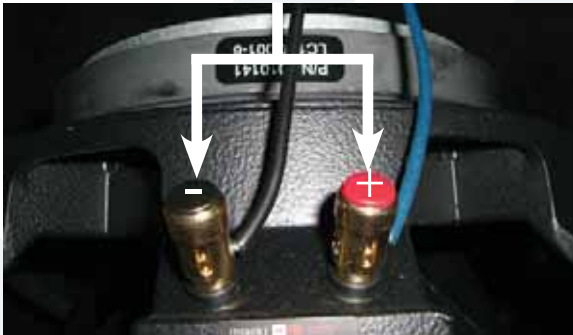
**Push down**

- 6** The positive (solid blue) and negative (solid black) cables are still attached to the woofer terminals. Remove the cables from their terminals simply by pushing down on the terminal and pulling out the cable. The woofer may be removed from the cabinet enclosure by angling it to the side ever so slightly.

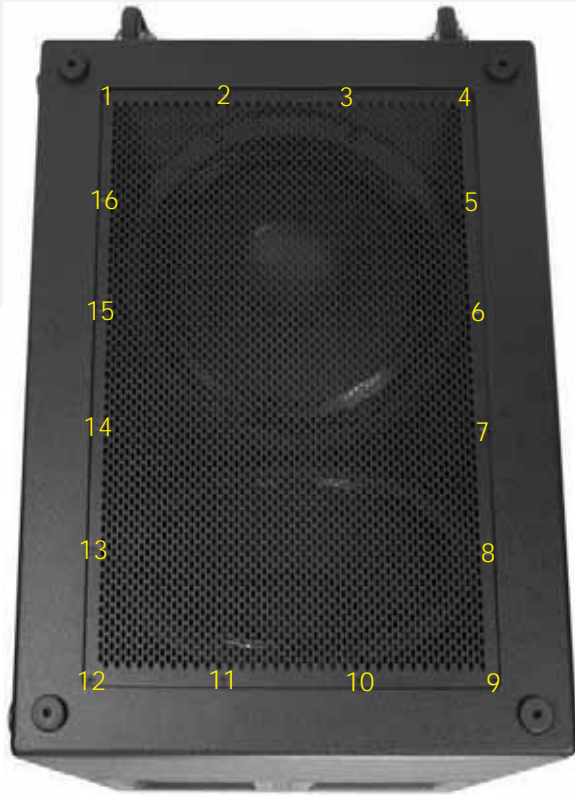
1 Sixteen screws need to be removed from the grill using the phillips head screwdriver. Make sure the wheels are facing upwards and the front of the cabinet is facing down.

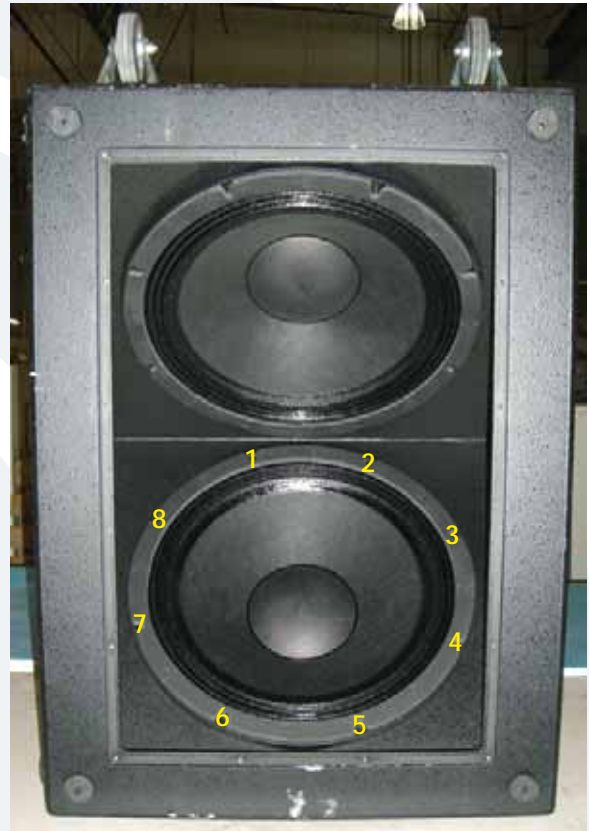
3 Eight screws need to be removed from the woofer using the 4mm allen wrench.

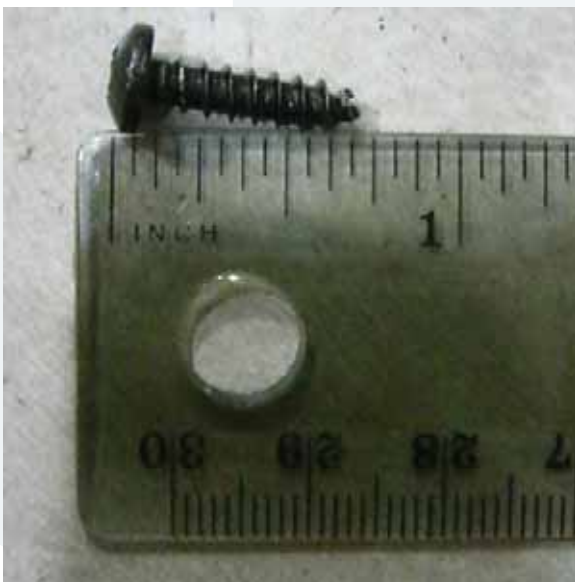
2 Keep the sixteen screws in a safe place.

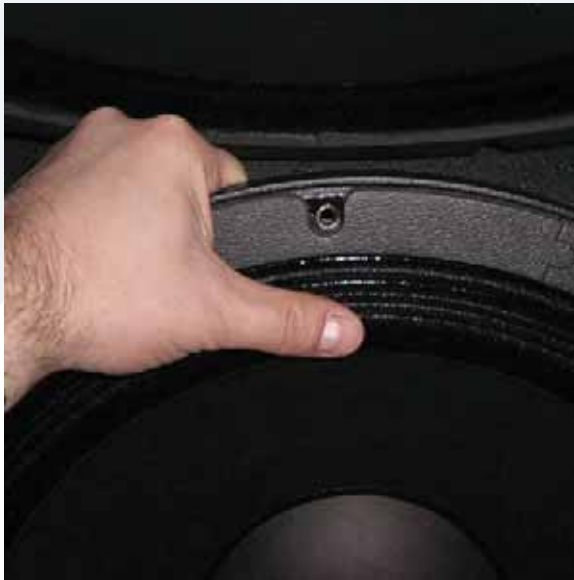
5 Carefully begin to remove the woofer. It may be easier to start at the top so the weight remains rested on the bottom until a firm grip of the entire woofer can be made.

Caution: The woofer is approximately 20 pounds with the weight unevenly distributed.

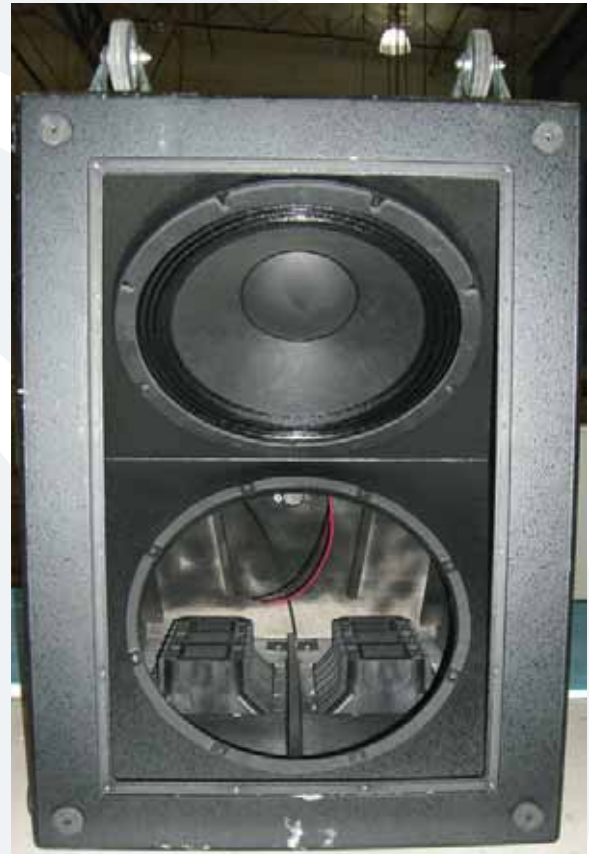
7 This is what it looks like with the grill and woofer removed. Place the new woofer (part #0010141) where the old one was. Follow the same steps as above, but backwards 6 to 1. Power up the SWA2801z and the new woofer should now be pumping out glorious lows. Awesome, you just replaced an 18" woofer!

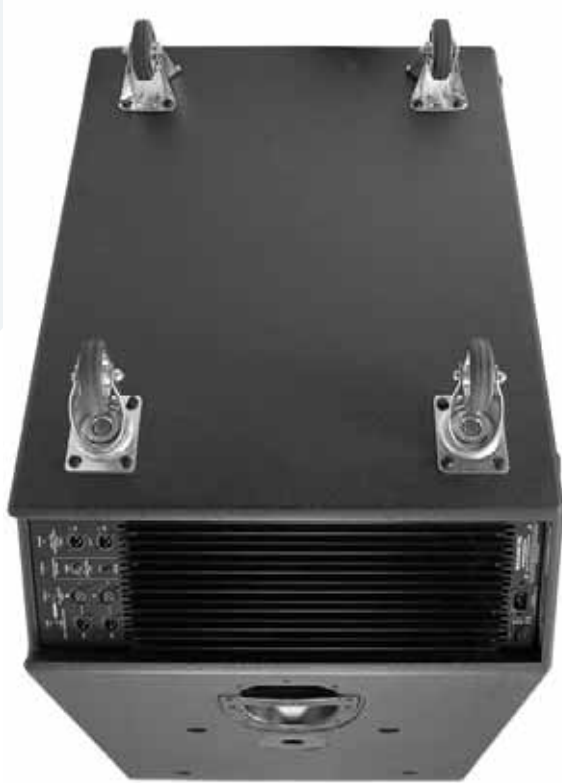
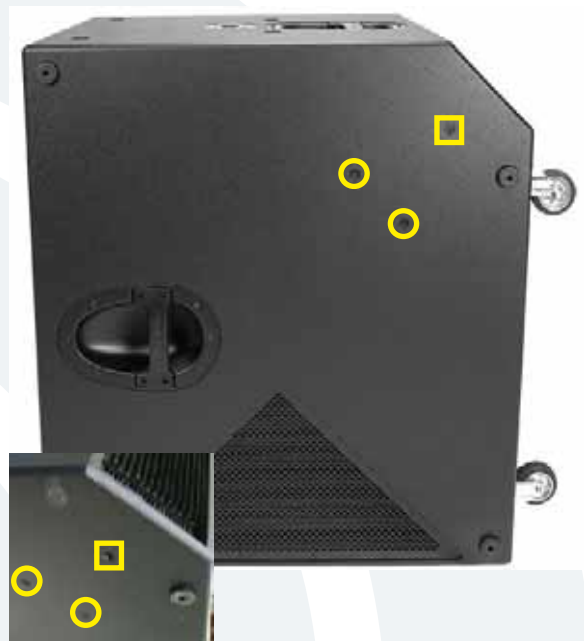
1 Five screws need to be removed from the SWA2801z amplifier assembly using the 5mm allen wrench. Two screws are located on the left side, three on the right. See the following pictures and further instructions. Make sure the wheels are facing upwards and the front of the cabinet is facing down.

3 The last remaining three screws are located on the right side of the SWA2801z (holding the bottom of the amplifier assembly to the cabinet).

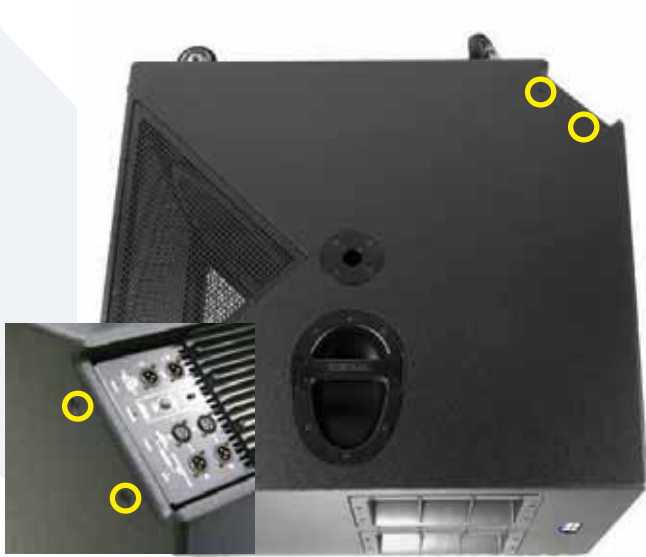
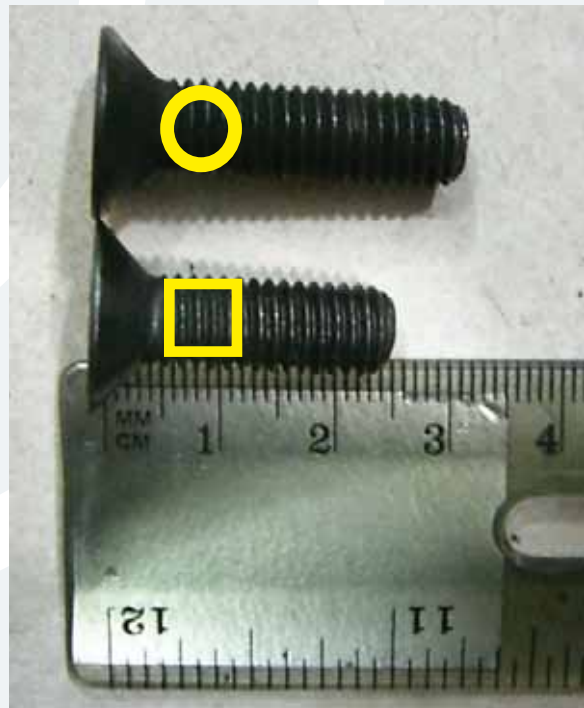
2 Two screws located on the left side of the SWA2801z patiently awaiting removal.

4 Keep the five screws in a safe place. Note: There are two different screws that connect the cabinet to the amplifier assembly (as seen above).

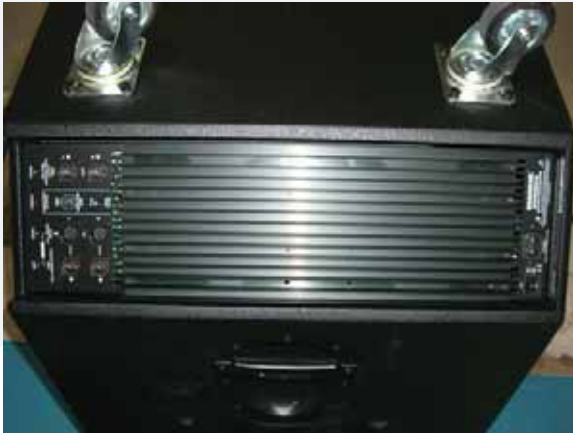
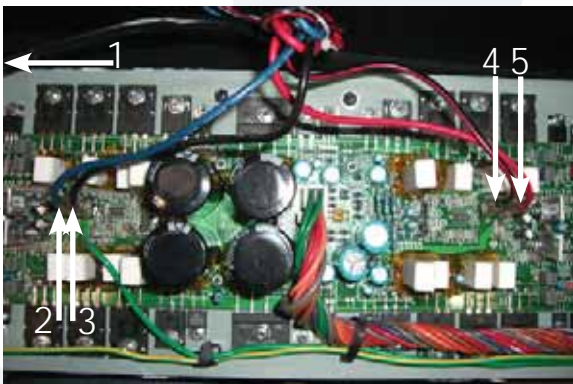
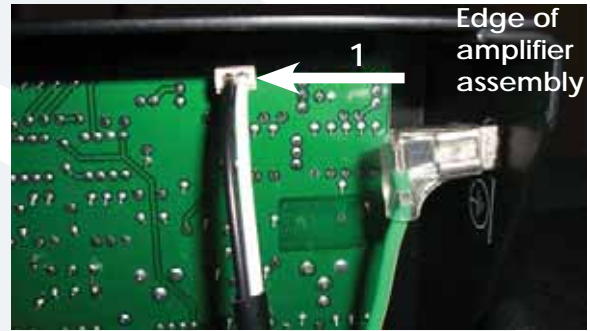
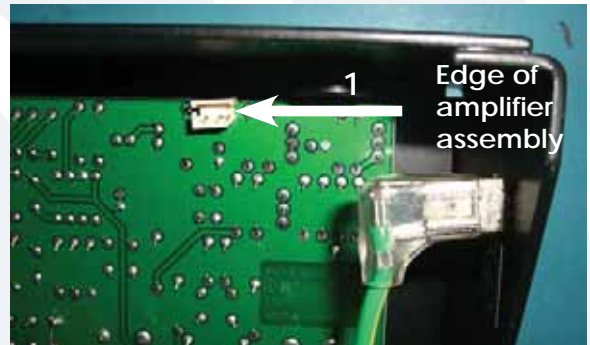
5a Closeups of the led PCB cable and connector are shown above. The white wire of the cable is closest to the edge of the amplifier assembly. The cable only fits in one way.

5 It may be easier to remove the amplifier assembly by gripping a ridge on each side of the assembly using a pair of pliers. Do not completely remove the amplifier assembly yet, as some cables need to be removed first. Five cables need to be removed from the amplifier assembly: (1) led PCB cable, (2) solid blue, (3) solid black, (4) red and black, and (5) solid red. Do not force cable removal or connection, although needle-nose pliers may aid in loosening the crimped cables. Notice their placement in the following pictures, as well.

Caution: The amplifier assembly is approximately 22 pounds, so please make sure to grasp it firmly.

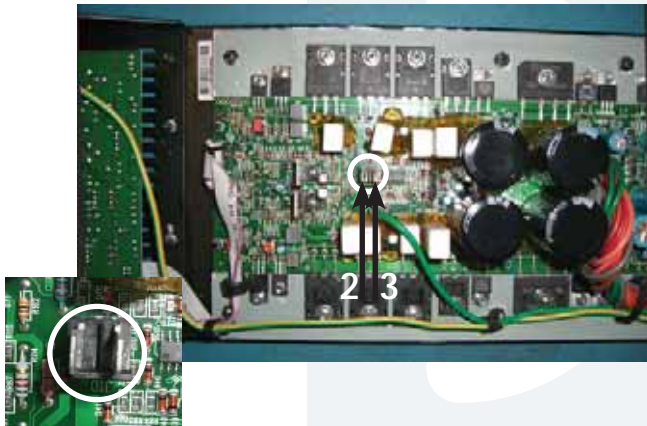
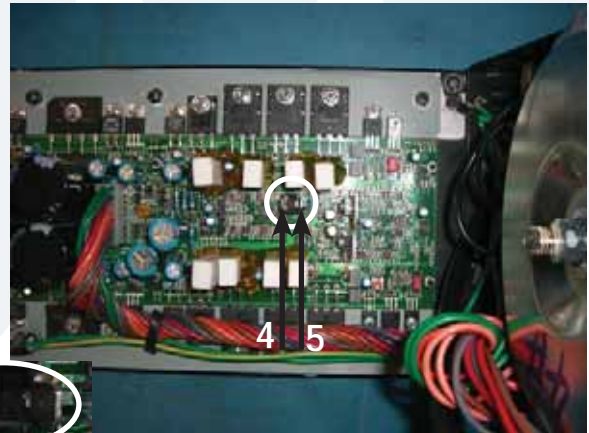
5c Closeups of the other woofer's cables and connectors are shown above. Make sure the cables are reconnected to the same terminals they were removed from (but on the new amplifier assembly). Once again, they are: (4) red and black and (5) solid red. Do not force cable removal or connection, although needle-nose pliers may aid in loosening the crimped cables.
